Boone Dam Hydro-Geo Model and Seepage Remediation

Patrick V. Kiser, PE
GCP&S Manager, Civil Engineering
01 December 2015

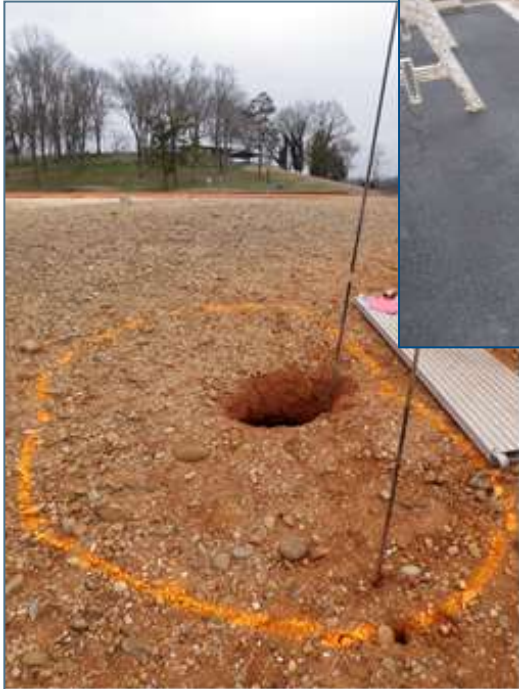
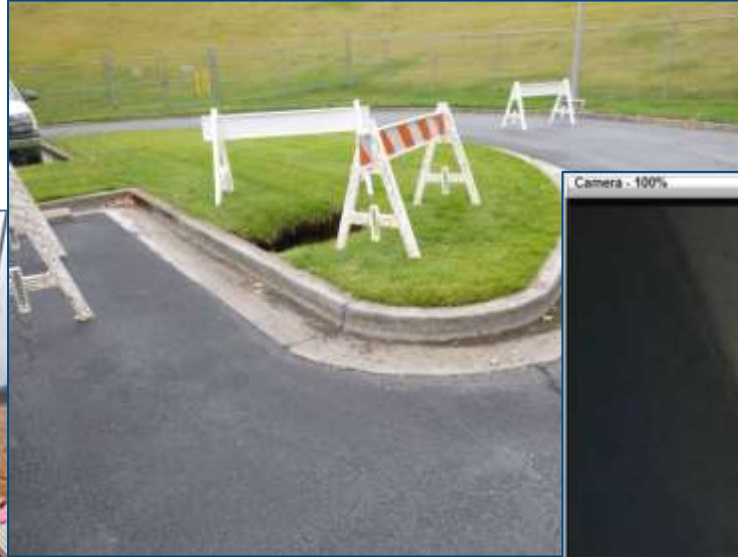
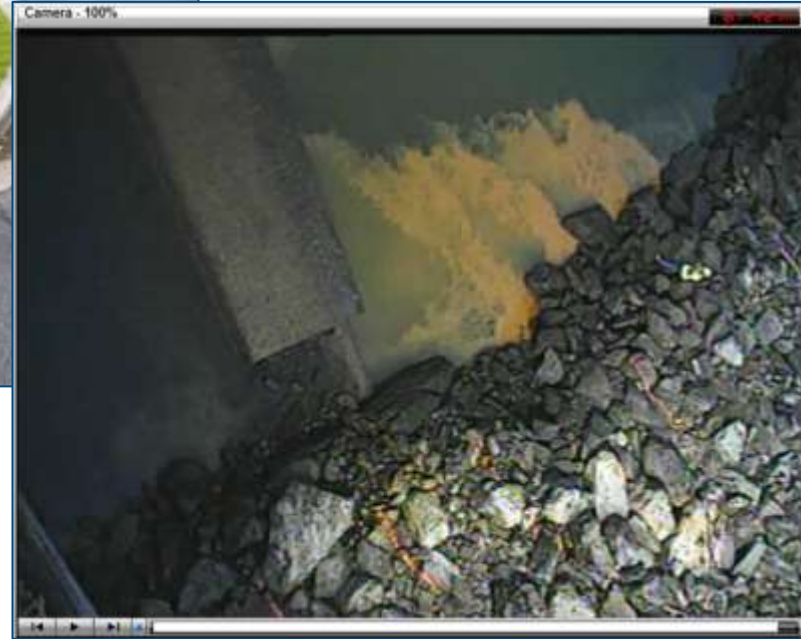
Background: Sinkholes and Turbid Discharge

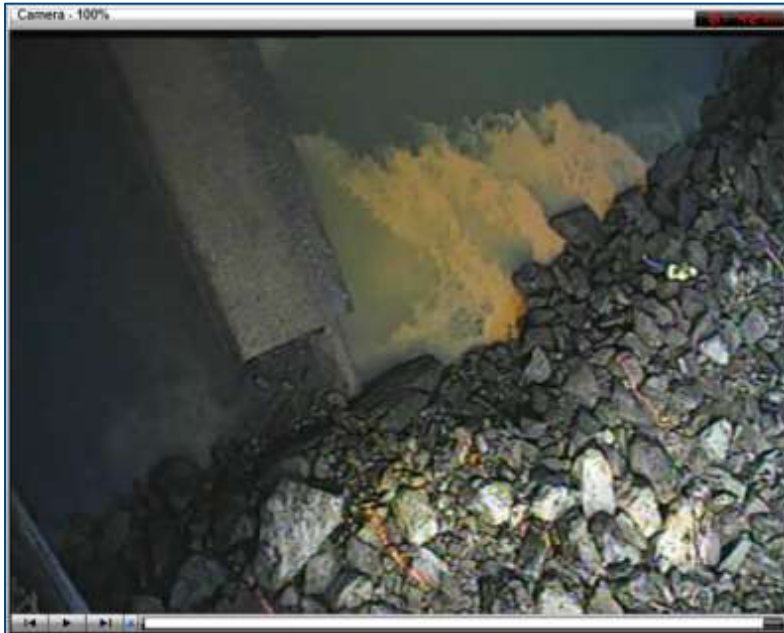
Muddy Seep in Tailrace

10/30/14 ▪ 18:42 ▪ Units Off ▪ HW 1372.7

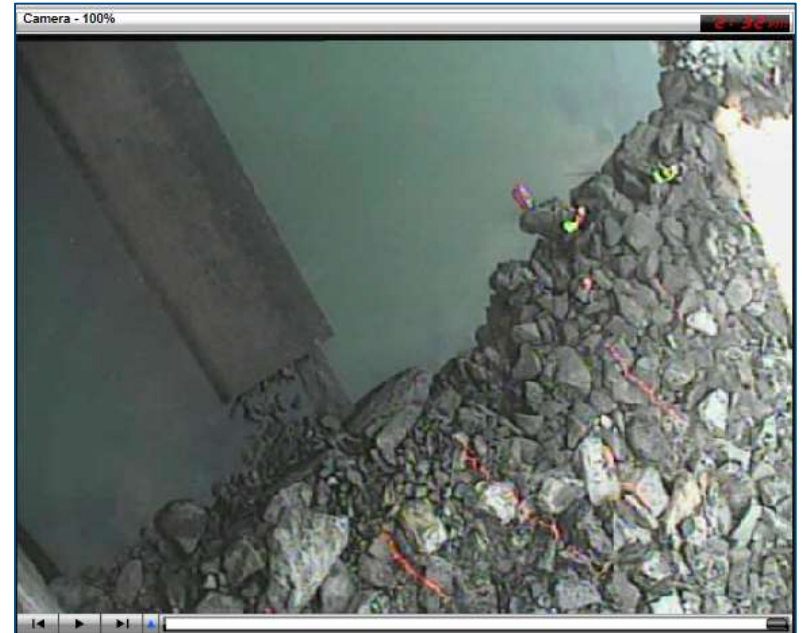
11/03/14 ▪ 14:32 ▪ Units Off ▪ HW 1367.4

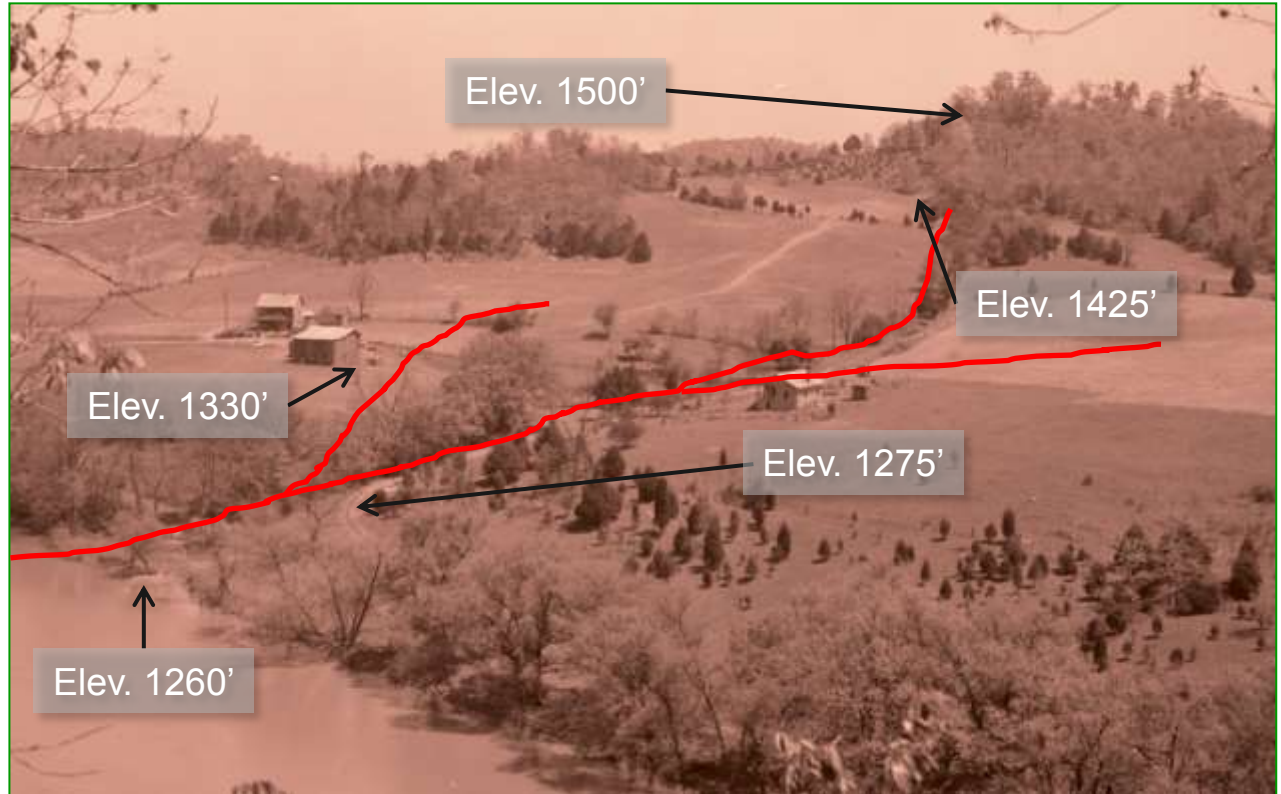
Preexisting
topographic
draw

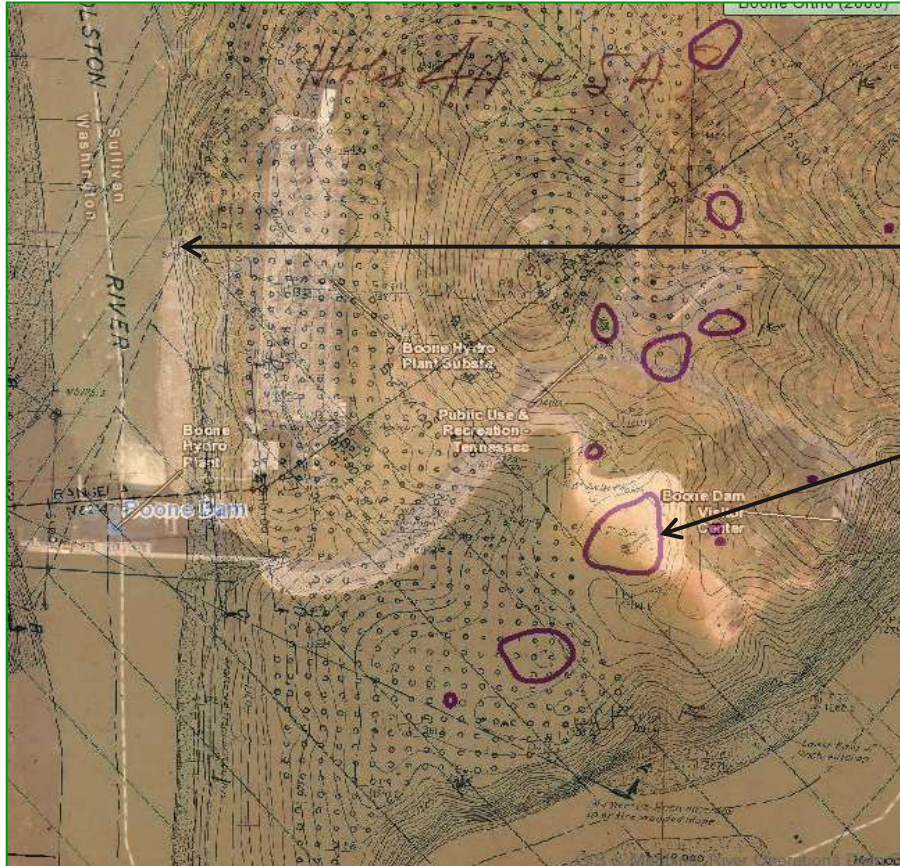
Preexisting sinkholes and natural springs

Spring prior to construction

Depressions prior to construction

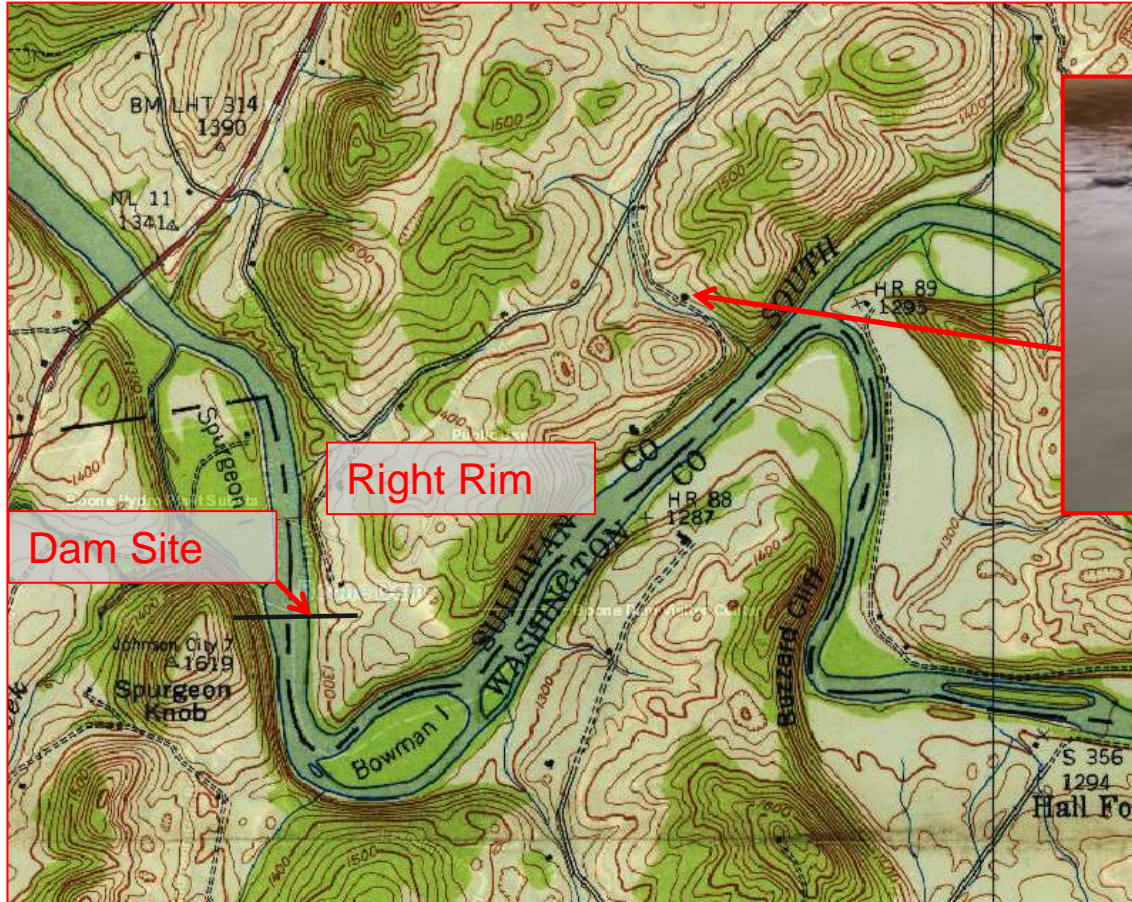
Artesian well in reservoir indicates higher head from regional groundwater recharge

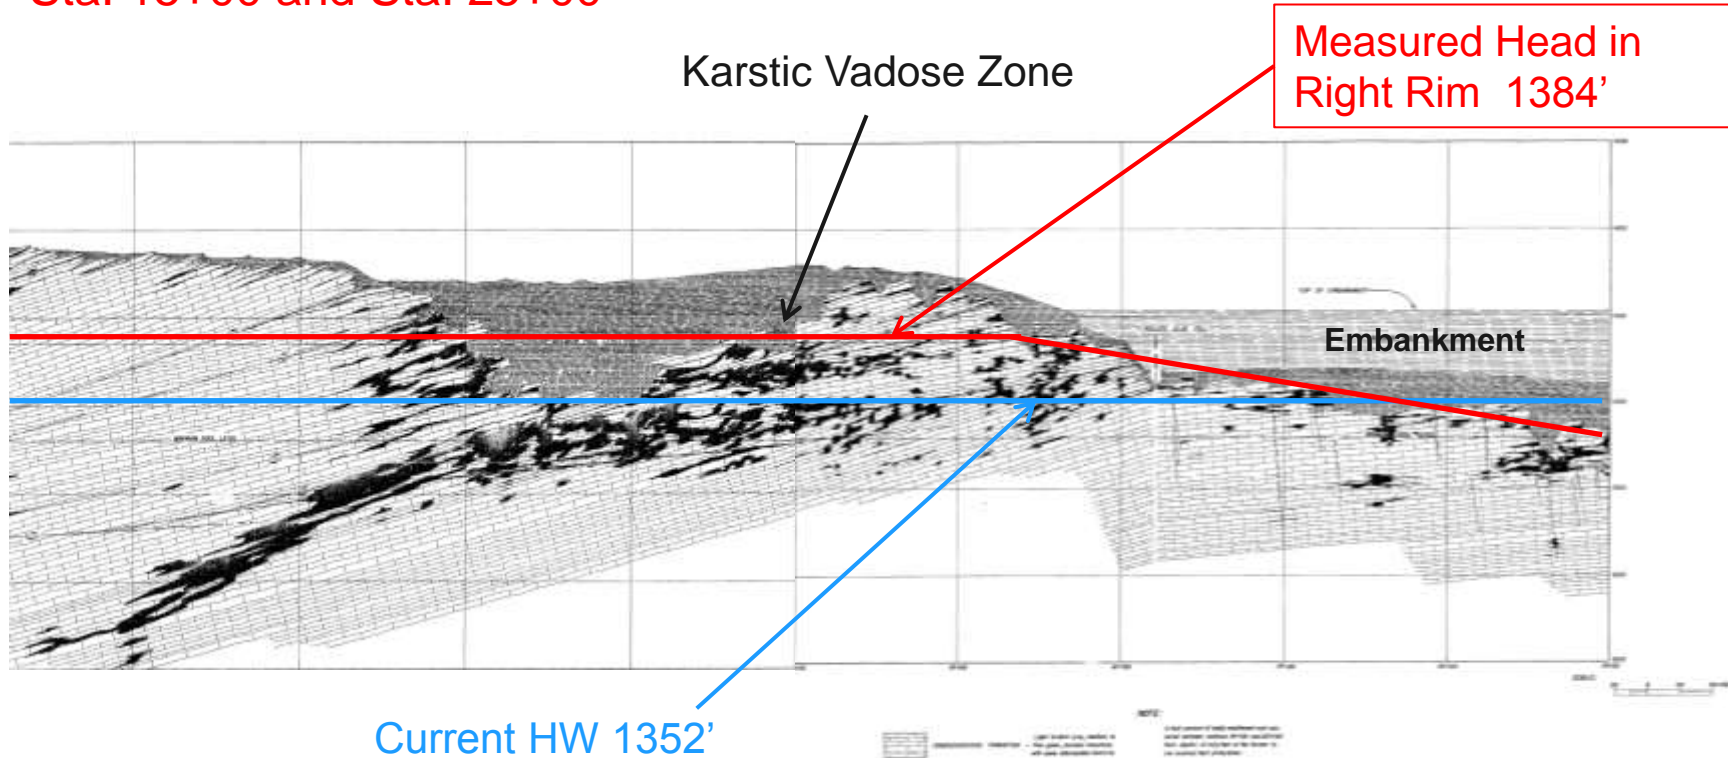
Extensive weathering in right abutment, Section along grout curtain between Sta. 15+00 and Sta. 25+00

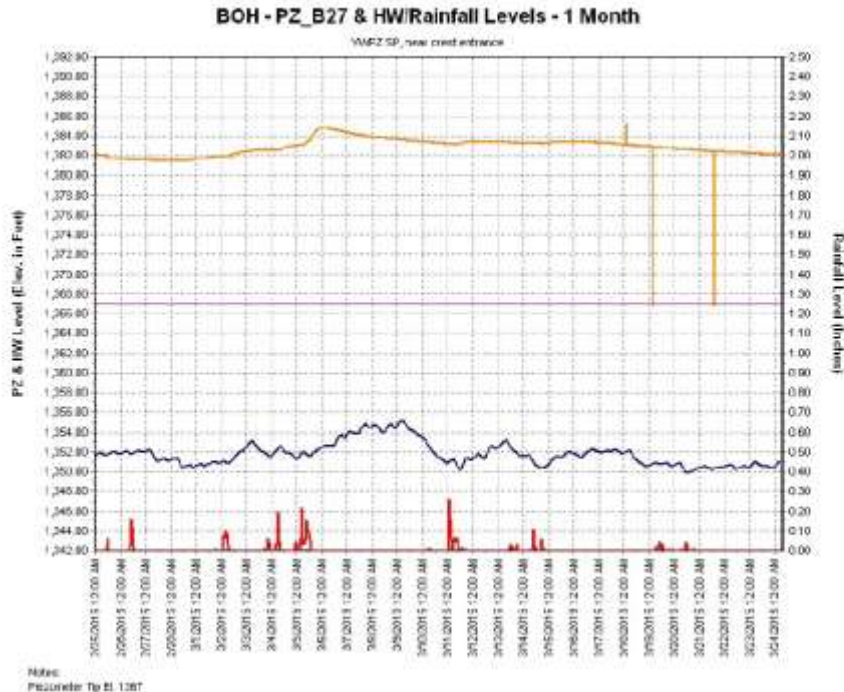
Piezometric data indicates heads significantly higher than headwater in the right rim and flow paths toward the toe. B-27, shown below, is ~ 20 feet higher than the current headwater.

Upstream of cutoff

Tip in Epikarst from Elev. 1389 to 1364

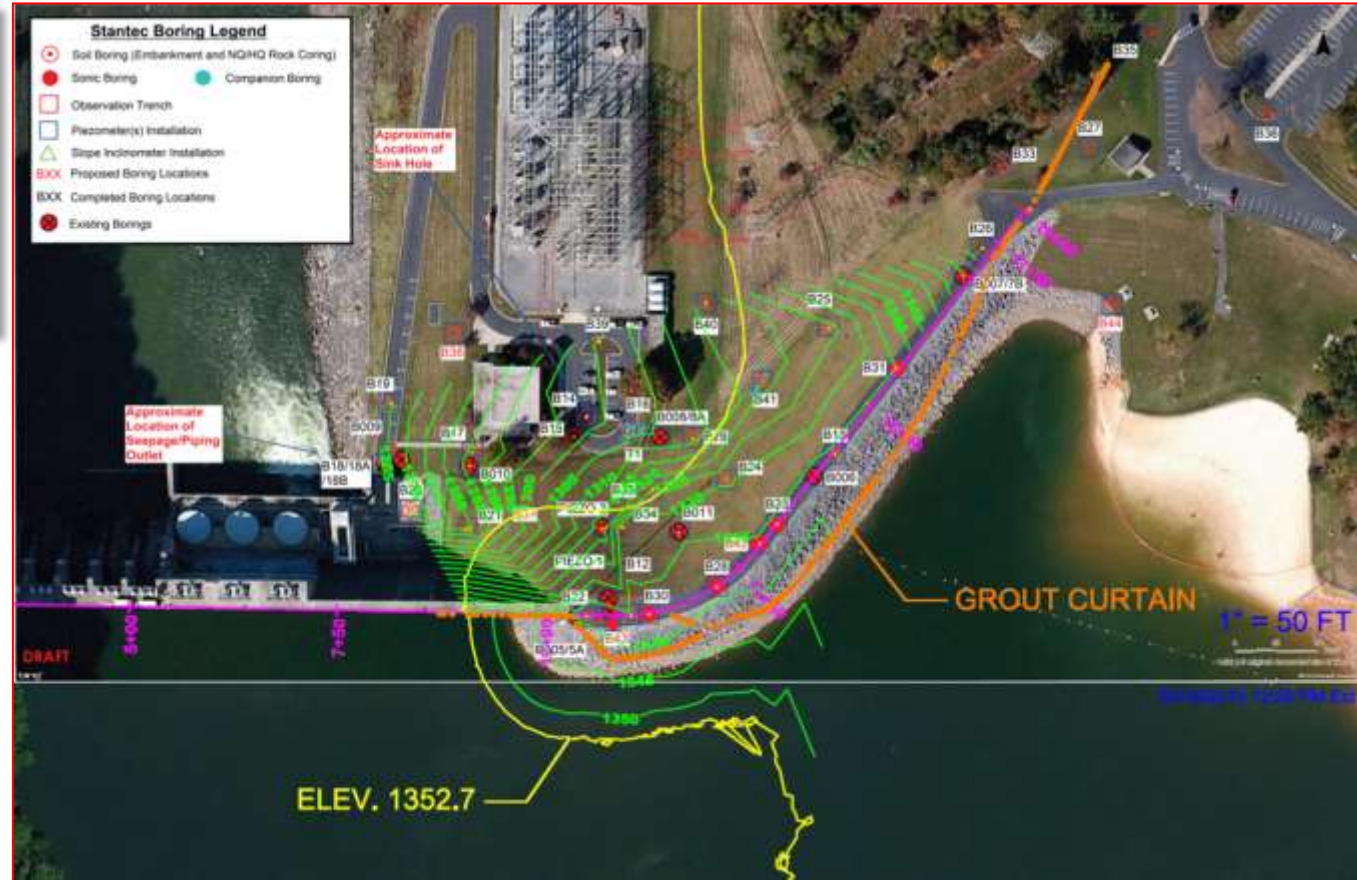
The piezometric contours indicate flow paths in the epikarst from the right rim toward the toe

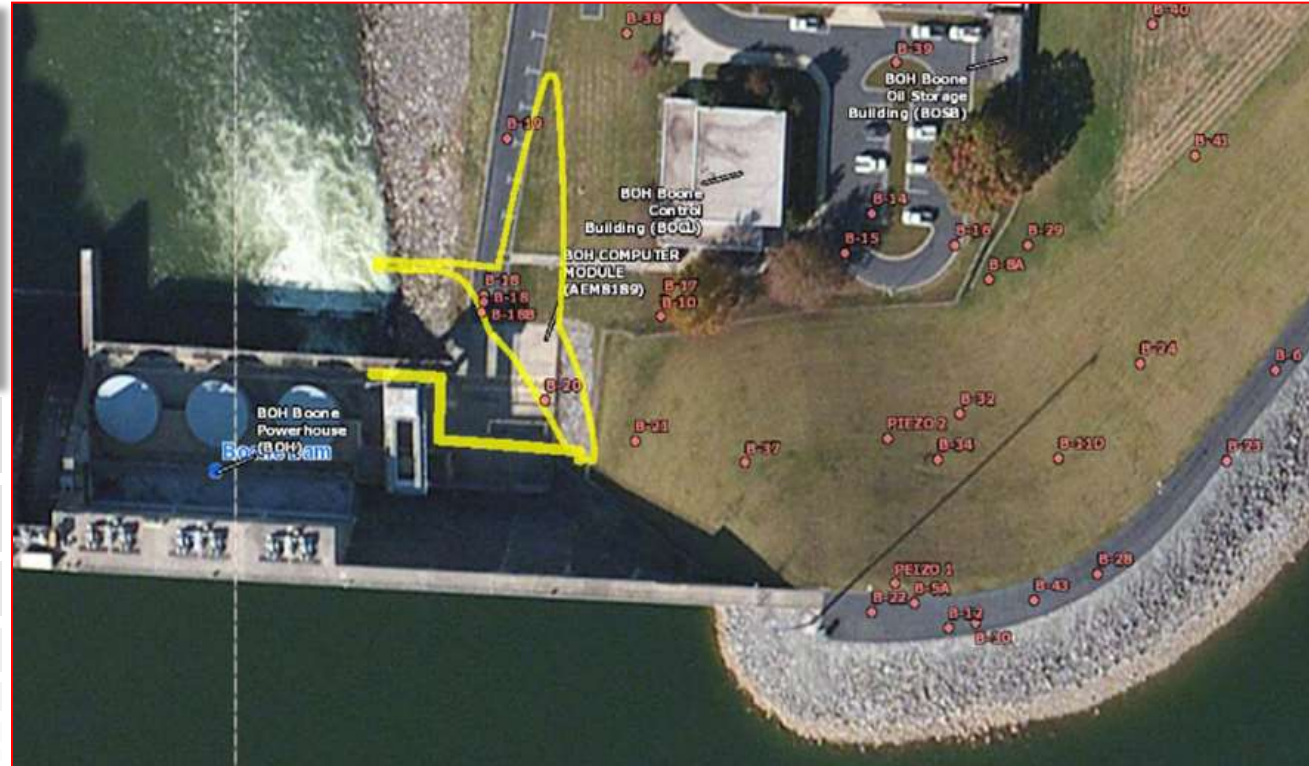
A French drain was required during construction to deal with excessive flows from springs in the area shown below.

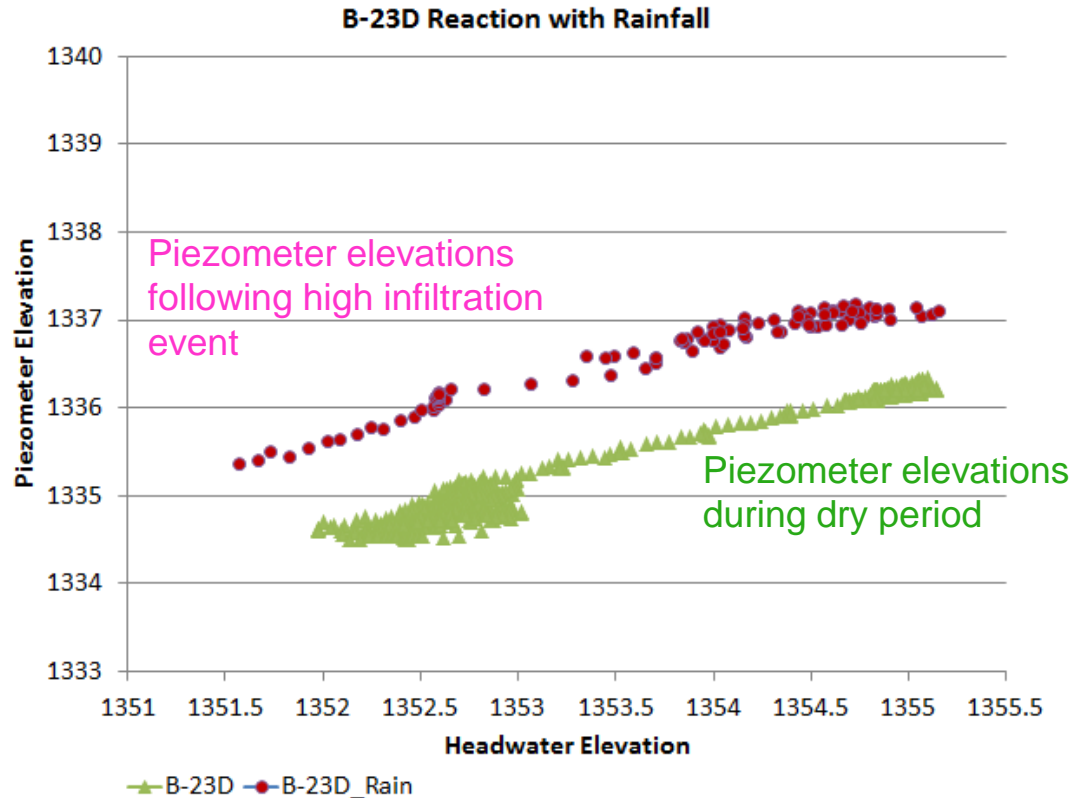
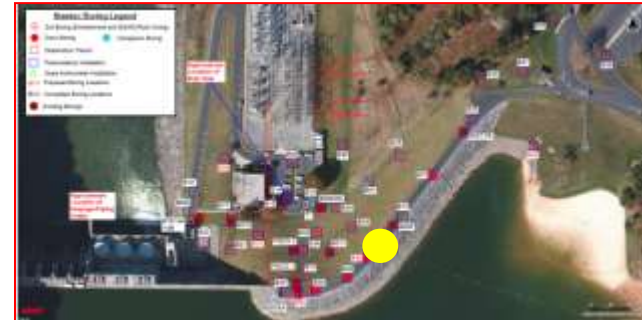
Vibrating wire piezometer B-23D fluctuates at higher elevations following high infiltration event

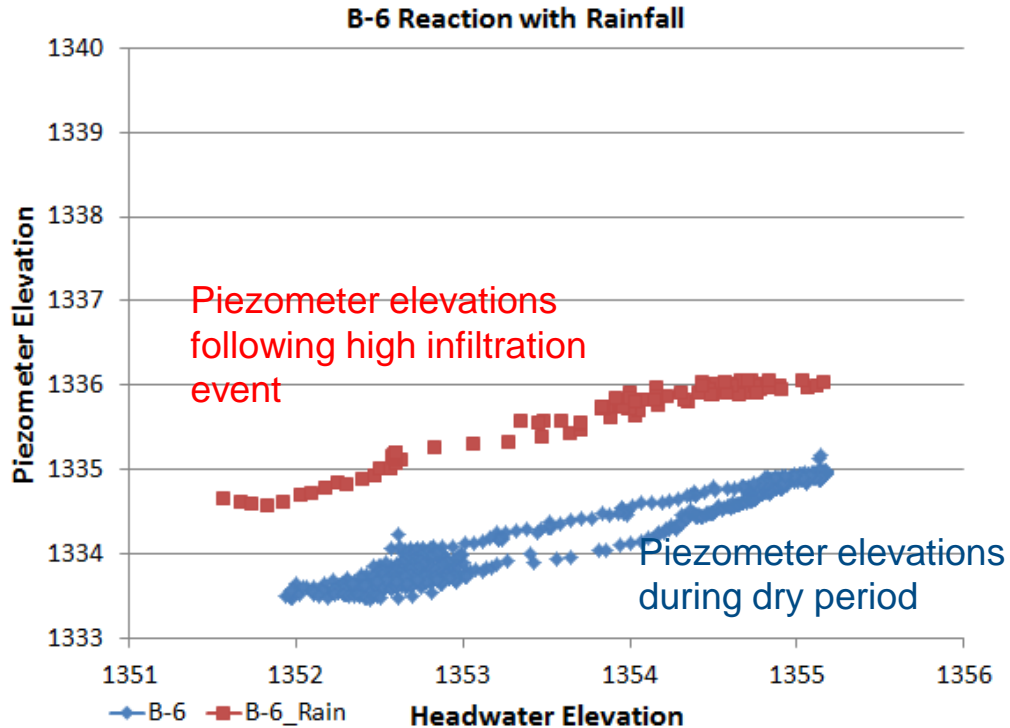
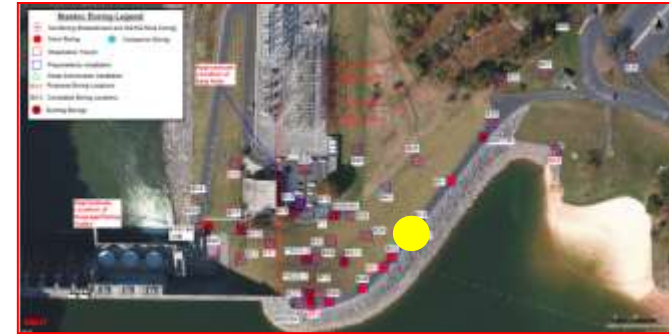
Open standpipe piezometer B-6 fluctuates at higher elevations following high infiltration event

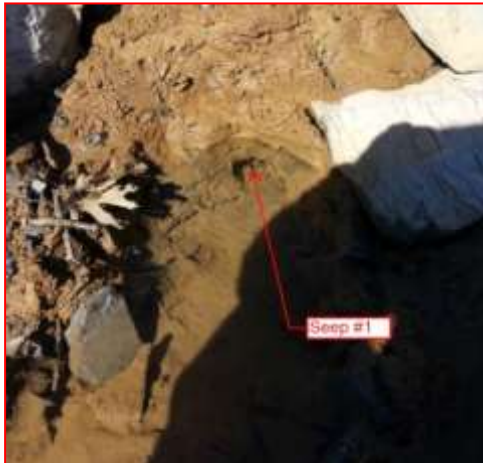
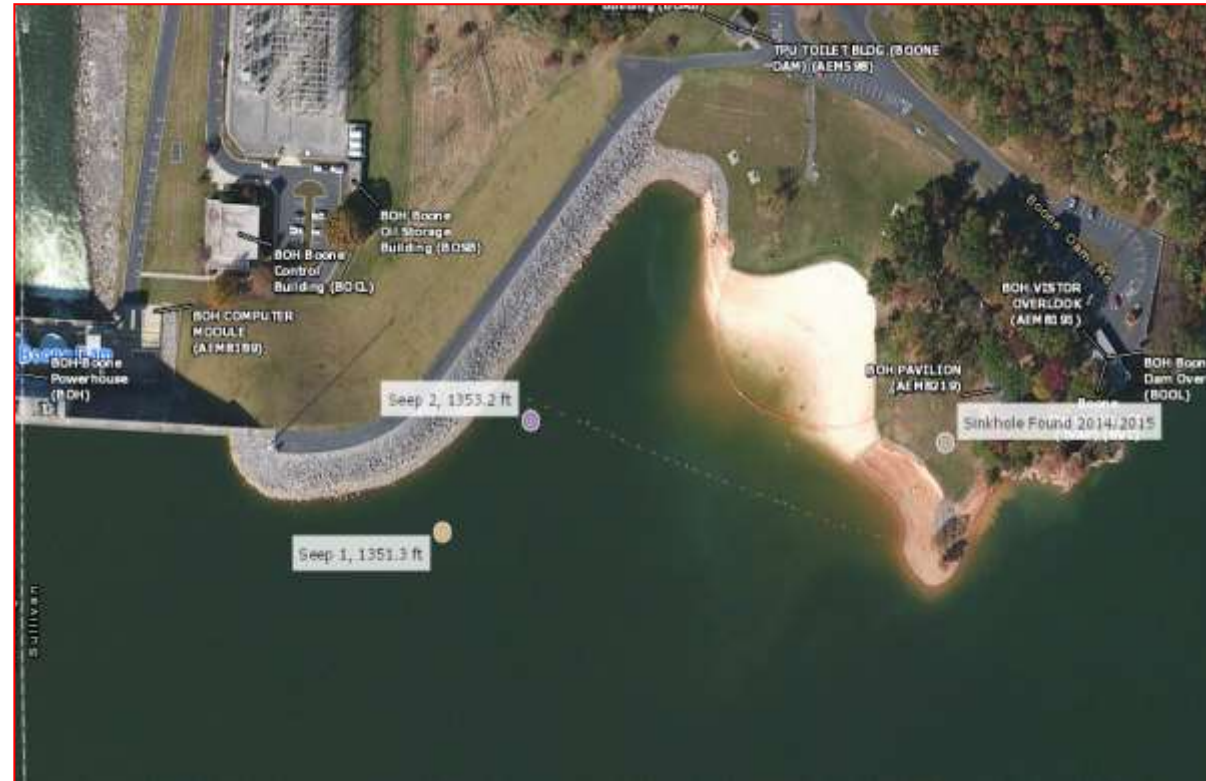
Following a high infiltration event on March 5, 2015 muddy seeps were observed along the upstream face of the dam

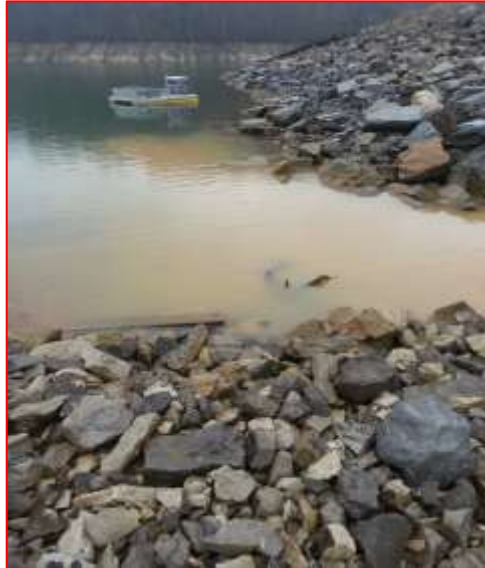
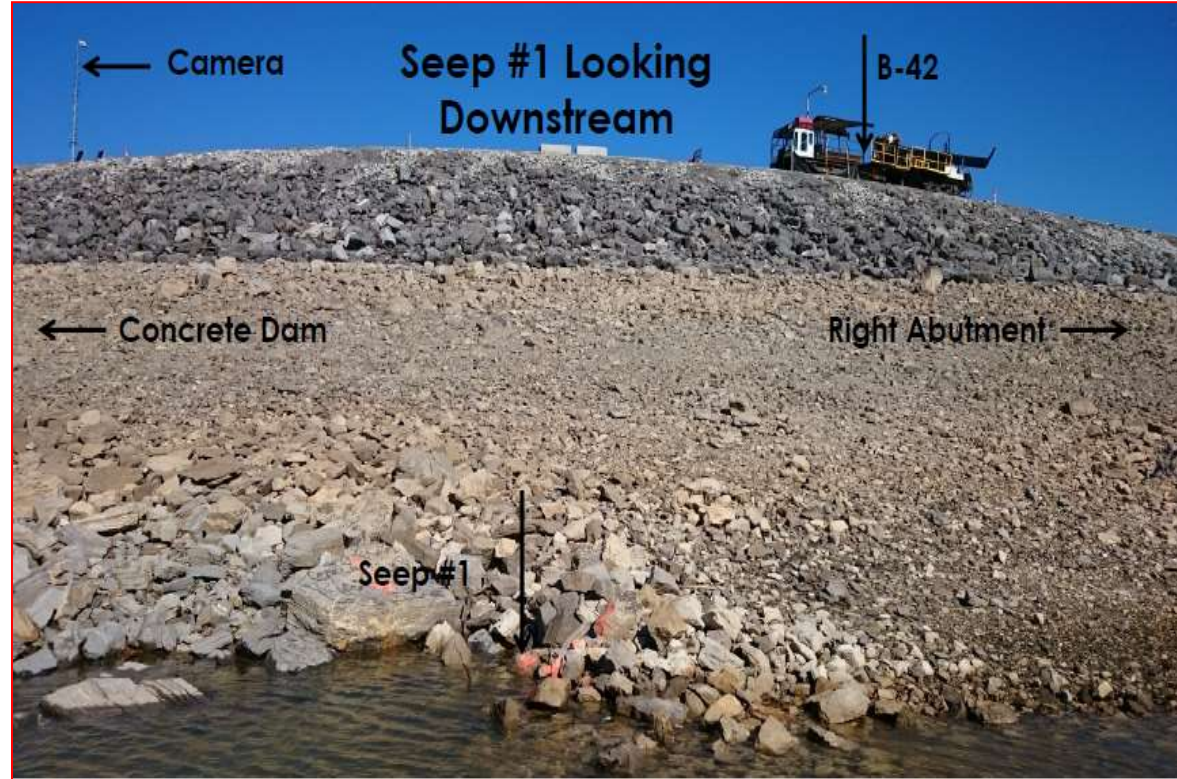
Following a high infiltration event on March 5, 2015 muddy seeps were observed along the upstream face of the dam

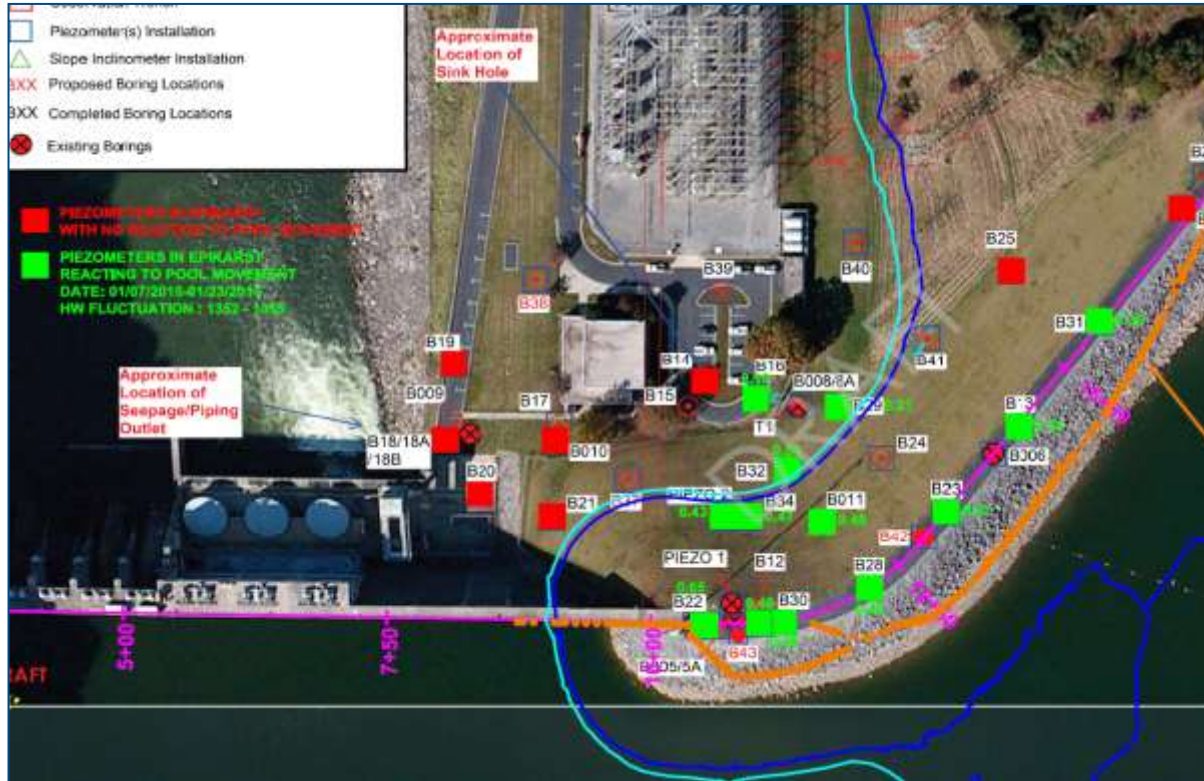
PZs respond to changes in HW with small lag times

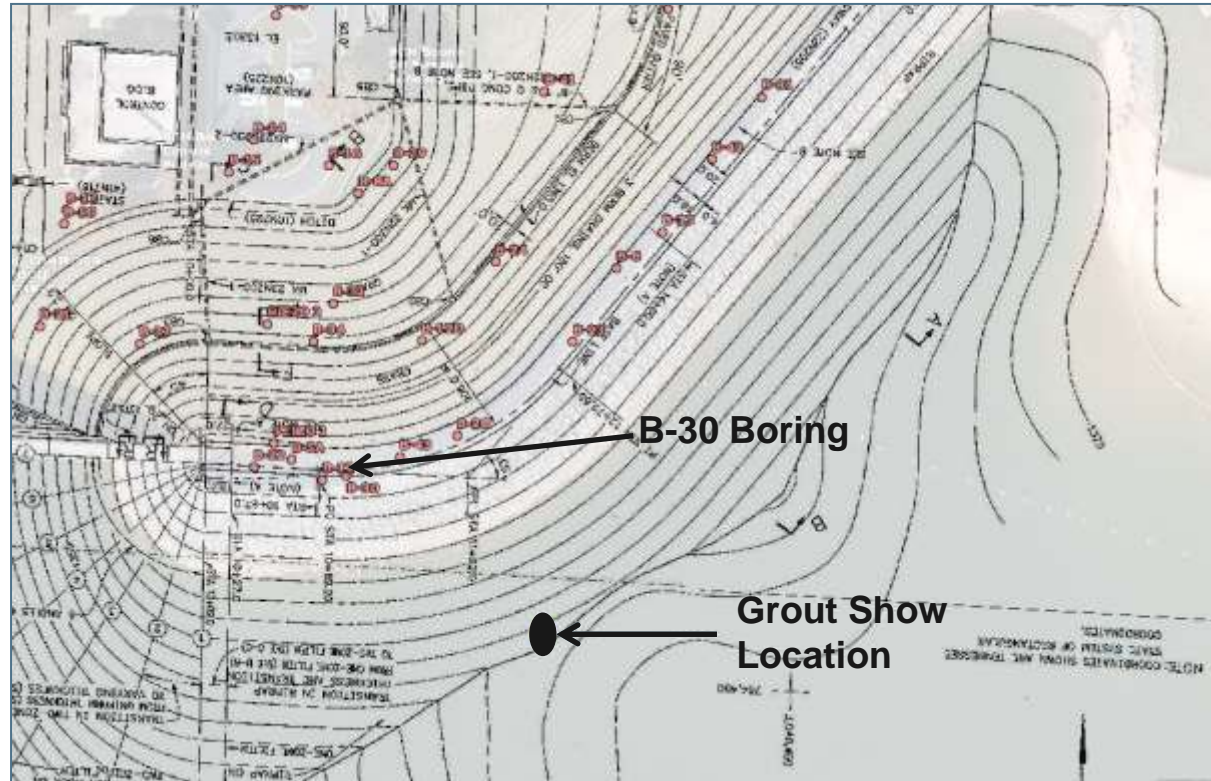
Grouting of the B30 instrument pushed grout from downstream of the cutoff to the reservoir

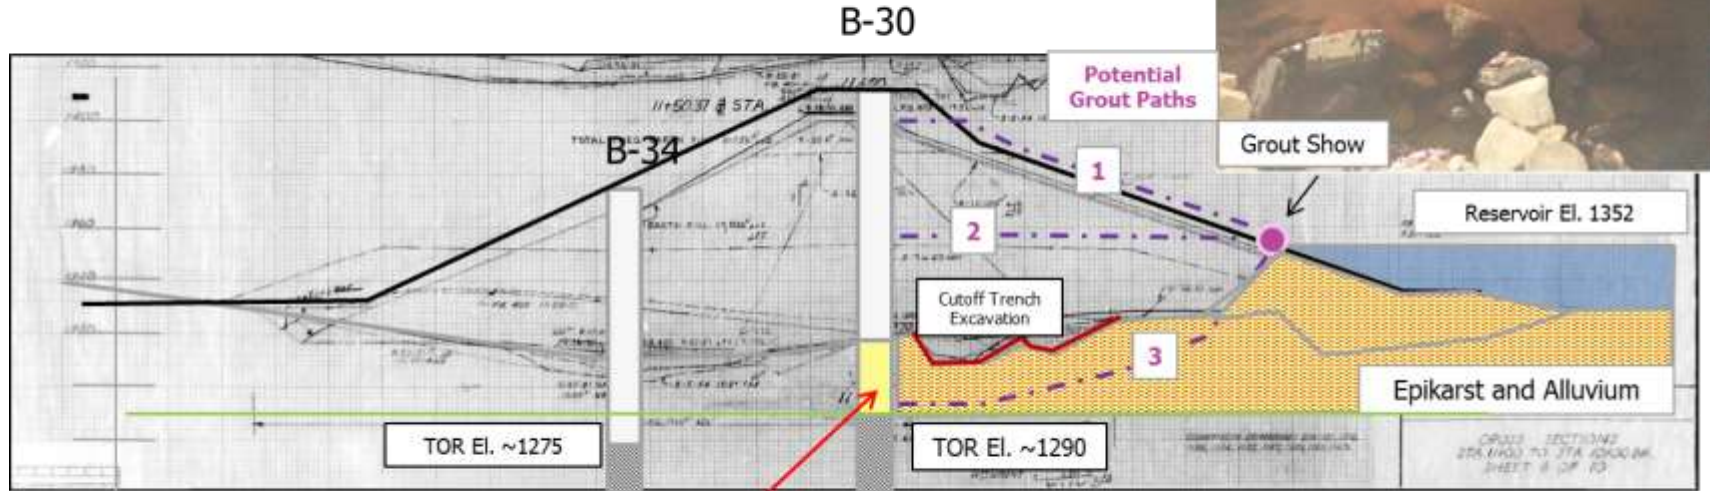
Grouting of the B30 instrument pushed grout from downstream of the cutoff to the reservoir

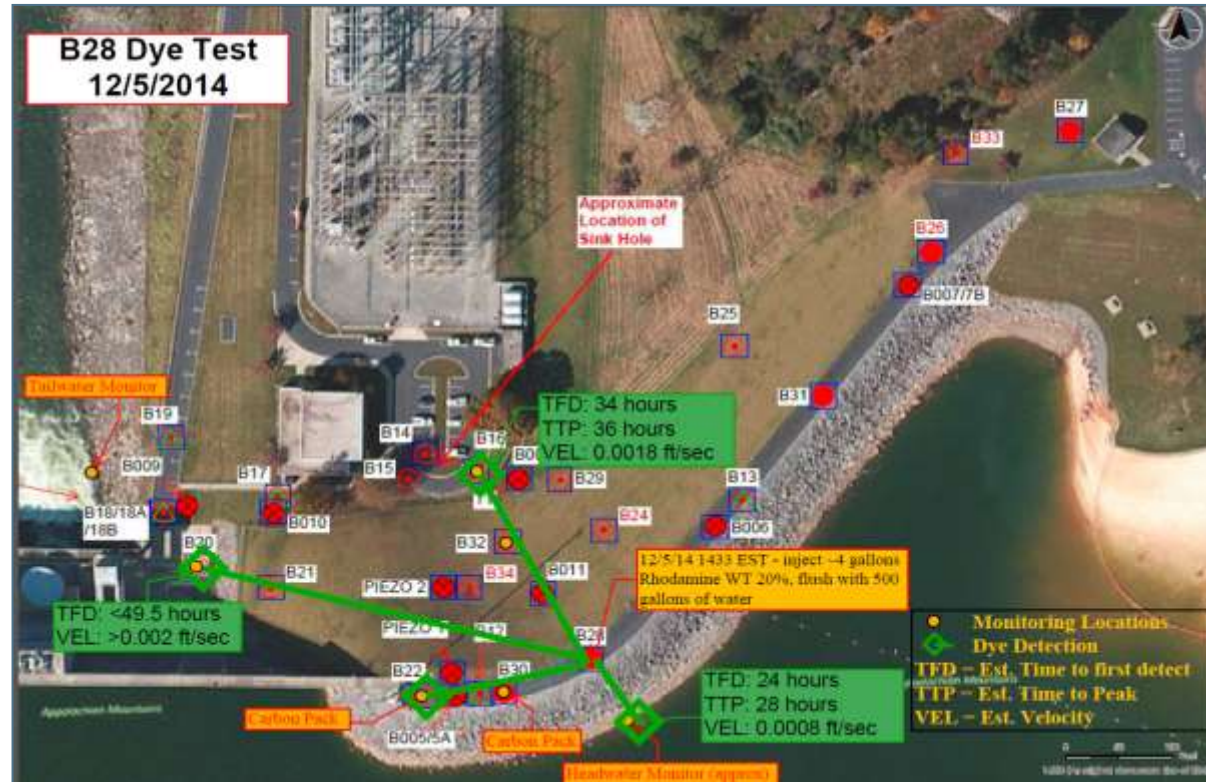
B28 dye test from downstream of cutoff had a detect to the upstream of the cutoff

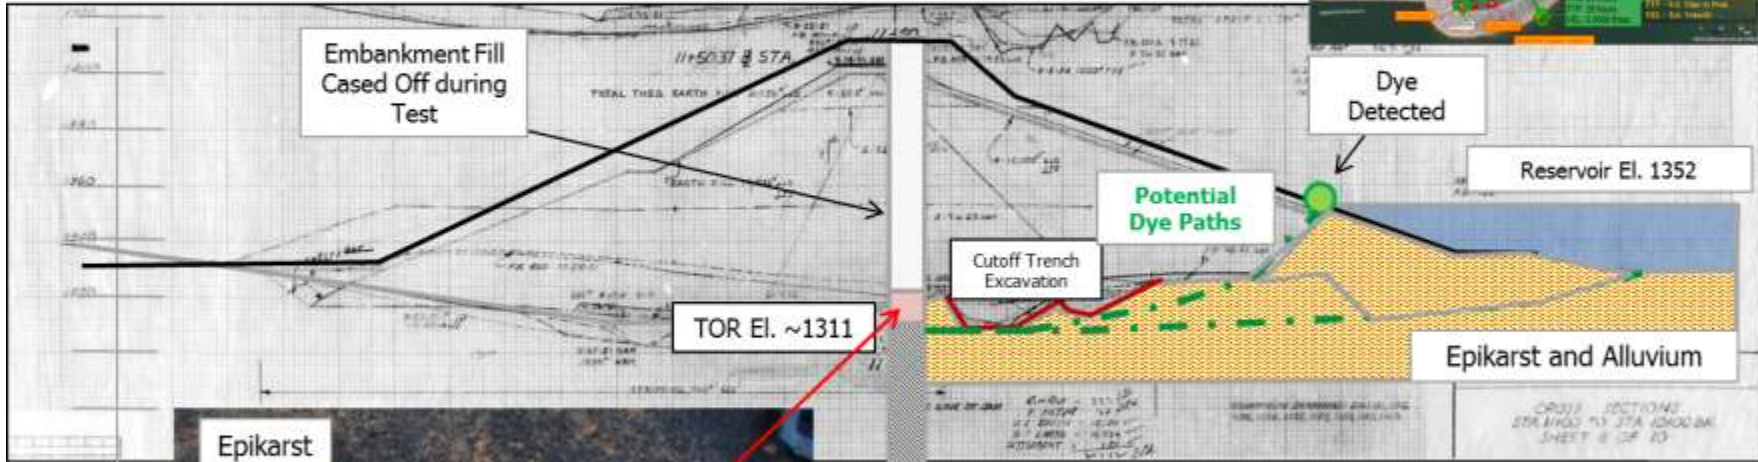
B-28

B28 dye test pushed dye from downstream of cutoff to the upstream of the cutoff

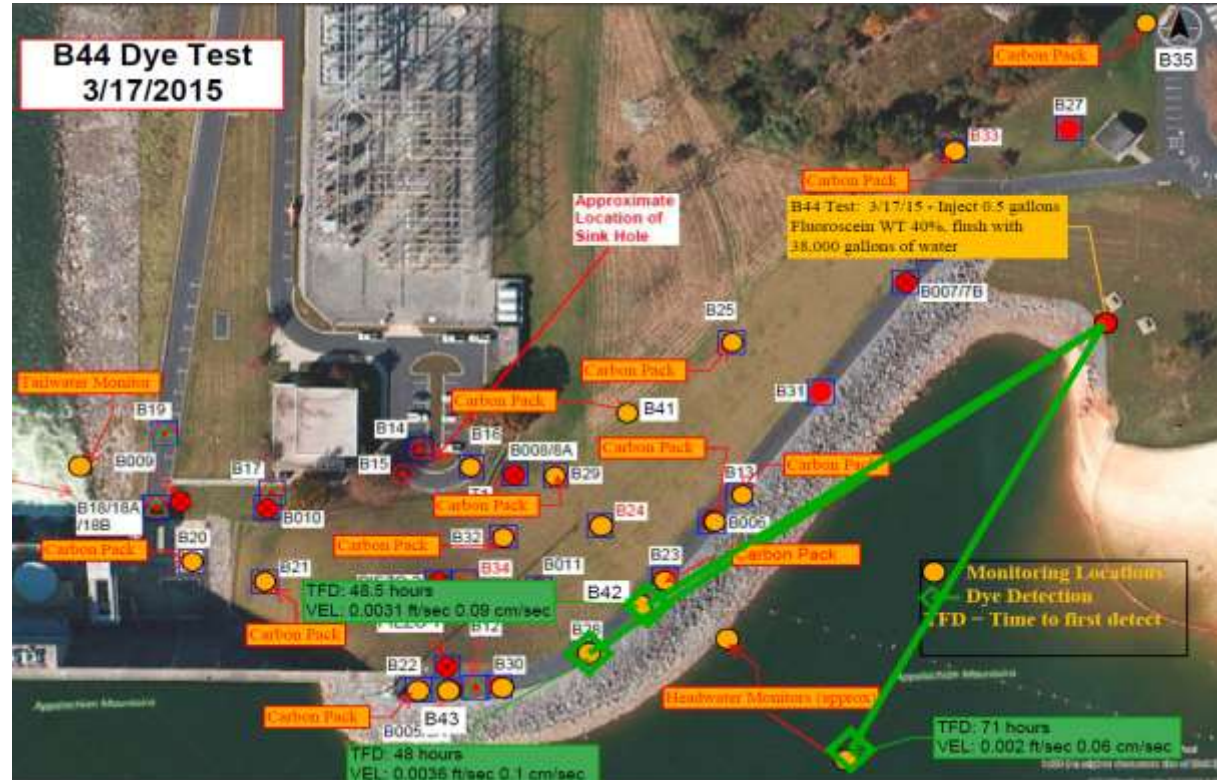
B-44 dye test (U/S) resulted in dye in B-28 and B-42 (D/S) epikarst and headwater

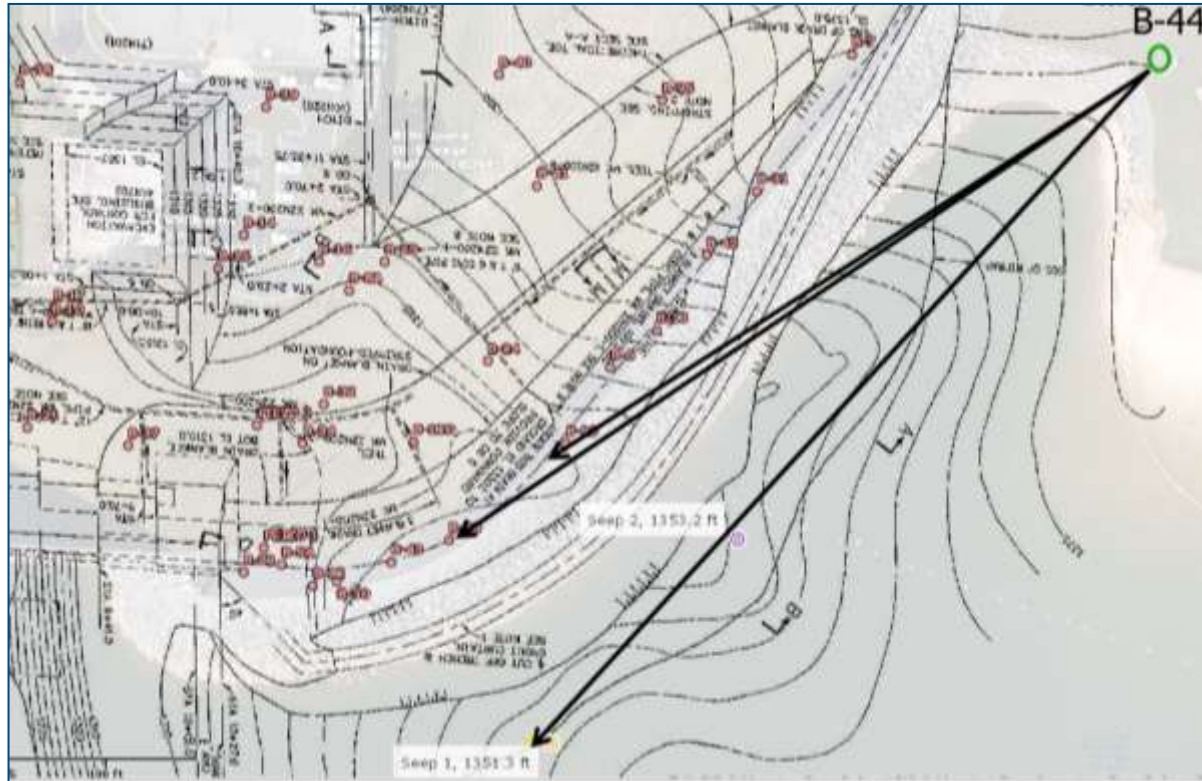
B-44 dye test (U/S) resulted in dye in B-28 and B-42 (D/S) epikarst

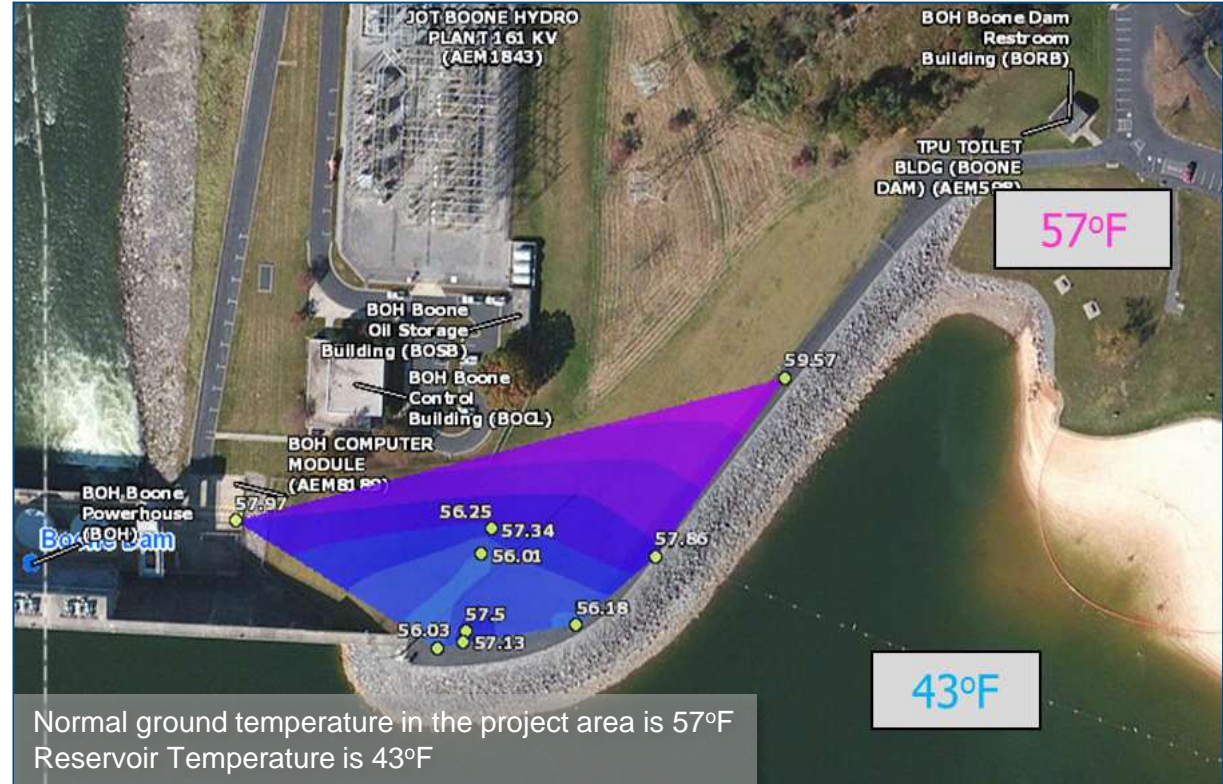
Temperature closely matches regional ground temperature and indicates very little flow through the embankment soils

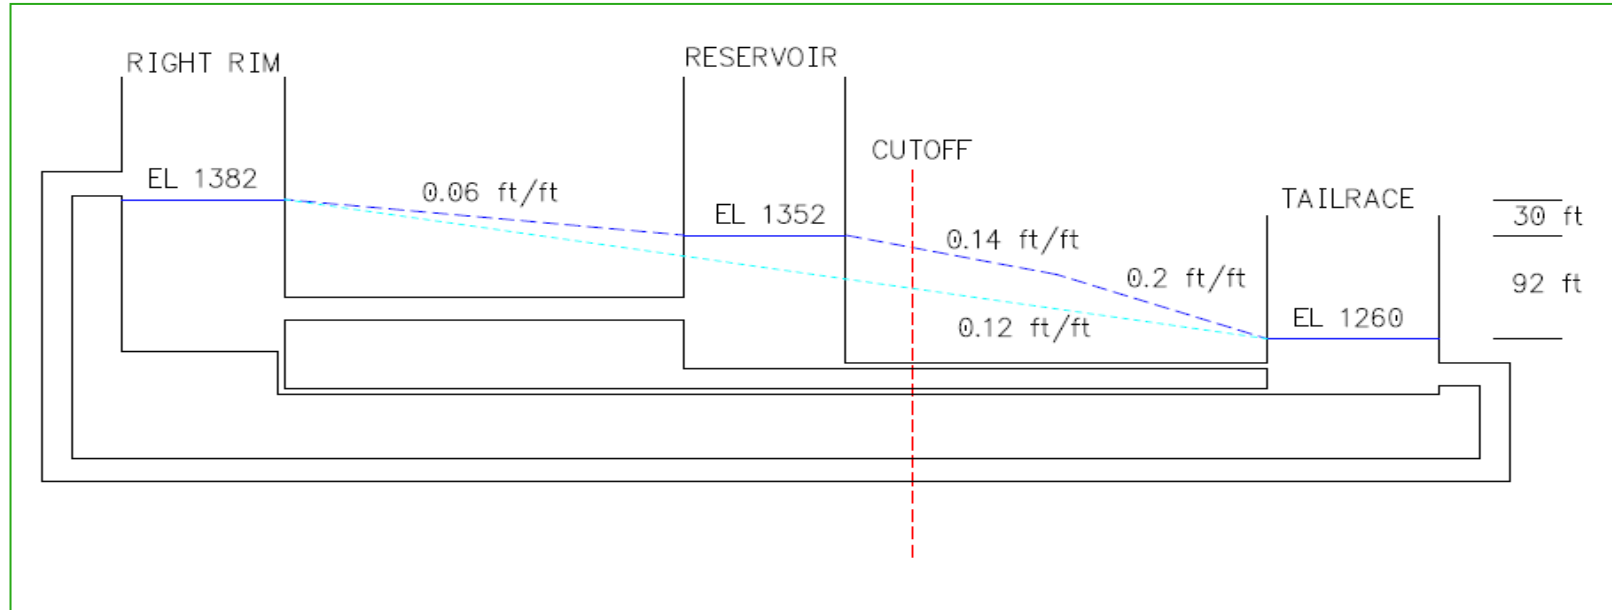
- Simplified model of the existing drainage network
- Demonstrates the constant source of head from the Right Rim
- Exhibits the potential for large fluctuations in the system dependent on water surface elevation in both Right Rim and Reservoir
- Illustrates the increased gradients due to the Reservoir
