**BUILDING
PROCESS SAFETY
CULTURE:
Tools to Enhance
Process Safety
Performance**

Challenger Case History

[The following information has been taken from the US government publication *Report of the Presidential Commission on the Space Shuttle Challenger Accident* (the Rogers Commission report).]

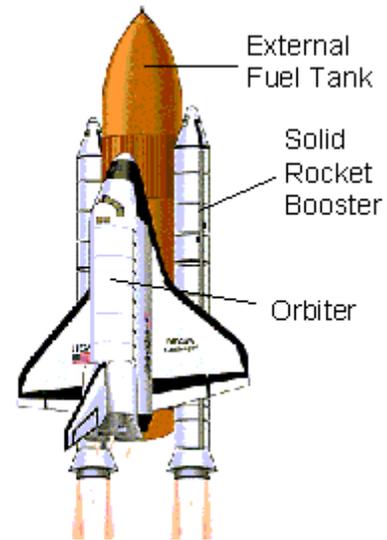
Just 0.7 seconds after ignition of the solid fuel booster rockets, even before the shuttle had cleared the launch tower, a field assembly joint in the right-hand solid rocket booster (SRB) began to fail, leaking hot combustion gases from the booster. Subsequent examination of photos taken during lift-off revealed a series of puffs of dark smoke discharging from the joint.

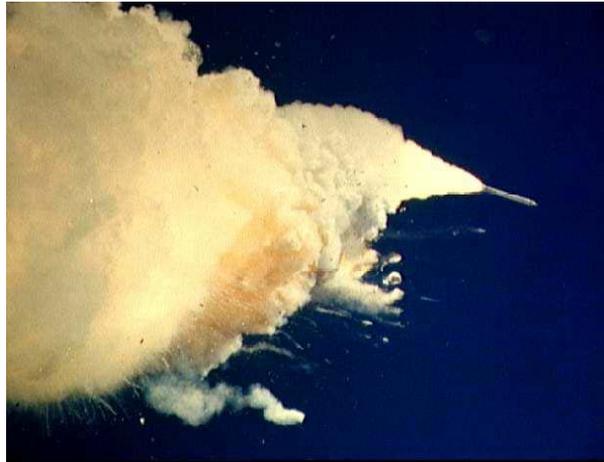
At about 73 seconds, the hydrogen tank failed catastrophically, and the liquid oxygen tank failed shortly thereafter. Within milliseconds, the explosively burning hydrogen and oxygen enveloped Challenger. Challenger broke into several large sections (photo on next page). The solid rocket boosters broke free and erratically flew about until Ground Control issued the remote destruct command. The main engine/tail section (with engines still burning), one wing, and the forward fuselage could be identified as they exited the fireball. It is believed that the crew module remained intact until it slammed into the sea.
