Misalignment + Corrosion = Failure!

July 2004

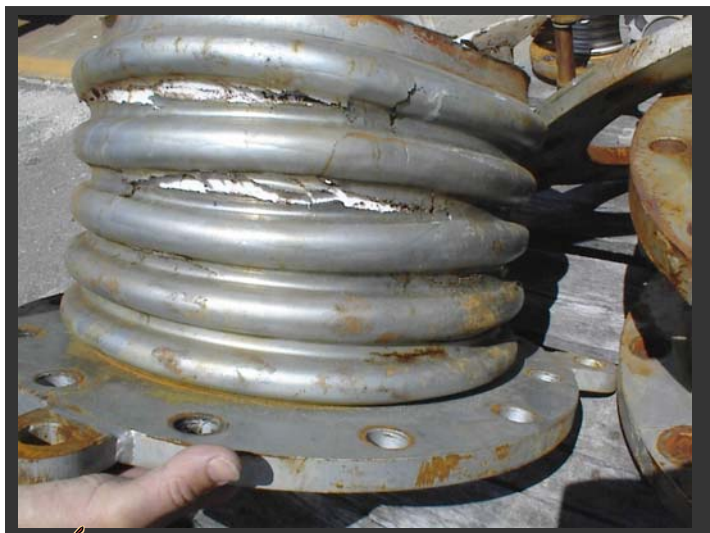
This TFE lined stainless steel expansion joint was part of a piping system containing a high concentration of HCl. The expansion joint was not installed properly and HCl had embrittled the stainless steel bellows. This embrittlement along with fatigue caused by improper alignment and insufficient restraint caused the joint to fail. The catastrophic failure you see in this picture occurred the day after it passed a visual inspection. Fortunately, the system pressure was low, the leak was small, and no one was around when it failed. In this case, there were no injuries. However, if the circumstances had been only slightly different...

- The piping to the vessel where this expansion joint was used was misaligned by approximately 3/4 inch. This caused stress on the expansion joint.
- The three retaining bolts that limit compression and extension were not installed on the expansion joint because of space limitations. This allowed excessive movement and placed even more stress on the joint.
- The specification for this joint had changed during a retrofit of the process for a new chemical service, but the expansion joint was not replaced with one of proper specification, requiring a higher grade of stainless. This likely contributed to the HCl embrittlement of the stainless steel making it prone to stress cracking and failure.

- ✓ Expansion joints are precision engineered equipment and **MUST** be installed correctly!
- ✓ Ensure that all equipment is installed per manufacturer's specifications!!! Use the facility's management of change (MOC) process to review ANY modification or change.
- ✓ When making visual inspections, note every change from previous inspections and notify the inspection department of those changes. *Protect yourself against sudden failure during the inspection.* Sometimes visual inspection while the equipment is in service is not enough. The equipment may have to be disassembled or simply replaced at a defined interval.
- ✓ Know and plan around common causes of failures:
 - 1) Expansion joints are usually weak spots in piping systems.
 - 2) Misalignment may cause stress cracking.
 - 3) HCl embrittles stainless steel.

Inspection and maintenance programs should not overlook common causes and expected failure modes for expansion joints.
