Corrosion Under Insulation (CUI)

January 2014

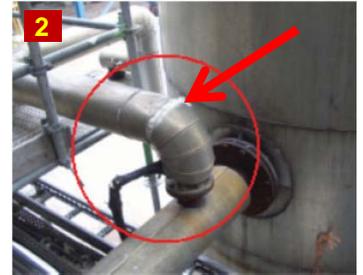
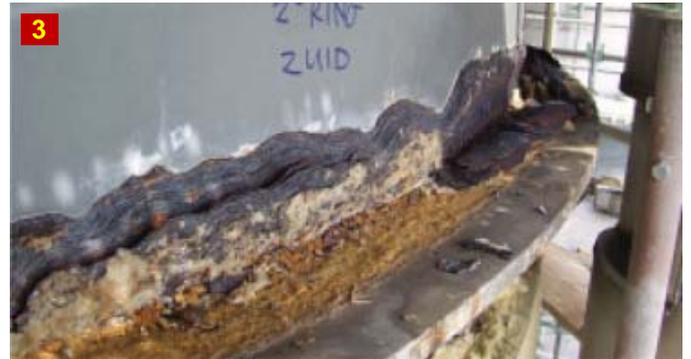
**(1) and (2) – Examples of damaged insulation
(3) – Corrosion resulting from damaged insulation**
