Accumulation of small changes leads to an explosion

November 2018

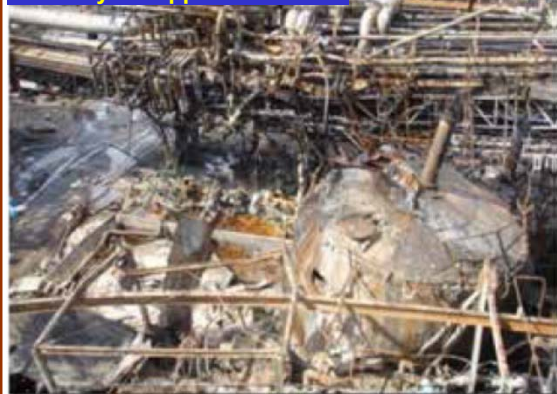
In September 2012, at an industrial site in Himeji, Japan, a 70 cu m (18,500 US gal) fixed roof acrylic acid (AA) tank exploded, and a fire followed. There was one fatality, a fire-fighter. 36 people were injured – 2 policemen, 24 fire-fighters, and 10 plant workers. The tank was destroyed and nearby facilities were significantly damaged (Photo 1). There were no major impacts to the neighborhood and environment.

Photo 1: Destroyed AA Tank

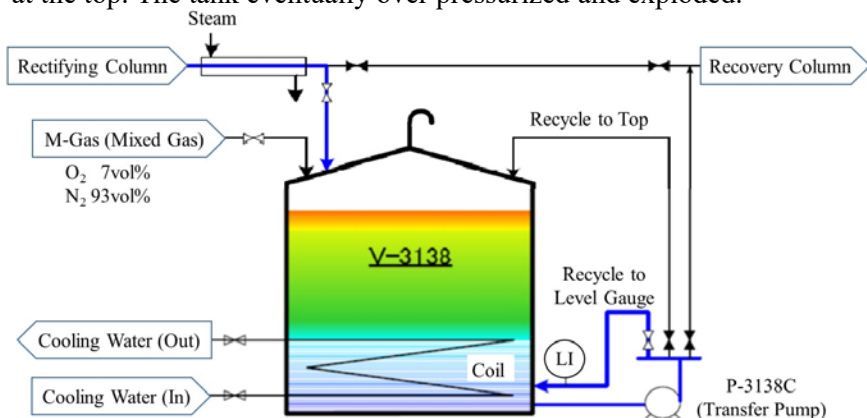
The tank provided intermediate storage between two distillation columns for purifying AA. Originally the tank had been used at full capacity. The contents were cooled and mixed by pumping from the bottom of the tank to the top. Later, the normal operating level was reduced to a level below the cooling coil. The contents were no longer recirculated to the top of the tank, but instead to a nozzle near the bottom that was also used to connect a level gauge (Drawing 2).

At the time of explosion, the plant was conducting a test of the downstream distillation column, which required stopping feed from this tank. The level of the tank gradually increased to its original operating level. Without recycle to the top of the tank, the AA above the cooling coils was not mixed and cooled. The temperature of the incoming AA was believed to be below the onset temperature for polymerization, and the AA contained polymerization inhibitor. However, the temperature in the tank increased, especially at the top. The tank eventually over pressurized and exploded.

Drawing 2: Only the bottom of the tank was cooled, the liquid above became hot

- Originally the pipe feeding the tank was hot water jacketed to provide freeze protection, but this was changed to steam.
- Removal of a steam trap made temperature control unreliable.
- The top layer was no longer mixed with cooler AA, and stayed warm from incoming AA.
- There are two exothermic AA self-reactions – dimerization and polymerization. Polymerization inhibitor does not stop the dimerization reaction. Experiments showed that heat from dimerization raised the temperature sufficiently to start a runaway polymerization reaction.
- The hazard of heat from dimerization was not recognized, so recirculation to the top of tank was not resumed.
- The tank had no temperature indicator. The first indication of a problem was observation of AA vapors escaping from the top vent on the tank.

- Never make any changes to your plant, even changes you think are small, without following your plant Management of Change (MOC) procedures.
- When you see any change in your plant, ask if there has been an MOC review. If there has been, and you were not informed of the change, tell your supervisor. You should always be informed of changes in your plant that impact your job.
- If something is different from normal operation, confirm operating procedures or ask your supervisor what to do.
- Accumulation of small changes can cause an incident with a big consequence. All small changes must be identified and the risk to the total system analyzed and adequately managed.
