# Lessons Learned from Recent Process Safety Incidents

ALBERT NESS

CENTER FOR CHEMICAL PROCESS SAFETY

These five incidents demonstrate how seemingly small mistakes or temporary lapses in judgment can result in disaster.

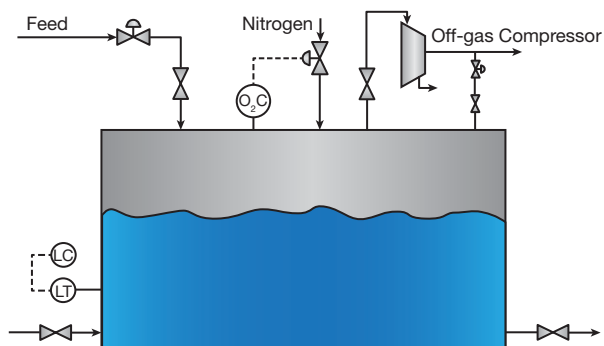
*Event details.* The 900,000-gal wastewater tank contained process wastewater from propylene oxide and styrene processes (Figure 2). There were thousands of feet of piping upstream of the tank where peroxides and caustic could mix. A nitrogen purge kept the vapor space inert, and an off-gas compressor drew the hydrocarbon vapors off before the waste was disposed of in a deep well.

Within the tank, decomposition of the peroxides generated dangerous levels of oxygen. However, the air in the headspace of the tank was stagnant and the analyzer did not detect the oxygen buildup because it was in a dead zone. Occasional nitrogen purging was inadequate to prevent the formation of a flammable atmosphere in the headspace and in the piping to the compressor.

After maintenance was completed, a failed attempt to restart the compressor drew flammable vapors into the suction line of the compressor. When the compressor was successfully restarted, the flammable vapors were ignited and flame flashed back to the tank, causing an explosion.

*Causes.* The wastewater tank was not considered part of the operating plant. Hence, the management and workers did not understand that a chemical reaction was taking place in the tank, generating oxygen. The lack of understanding enabled a series of poor decisions, such as discontinuing the nitrogen purge, poor design and location of the temporary oxygen probe, no management of change (MOC) review of these decisions, and no pre-startup safety review.

▲ **Figure 2.** A 900,000-gal wastewater tank had a nitrogen purge to keep the vapor space inert and an off-gas compressor to draw off hydrocarbon vapors before waste disposal.

*Key lessons.* Keep in mind that the chemicals that enter any wastewater tank are still prone to reaction. Ensure that proper MOC procedures are followed before any maintenance work is performed. In this incident, the workers did not know that a chemical reaction that could produce an oxygen buildup was taking place in the tank. Therefore, they did not comprehend the importance of continuing an effective nitrogen purge.

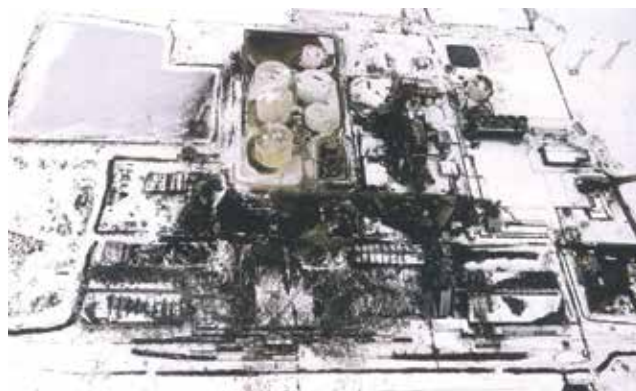
On Dec. 13, 1994, a massive explosion occurred in the ammonium nitrate (AN) portion of Terra Industries' fertilizer plant in Port Neal, IA (Figure 3). The explosion occurred after the process had been shut down and ammonium nitrate solution was left in several vessels. Multiple factors contributed to the explosion, including strongly acidic conditions in the neutralizer, application of 200-psig steam to the neutralizer vessel, and lack of monitoring of the plant when the process was shut down with materials in the process vessels. Four people were killed and 18 injured. Serious damage to other parts of the plant caused the release of nitric acid into the ground and anhydrous ammonia into the air (5).

**Causes.** The U.S. Environmental Protection Agency (EPA) investigation concluded that the conditions that led to the explosion occurred due to the lack of safe operating procedures. There were no procedures for putting the vessels into a safe state at shutdown, or for monitoring the process vessels during shutdown. The EPA found that other producers either emptied the process vessels during a shutdown or maintained the pH above 6.0. Also, other producers either did not allow steam sparges or, if steam sparges were used, they were conducted under direct supervision of operators.

The EPA also noted that no hazard analysis had been done on the AN plant, and that personnel interviewed “indicated they were not aware of many of the hazards of ammonium nitrate” (5).

▲ **Figure 3.** A massive explosion devastated this ammonium nitrate fertilizer plant. Source: (5).

**Key lessons.** Operating procedures need to cover all phases of operation. In this event, the lack of procedures for shutdown and monitoring the equipment during shutdown led operators to perform actions that sensitized the AN solution and provided energy to initiate the decomposition reaction.

Because there had been no hazard identification study, personnel did not know about the conditions that sensitize AN to decomposition. A hazard assessment of the shutdown step would have revealed that the pH of the neutralizer could not be measured if there was no solution flowing through the overflow line, and that the temperature of the neutralizer could not be accurately measured without any circulation in the tank. A complete hazard identification study would have covered backflow of ammonium nitrate into the nitric acid line, and better design solutions could have been identified.

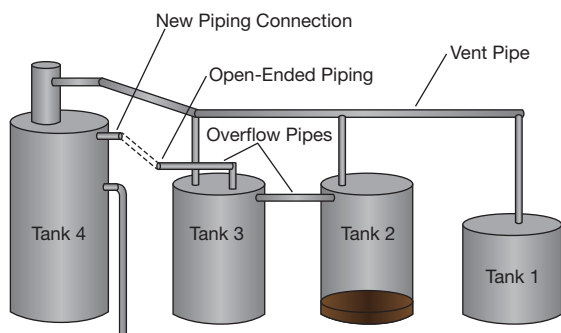
**Event details.** Contract workers were connecting piping between two recently moved tanks (Tanks 3 and 4 in Figure 4). Several days earlier, crude oil residue was removed from Tank 4 and the tank was flushed with water. However, the contractors did not clean out or purge the crude oil residue from Tank 2 or Tank 3.

Almost immediately after the welder started welding, flammable hydrocarbon vapor that was venting from the open-ended pipe attached to Tank 3 ignited. The fire flashed back into Tank 3, spread through the overflow connecting pipe from Tank 3 to Tank 2, and caused Tank 2 to explode. The lids of both tanks were blown off and the two maintenance workers and foreman were thrown off the tanks to the ground. The welder was thrown off the ladder, but his harness prevented him from falling to the ground.

**Causes.** The root cause of this incident was hot work being conducted in the presence of a flammable atmosphere without using any safe work permitting procedure. A gas detector should have been used to test for flammable vapor. The open pipe on Tank 3 was not capped or isolated. All of the tanks were interconnected, and some of the tanks still contained flammable residue and crude oil.

▲ **Figure 4.** Contractors were tasked with installing a pipe between two tanks. Vapors escaping from Tank 3 ignited and caused an explosion. Source: Adapted from (6).

when hazardous chemicals, in this case flammable vapors, are present. The contractor, Stringer’s Oilfield Services, did not require the use of safe work procedures, specifically hot work permits in this case.

Contractors need to be managed in such a way as to ensure they know about and use safe work practices. The owner of the wells and tanks, Partridge-Raleigh, relied on contractors to do most of its well commissioning work, such as installing tanks, pumps, and piping — this is a common practice. Partridge-Raleigh did not, however, manage the contractors to make sure they used safe work practices.

Companies need to be aware of and follow best industry practices. Several National Fire Protection Association (NFPA) and American Petroleum Institute (API) guidelines cover this situation. If Partridge-Raleigh or Stringer’s Oilfield Services had adopted any of these industry standards, this incident could have been prevented:

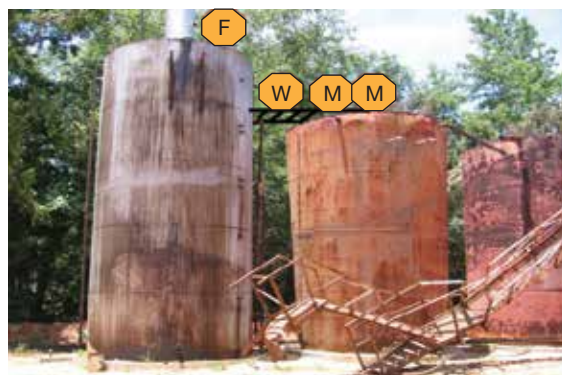
Before starting to weld, the welder checked for flammable vapors in Tank 4 by inserting a lit welding torch into it, an unsafe act known as flashing the tank. Then, as the CSB report (6) states, “The foreman climbed to the top of Tank 4. Two other maintenance workers climbed on top of Tank 3; they then laid a ladder on the tank roof, extending it across the 4-ft space between Tanks 3 and 4, and held the ladder steady for the welder. The welder attached his safety harness to the top of Tank 4 and positioned himself on the ladder (6).” Figure 5 illustrates the workers’ locations.

▲ **Figure 5.** The workers killed and injured in the Partridge-Raleigh oilfield tank explosion were on top of two tanks with a ladder stretching between them. The foreman (F) stood on Tank 4, while the two maintenance workers (M) stood on Tank 3, and the welder (W) positioned himself on the ladder. Source: (6).

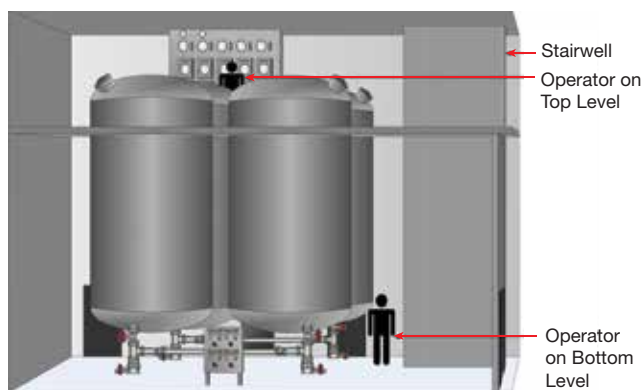
*Event details.* The facility produced PVC by heating VCM, water, suspending agents, and reactor initiators under pressure in a batch reactor. There were 24 reactors in a building, and the reactors were put in groups of 4, with a control station for every two reactors (Figure 6). When a reaction was complete, the PVC solution was transferred through the bottom valve to a vessel for the next step in the process.

▲ **Figure 6.** Reactors at the PVC plant were arranged in groups of four. One operator monitored the reactors from the top level, while another operator, on the lower level, drained the tanks. Source: (7).

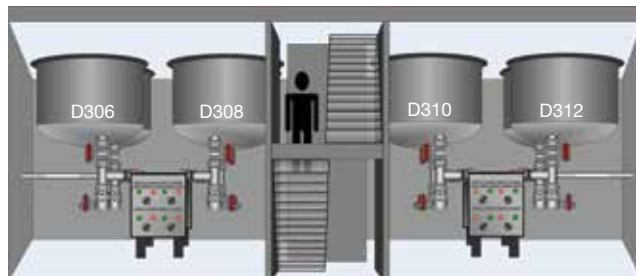
*Causes.* The operator overrode an interlock, which led to a release of hot, pressurized VCM. Formosa Plastics did not have comprehensive written standards, such as requiring shift supervisor approval, for managing interlocks on the vessels. Employees were unprepared for a major accident at the facility.

- The reactor groupings had similar layouts (Figure 7).
- The operators on the lower levels were not given radios, which would have made communication with the reactor control operators on the upper level easier. (Similar Formosa plants had radios or an intercom system.)
- Formosa eliminated an operator group leader position and gave its responsibilities to the shift supervisors, who

▲ **Figure 7.** Reactors D306 and D310 occupied the same place in their respective, identical tank rooms. At the bottom of the stairway, the operator became confused and went into the wrong room, where he emptied the wrong reactor. Source: (7).

**Key lessons.** Operators and engineers must follow operating procedures and protocols intelligently, and, when the process moves outside the operating envelope, stop work, get experienced advice as needed, and shut down as appropriate. The Formosa operator should have obtained supervisory approval to override the interlock.

Furthermore, in this event, the operators had to cope with an error-prone design — the reactor layout made it easier for a mix-up to occur. An emergency transfer procedure required bypassing the bottom valve interlock, so an easy means was provided to do this. Engineers who design and run plants should try to provide engineering controls and monitor shift notes and logs for instances of interlock bypassing. In this case, a reactor status indication on the operating floor could have been provided, and more-rigorous enforcement of operating procedures and interlock management implemented.

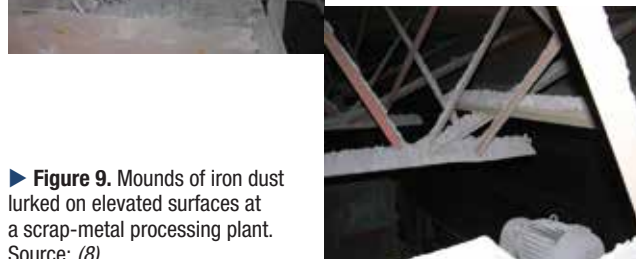
**Second incident.** On March 29, 2011, a Hoeganaes engineer and a contractor were replacing igniters on an annealing furnace. They had difficulty reconnecting a gas line, and the engineer used a hammer to force the connection. Large amounts of dust on surrounding surfaces were dispersed by the hammering and ignited almost immediately. The engineer suffered first- and second-degree burns, while the contractor was able to escape. The engineer was wearing flame-resistant clothing (FRC), which may have helped prevent more serious burns. Figure 9 is a photo taken at the Hoeganaes plant on Feb. 3, 2011, about two months before this incident (8). This photo shows how much dust had piled up on the plant's surfaces.

▶ **Figure 9.** Mounds of iron dust lurked on elevated surfaces at a scrap-metal processing plant. Source: (8).

The importance of housekeeping in a facility that handles solids cannot be overstated. All three of these incidents were exacerbated by the large quantities of combustible dust present (Figures 8 and 9). Poor housekeeping has been involved in most, if not all, high-consequence dust explosions (10). At the Hoeganaes plant, control of dust emissions and housekeeping were ineffective. Baghouse filtration systems that were installed to control dust were frequently out of service, and the CSB investigators observed that the baghouses leaked when the bags were pulsed. The 2008 insurance audit also noted that housekeeping needed to be improved in several areas. The ineffective dust control and housekeeping enabled dust layers with more than enough dust to fuel the flash fires to accumulate. These deficiencies were contributing factors to all three incidents.
