## Contamination As a Contributing Factor

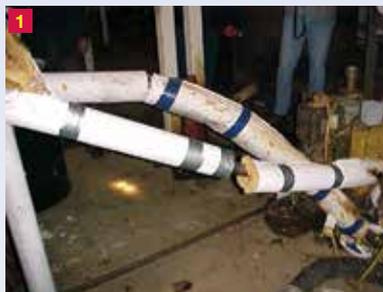
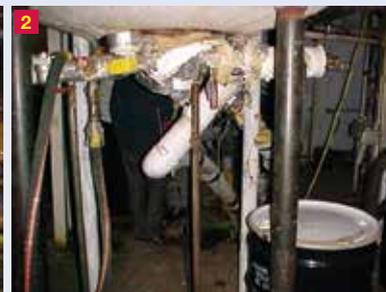
**Incident 1.** A closed valve isolated a pipe containing an organic residue from distillation processes and liquid from process vent systems. The pipe was steam-traced to keep the residue from solidifying. During a weekend shutdown, the pipe exploded (Images 1 and 2). No one was injured because the building was not occupied and damage was minimal.

The temperature control system on the steam-tracing system had failed, causing temperatures to rise. This alone should not have created the conditions for decomposition and explosion, but the residue had been contaminated with approximately 1% water. Water vapor from process vessels condensed in the vent system and drained into a residue tank. Lab tests confirmed that this amount of water reduced the decomposition temperature of the residue by about 100°C. The temperature due to the steam temperature control failure was high enough to initiate decomposition.

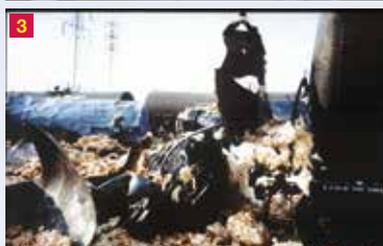
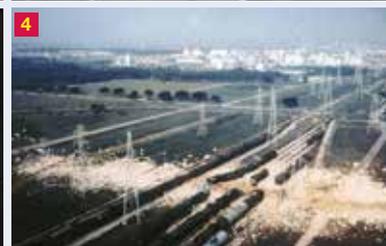
**Incident 2.** A railroad tank car containing crude methacrylic acid (MAA) was hot and venting material from its relief valve. The area was evacuated, and after some time, the railcar exploded, destroying the car and causing significant damage in the area (Images 3 and 4). Because people were evacuated, no injuries occurred.

Crude MAA contains strong mineral acids from the manufacturing process, which corrode stainless steel. The dissolved metal from corrosion increases the tendency of MAA to polymerize. Crude MAA is supposed to be stored in lined tank cars, but, in this incident, an unlined stainless steel tank car was used. In addition, the plant did not add the specified amount of polymerization inhibitor to the crude MAA. The inhibitor stabilizes MAA by stopping slow polymerization that can occur even in pure MAA. The metal contamination from corrosion of the tank car may have induced the polymerization, and the reduced inhibitor concentration diminished the stability of MAA, ultimately leading to the runaway polymerization and explosion.
