# Risk-Based Process Safety

What happens when organizations don't follow risk-based process safety guidelines?

**B. KARTHIKEYAN**  
PRISM CONSULTANTS

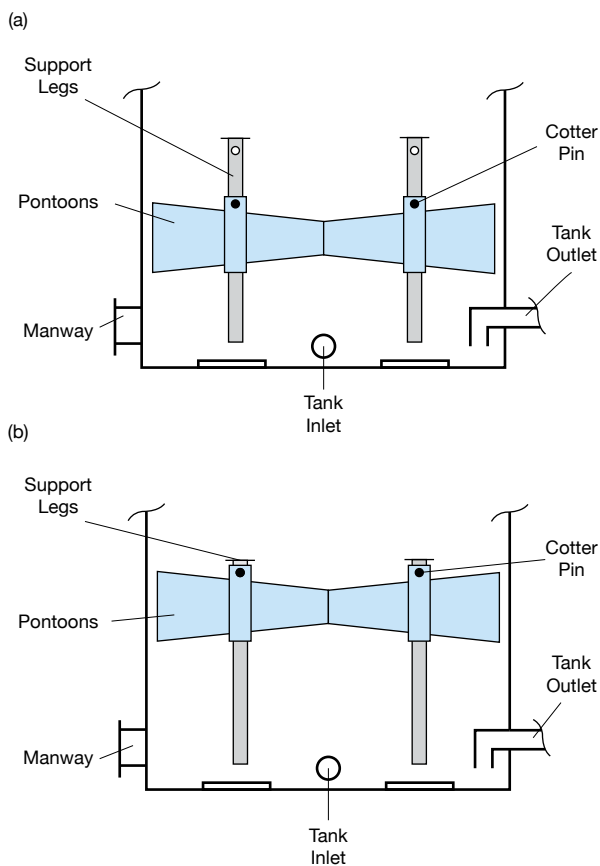
A floating-roof tank stored liquid naphtha. The roof was mounted on hollow sections called pontoons, which enabled it to float and rise and fall with the level of product inside the tank. Support legs on the roof could be adjusted to two positions: a low position for normal operation (Figure 1a) and a high position to provide space for cleaning and maintenance (Figure 1b).

▲ **Figure 1.** These diagrams show the floating roof with the support legs in (a) low and (b) high positions.

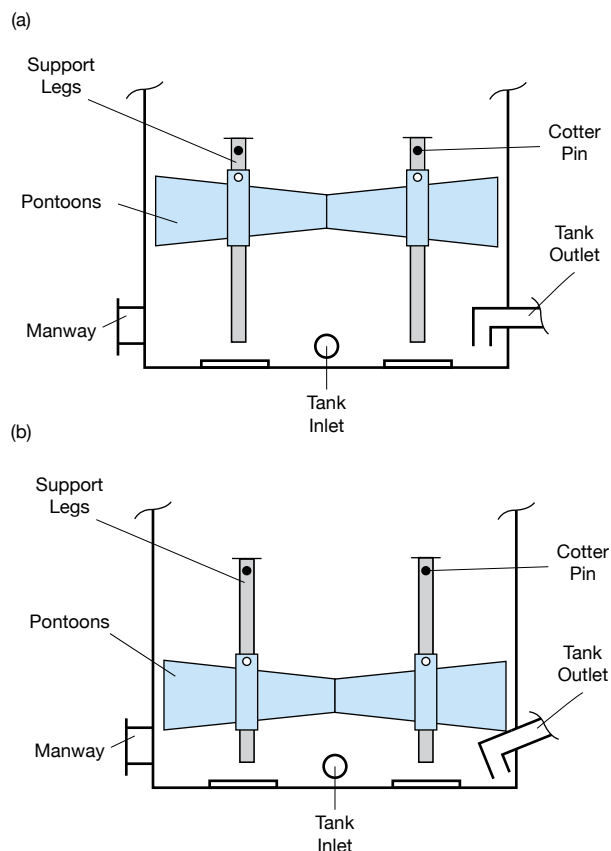
Step 3 was carried out incorrectly and the cotter pin was fixed in the high position on the support legs but without sup-

porting the pontoon (Figure 2a). When the tank was emptied during Step 4, the pontoons settled onto the floor of the tank, damaging the pump suction nozzle and other accessories (Figure 2b). The operator observed the pump suction piping bending upward and stopped the emptying operation before the flanges in the tank outlet line gave way. Further analysis of the event revealed that the drawings for the tank were not available and the shift crew was given oral instructions to perform the operation.

▲ **Figure 2.** (a) The cotter pin was inserted through the support leg but not the pontoon when the legs were transitioned from the low to the high position. (b) As the tank was emptied, the unsupported pontoon dropped to the tank floor, causing damage.

The process knowledge management element requires accurate and complete process knowledge to identify process hazards and analyze risk. In this incident, the drawings for the tank internals were not available and the operation was carried out based on past experience.

The safe work practices element ensures that written procedures are available for all activities not covered by operation and maintenance procedures. Decommissioning the tank and changing the support leg height for the floating roof should have been covered by a written, approved procedure, complete with sketches, drawings, and warning statements.
