## Several Errors Led to a Hydrogen Leak and Fire

September 2025

A release of high-pressure hydrogen occurred at a hydrogen trailer transfer/filling facility in Santa Clara, CA, on June 1, 2019 (7).

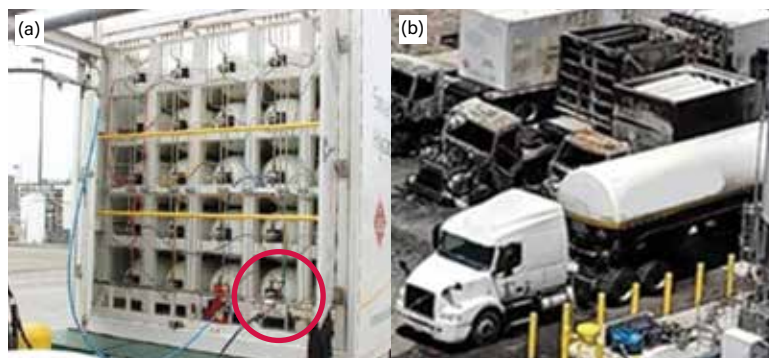
▲ **Figure 1.** In June 2019, (a) operators filling a hydrogen tube truck spotted a leak (circled in red) which led them to shut down operation and begin maintenance on the unit. When they realized that they did not have all of the components necessary to complete the maintenance, a trainee was sent to completely shut off the hydrogen supply. (b) However, while doing so, he inadvertently restarted hydrogen flow to the unit, allowing hydrogen to flow freely from the opened system, which led to a deflagration explosion and jet fire (7).

A driver and trainee were filling a tube trailer from a hydrogen tank nearby. When the trailer modules were about 95% full, the trainee noticed a hydrogen leak near the fill-line manual isolation valve and informed the driver. The driver instructed the trainee to stop the filling operation. The trainee stopped the filling process for both modules but did not disconnect the trailer from the fill system piping. The driver closed the manual valve (Figure 1a) to isolate the front module from the supply, depressurized the fill manifold, and removed a piping section to repair the leak. The driver did not have the parts to complete the repair and instructed the trainee to shut off the hydrogen supply. The trainee inadvertently restarted the filling process by pressing the wrong control button. This opened pneumatic valves on the trailer, allowing gaseous hydrogen to escape at a high flowrate through the disassembled piping. The hydrogen-air mixture ignited and resulted in a hydrogen-air deflagration explosion followed by a jet fire.

The fire and explosion caused piping damage (Figure 1b) and activated the hydrogen temperature-pressure relief devices, adding fuel to the incident. The fire spread to other materials on adjacent vehicles. Approximately 250 kg (550 lbs) of hydrogen was released during this event. There were no serious injuries.

- Use the proper isolation or lockout-tagout (LOTO) procedures for possibly hazardous equipment. Before opening any connections, inspect the piping to confirm all valves are in the correct position.
- When a leak occurs, follow the company's leak procedure. If possible, safely isolate the leak and notify the correct people.
- Process controls should be easily understood. If control labels are hard to understand, ask for clarification.
- Repair process equipment only if you have been trained and approved by experienced personnel.
- When working with a newer employee, provide clear instructions for the assigned tasks. It is better to demonstrate to new personnel how to perform a job correctly than to only tell them.
