Title: **Fuel Station 1000 bar ASME Vessel PRV Activation and Vent System Failure**

Incident Date: **Fall 2024**

Incident Location: **United States**

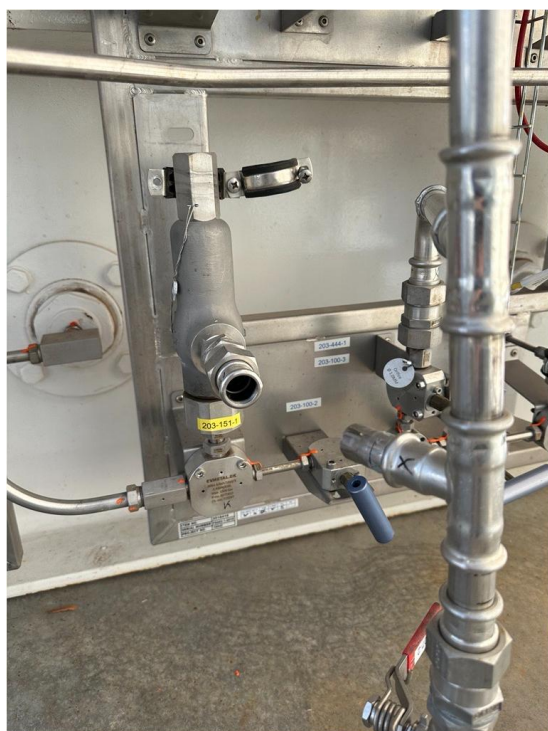
A bank of eight 1000 bar hydrogen storage vessels located at a private fueling station was being refilled from a compressor. A pressure relief valve (PRV) activated and released hydrogen into the storage system vent stack. During the activation, there was a separation of a 3/4" press-fit joint at the exit of the relief valve which led to deformation of the discharge manifold and a horizontal release into an outdoor open area. The PRV failed to reseal. Emergency responders secured the area and allowed the hydrogen to vent as the system gradually decreased to atmospheric pressure over a period of three days.

There were no injuries. Property damage was limited to the PRV and vent piping network. There was no ignition and approximately 194 kg was released during the incident.

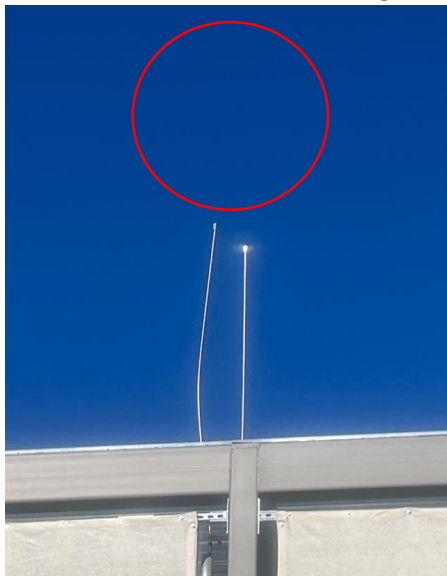
The investigation observed that a contributing factor to the valve chatter was that the original $\frac{3}{4}$ " diameter X 30' long vent discharge manifold design deviated from the original manufacturer's design of $1\frac{1}{2}$ " x 20'. The smaller size and longer length created excessive pressure drop which caused the chattering condition. In addition, the use of an engineered vent stack cap which was not sized properly for the flow rate unintentionally restricted the outlet flow of the PRV. While not confirmed, it is likely that the back-pressure from the small piping and the vent stack cap resulted in exceeding the pressure rating of the fitting at the immediate outlet of the PRV. The combination of the overpressure and the hammering action from the chattering led to the separation of the fitting.

The separation of the fitting resulted in the hydrogen being released in an uncontrolled manner at grade level instead of the intended 30' elevation.
