**BUILDING
PROCESS SAFETY
CULTURE:
Tools to Enhance
Process Safety
Performance**

Piper Alpha Case History

[The following information has been taken from the UK government publication *The Public Inquiry into the Piper Alpha Disaster* (the Lord Cullen report). While this summary has been condensed and paraphrased, it is believed to be consistent with the facts and conclusions outlined in the Cullen report.]

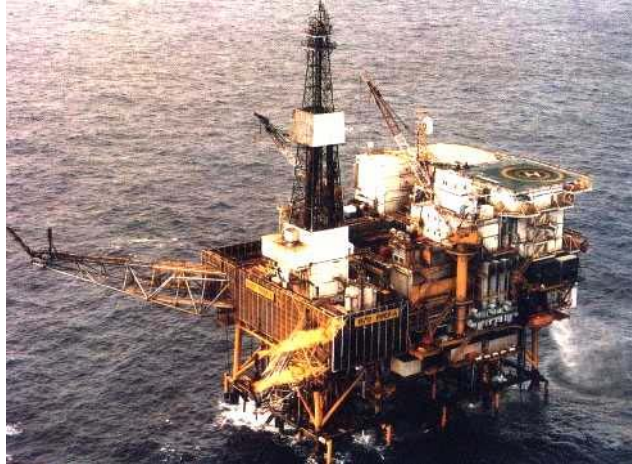
On July 6, 1988, the Piper Alpha oil platform experienced a series of catastrophic explosions and fires. This platform, located in the North Sea approximately 110 miles from Aberdeen, Scotland, had 226 people on board at the time of the event, 165 of whom perished (in addition, two emergency response personnel died during a rescue attempt). The platform was totally destroyed.

Subsequent investigation was hindered by a lack of physical evidence; however, based upon eyewitness accounts it was concluded that, most likely, a release of light hydrocarbon (condensate; i.e., propane, butane, and pentane) occurred when a pump was restarted after maintenance. Unbeknownst to the personnel starting the pump, a relief valve (RV) in the pump discharge had also been removed for service and a blank had been loosely installed in its place on the piping flange (which was not readily visible from the pump vicinity). Upon restart of the pump, this flange leaked, producing a flammable hydrocarbon cloud, which subsequently found an ignition source.

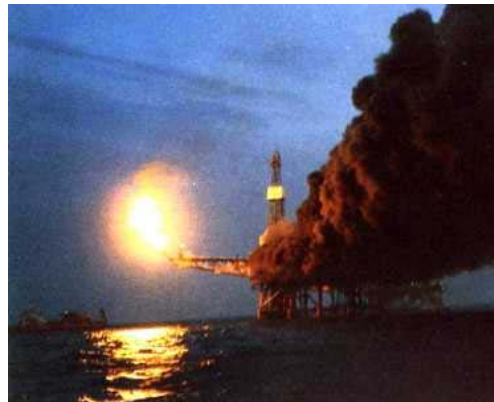
- 70
- 75
- 80 • The permit to work (PTW) system was often not implemented according to procedure (“... the procedure was knowingly and flagrantly disregarded.”). For example, (1) omissions (e.g., signatures and gas test results) were common, (2) operations representatives often did not inspect the jobsite before suspending the permit at the end of the shift, or closing the permit indicating the work had been completed, and (3) craft supervisors often left permits on the control room desk at the end of a shift, rather than personally returning them to the responsible operations representative, as required by the procedure.

- 85 • Although the PTW system was monitored by the lead safety operator, no indications of problems were reported, and management did not independently review the operation of the system. Based upon an absence of information to the contrary, management assumed that they “knew that things were going all right.” It is noted that a senior maintenance technician had voiced his concerns about the PTW system at a meeting at corporate headquarters earlier in the year. In addition, the company had entered a guilty plea in a civil legal proceeding involving a worker fatality caused, in part, by a PTW system problem; however, no substantive improvements in

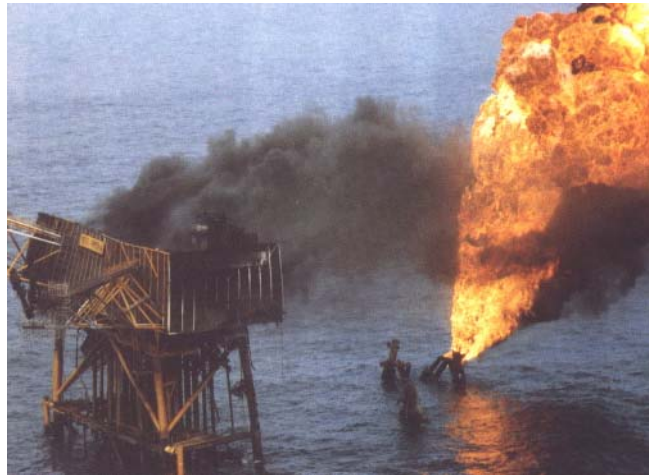
- The diesel-powered fire pumps had been placed in manual control mode due to the presence of divers in the water around the platform. This practice was more conservative than company policies and a 1983 fire protection audit report had recommended that this practice be discontinued. Placing the pumps in manual meant that personnel would have had to reach the pumps to

start them after the explosion. However, conditions prevented this and, as a result, the Piper Alpha deluge system was unavailable.

- Had firewater been available, its efficacy might have been limited. Distribution piping, including that in the platform module where the fires were most severe, was badly corroded and pluggage of sprinkler heads was a known problem dating back to 1984. Various fixes had been attempted and a project to replace the fire protection piping had been initiated, but work was lagging behind schedule. Tests in May 1988 revealed that approximately 50% of the sprinkler heads in the subject module were plugged.
