The primary focus of this presentation are the circumstances leading up to the Columbia shuttle disaster. However, to emphasize that Columbia was not a one-of-a-kind event, and to illustrate the potential consequence of failing to acknowledge and address cultural weaknesses, the Challenger shuttle disaster (which occurred 17 years before) is described, and parallels are drawn.

Also, to provide relevance to our industry, the Piper Alpha and Flixborough disasters are described in a way that emphasizes the general applicability of the safety culture learnings from Columbia.

Most of the information in this presentation was taken from from the publicly available investigation reports. The *Process Safety Culture* project team feels that the lessons and organizational root causes identified in these four investigations are applicable to all organizations that operate facilities handling hazardous materials or that engage in hazardous activities.

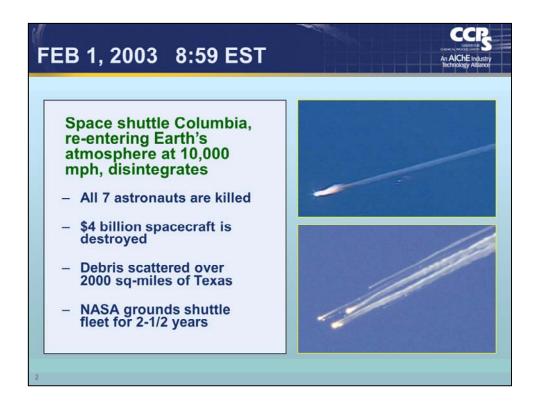
On February 1, 2003, the Space Shuttle Columbia disintegrated during re-entry into the Earth's atmosphere, killing all seven crewmembers aboard.

[The photos on this slide are two views, taken from the ground, of Columbia as it was breaking apart.]

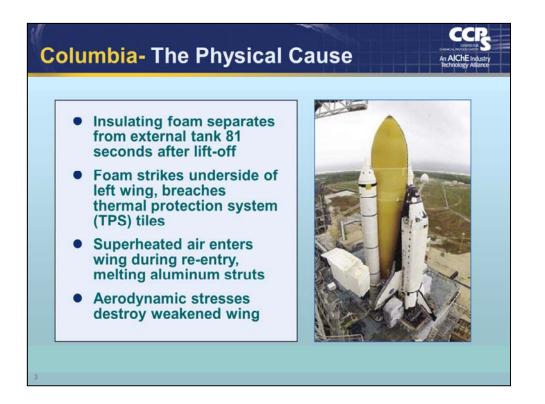
The physical cause leading to the loss of Columbia and its crew was a breach in the Thermal Protection System (TPS) on the leading edge of the left wing, caused by a piece of insulating foam that separated from the external fuel tank and struck the wing at 81.7 seconds after launch. The circles and arrow in the figure show the point of origination, point of impact, and likely trajectory of the foam. While the foam is lightweight, it would have been moving at a speed of about 500 mph relative to the shuttle at impact.

(The external fuel tank assembly, which includes the cryogenic liquid hydrogen and liquid oxygen tanks, is insulated to prevent the formation of ice that could break free during launch and damage the shuttle. The foam broke away from the left bipod ramp section of the tank; i.e., a "strut" that anchors the fuel tank to the shuttle during launch).

During re-entry, the breach in the TPS allowed superheated air to penetrate the left wing and progressively melt the aluminum structure of the wing. This weakened the structure until increasing aerodynamic forces caused failure of the wing, loss of control, and break-up of the Shuttle. This breakup occurred in a flight regime during which, given the current design of the Shuttle, there was no possibility for the crew to survive (the shuttle's speed would have been on the order of 10,000 mph at the time).

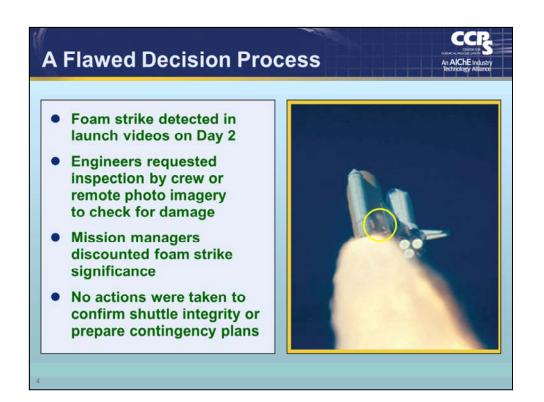
During routine reviews on the 2nd day of the mission, of video taken during the launch, it was observed that a piece of foam broke free from the external tank and struck the shuttle. The circle in the photo shows the cloud of debris that was produced by the collision.

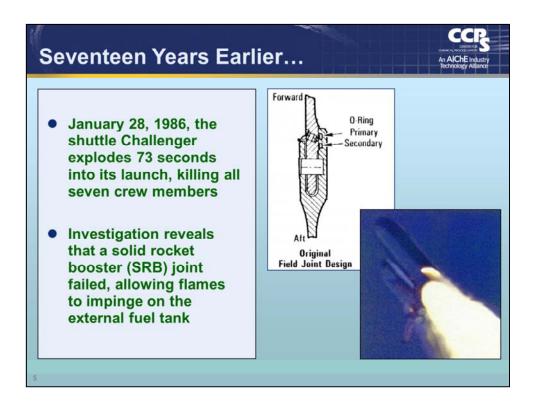
The Challenger space shuttle was destroyed in a massive explosion approximately 73 seconds into its launch. Subsequent investigation revealed that a field assembly joint in one of the two solid rocket boosters (SRBs) had failed, allowing hot combustion gases to contact the external fuel tank.

The two illustrations show a cross-section of a SRB field joint, and the jet of flame issuing from the joint during take-off. The joint design incorporates two o-rings to seal the joint during the firing of the rocket.

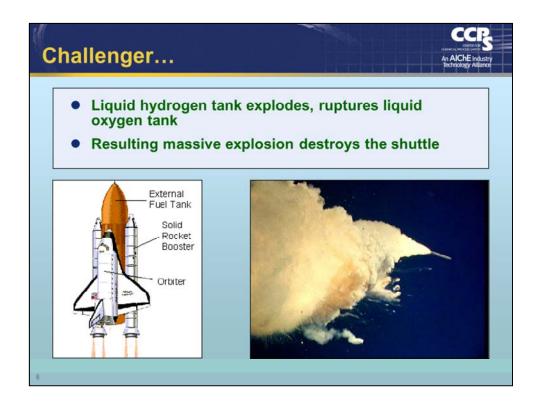
The flame from the field joint impacted the external fuel tank at a point where the liquid hydrogen tank was located. The liquid hydrogen tank failed and the resulting explosion caused the SRB to rotate away from the external tank in a manner that resulted in the nose of the SRB puncturing the liquid oxygen tank like a can opener.

The simultaneous release of the liquid hydrogen and liquid oxygen resulted in a massive explosion that destroyed the shuttle orbiter.

[The photo on the left shows the SRBs, still burning, rocketing away from the shuttle debris just after the explosion.]

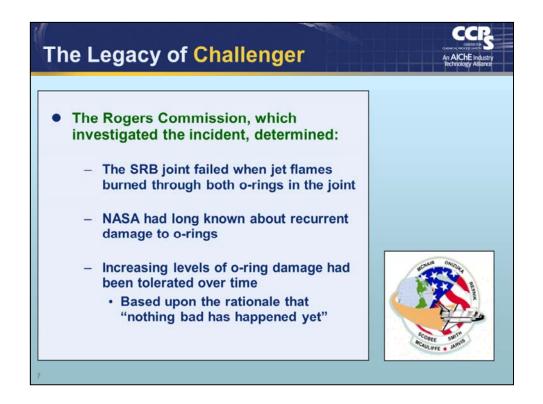
The subsequent investigation confirmed that a field joint had indeed failed when flames from the SRB burned through both the primary and secondary o-rings and the putty between them. Further, it was learned that SRB o-ring damage was not unique to this mission. A pattern of o-ring damage extending over several years had preceded this mission. Even though progressively more severe degrees of damage had been observed over time, Shuttle Program management had grown increasingly complacent to o-ring damage, since the o-ring damage had not yet seriously impacted a mission.

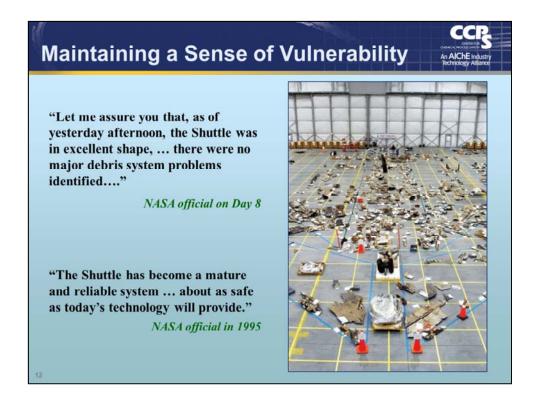
[The photo shows debris, recovered after the Columbia break-up, laid out on a grid pattern approximating where the debris had originated from on the shuttle.]

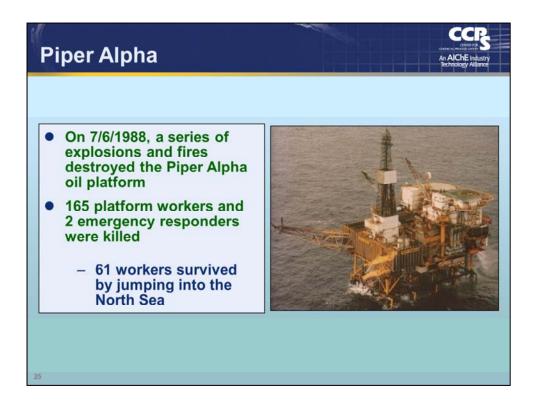
The Piper Alpha oil platform was located in the North Sea approximately 110 miles from Aberdeen, Scotland. At the time of the incident it had 226 people on board, 165 of whom perished (in addition, two emergency response personnel died during a rescue attempt).

The platform was totally destroyed.

[The photo shows the Piper Alpha platform prior to the explosion.]

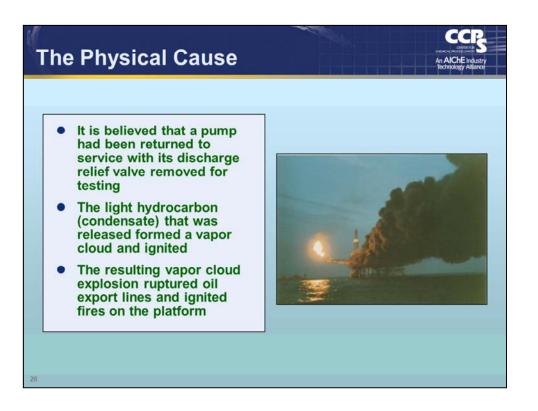
While the investigation of the incident was hindered by a lack of physical evidence, based upon eyewitness accounts it was concluded that, most likely, a release of light hydrocarbon (condensate; i.e., propane, butane, and pentane) occurred when a pump was restarted after maintenance.

Personnel restarting the pump were not aware that a relief valve (RV) in the pump discharge had also been removed for service and that a blank had been loosely installed on the piping flange (which was not readily visible from the pump vicinity) in place of the valve.

Upon restart of the pump, this flange leaked, producing a flammable hydrocarbon cloud, which subsequently found an ignition source. The resulting explosion breached crude oil lines on the platform, resulting in large hydrocarbon fires on the platform.

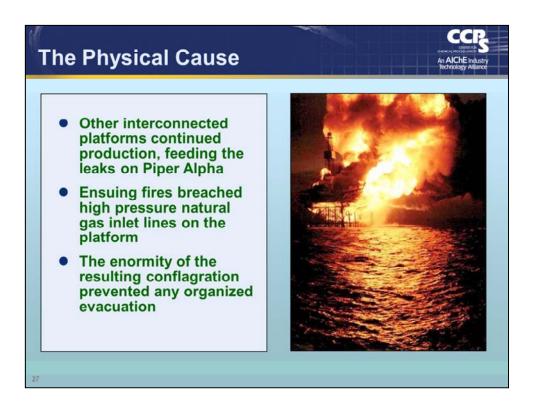
The heat from the oil fires ultimately weakened large diameter, high pressure natural gas lines on Piper Alpha. These lines ruptured in succession, resulting in catastrophic explosions.

[The photo shows the platform during one of the explosions occurring after the rupture of a gas riser.]

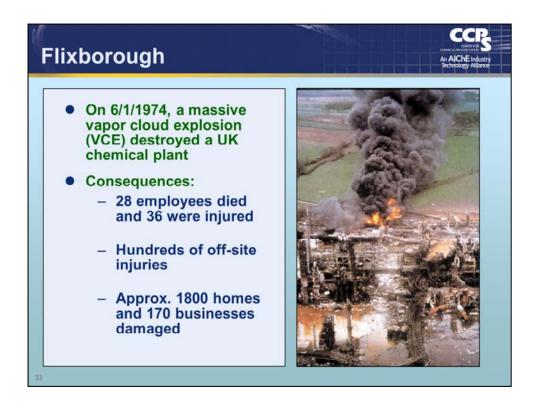
The Flixborough Works of Nypro (UK) Limited manufactured cyclohexanone via the partial oxidation of cyclohexane (cyclohexanone is used to make caprolactum, a nylon intermediate). The process operated at approximate 125 psi and 155 °C.

There was a significant number of injuries, and considerable building damage, in the nearby villages.

[The photo shows a portion of the plant after the explosion.]

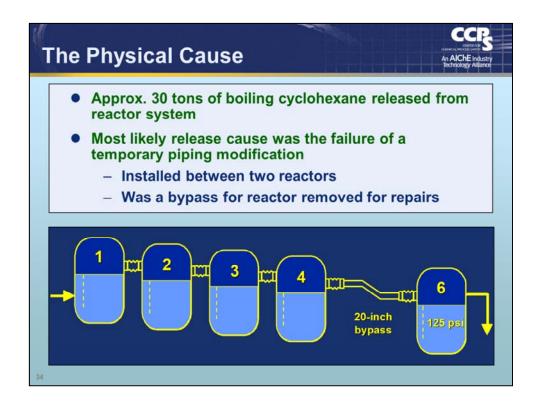
One of six vessels in the reactor train was removed after a six ft long crack was detected in the vessel shell. The gap between the adjacent reactors was subsequently spanned by a 20 inch diameter jumper.

The investigation determined that the most likely cause of the explosion was the failure of this jumper, which released at least 30 toms of boiling cyclohexane, which formed a vapor cloud, found an ignition source, and exploded.

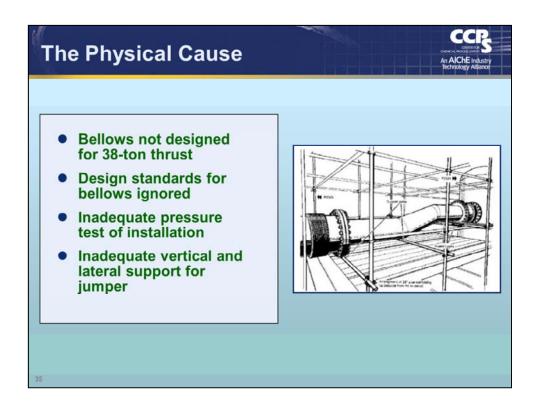
Because the reactors were staggered in elevation, it was necessary to incorporate a dogleg into this piping jumper. This jumper was fabricated and installed, supported only by scaffolding.

The installed jumper was leak checked at normal operating pressure, but the system was not pressure tested in a fashion appropriate for this sort of modification to a pressurized process system. Had the jumper been tested at 1.3X the reactor design pressure (as required by British standards) it would have likely failed... hopefully preventing the explosion that subsequently occurred.

It is believed that the unbalanced forces imposed on the bends in the piping, coupled with the flexibility introduced by the expansion bellows on each end of the jumper, allowed the inadequately supported and unconstrained jumper to oscillate. Ultimately, one of the bellows failed.

[The figure shows the installed jumper, supported on scaffolding. Surprisingly, perhaps, the jumper remained in service for two months before failing.]
