# Oxygen Related Accidents/ Incidents in Gas Industry – Learnings

Haris Farooqi

Director, Plant Technical Solutions – Asia, Air Products

2<sup>nd</sup> October 2018, Singapore

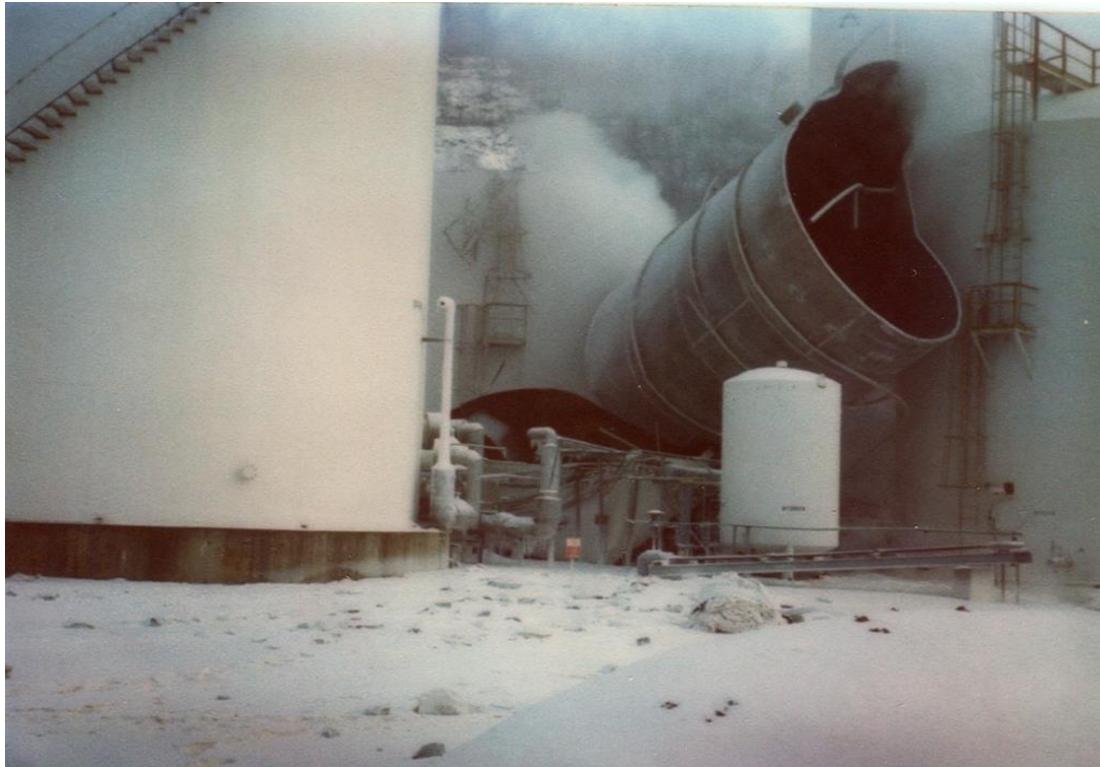
# ASU Flat Bottom Tank (FBT) Incident Aftermath - 1978

- LIN Flat Bottom Tank over pressured
- Inner vessel separated from foundation; lifted out from outer tank and fell to grade
- Breaking liquid outlet line on adjacent LOX flat-bottomed tank
- Resulted in LOX spill (800 T)
- 5 off-site fatalities

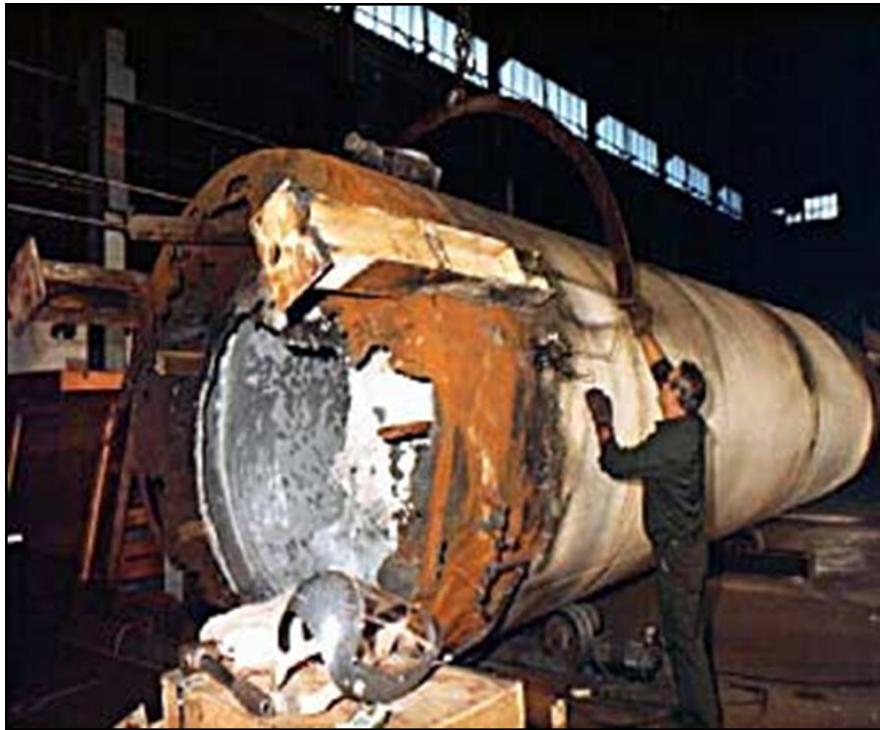
## LOX Tank Fire - 1981

- Resulted in **several fatalities**
- Vertical LOX storage tank ignited and burned through the bottom and top
- Tank had an aluminum inner vessel and a carbon steel outer vessel.
- Likely cause: **friction** from an aluminum internal tube (dip tube) **rubbing** against an aluminum support caused the ignition.
- Company has **prohibited** the **use** of **aluminum** inner vessels in **LOX tanks** since this incident.

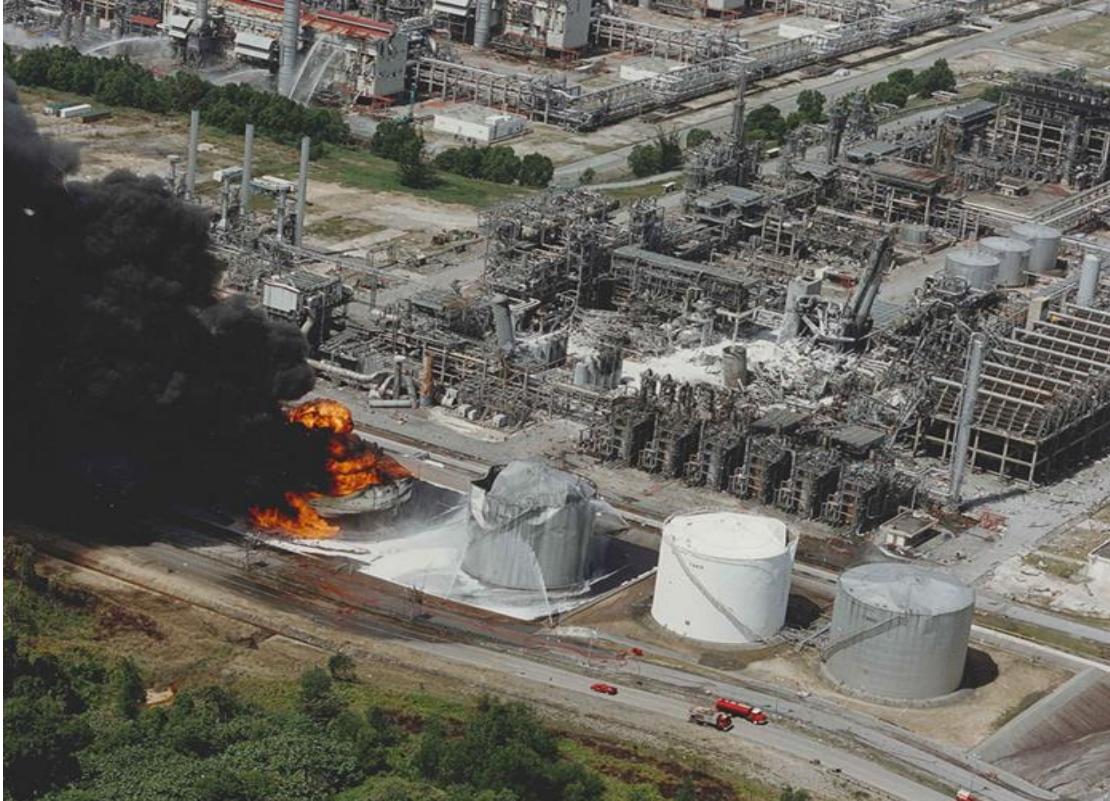
# ASU Plant Explosion - 1997

- ASU reboiler explosion led to fire
- [Hydrocarbon Accumulation](#) >> Combustion >> Aluminum burning/explosion

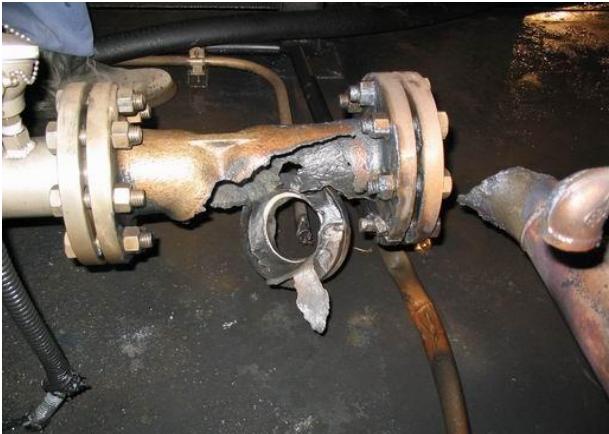
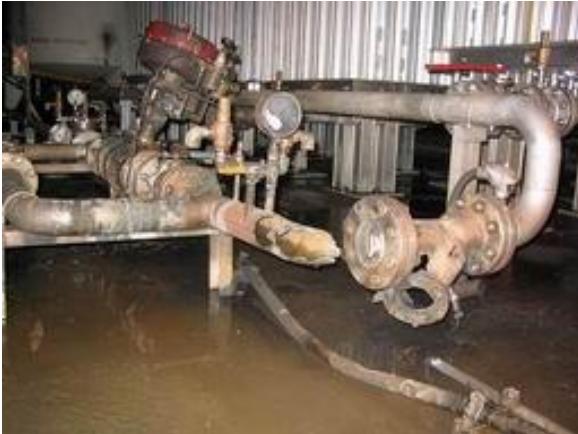
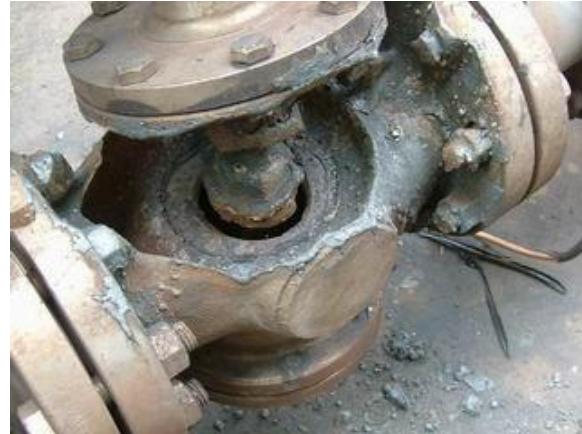
# Oxygen Energy Release

- Oxygen Energy released during **commissioning** of pressure control manifold.
- Eight people severely injured (burns) - **one** subsequently **died**.
- Highlights need for oxygen piping **design expertise**, **oxygen cleanliness**, adequate Hazard Review and Operational Readiness Inspection and safety precautions during **commissioning**.

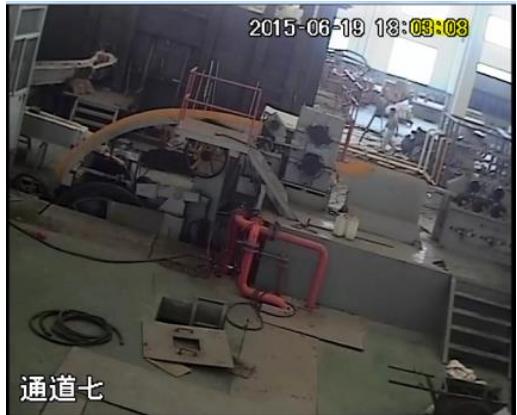
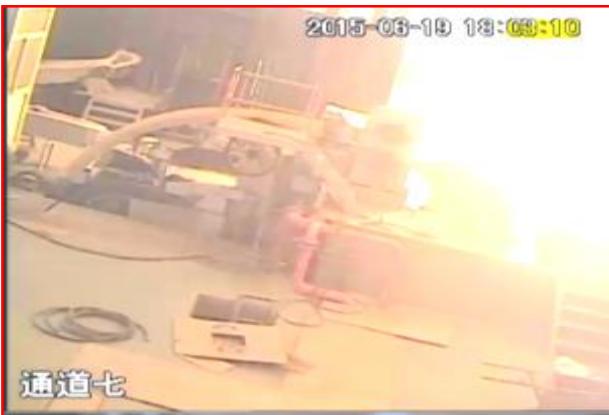
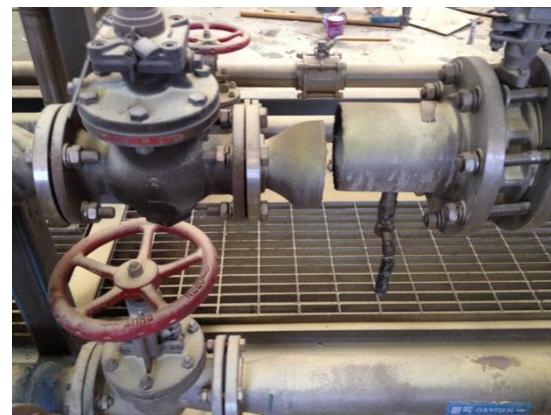
# Oxygen Fire – Oxy-Combustion Skid

- Flame erupted from an oxy-combustion skid being **commissioned** at customer location
- Multiple burn **injuries to personnel** who were present there **to get trained**
- Likely ignited by rust/particles in a strongly oxidized **hydrocarbon mixture** (HC solvent introduced by customer for pipe cleaning) carried from upstream pipe
- Flame released out of **poor quality weld** on the oxygen piping skid.

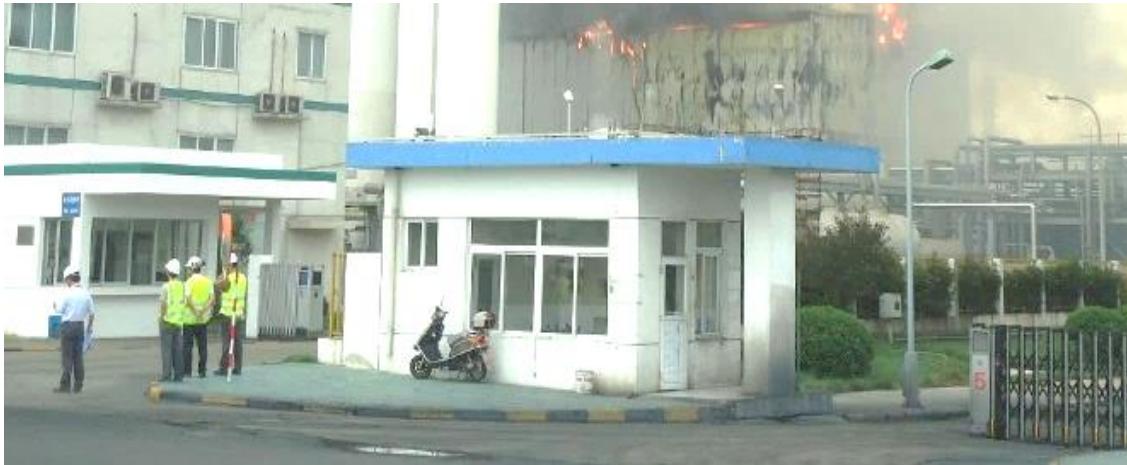
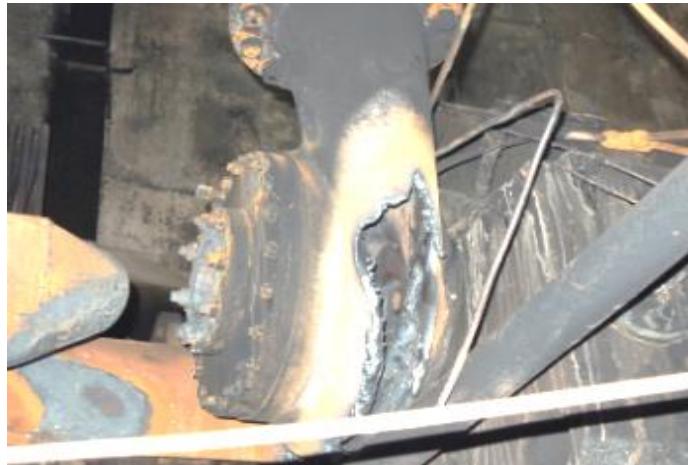
## N2 Compressor Fire (O2 Migrated via cross tie-in)

- 2<sup>nd</sup> GAN compressor **was added for reliability of supply (locally)** with cross tie-in so that both ASU1 and ASU2 can feed into either of the GAN compressors
- On day of incident, ASU 1 tripped and was being restarted. N2 with high O2 (during ASU restart) was fed to the compressor (**manual valve in cross-tie not fully closed**) – led to fire in compressor

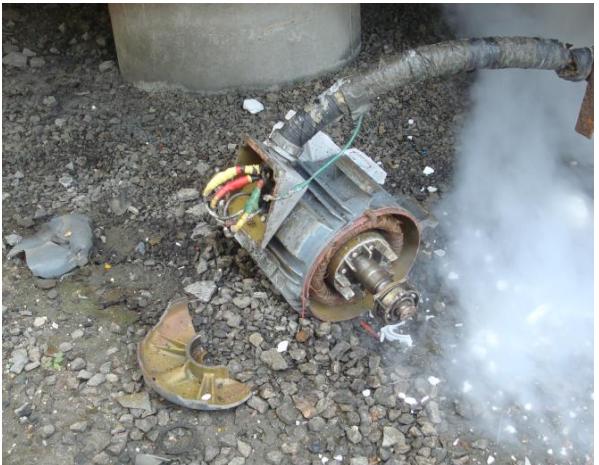
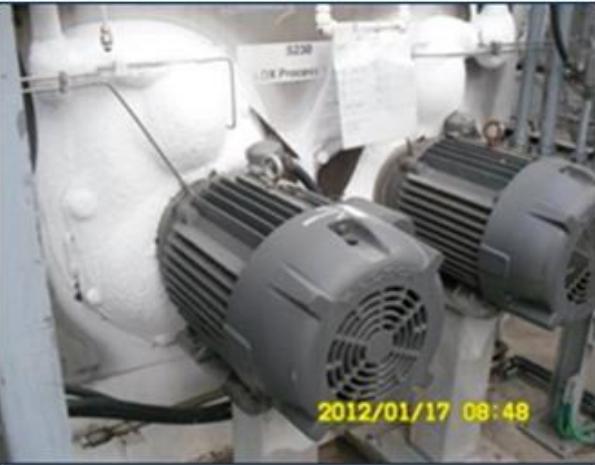
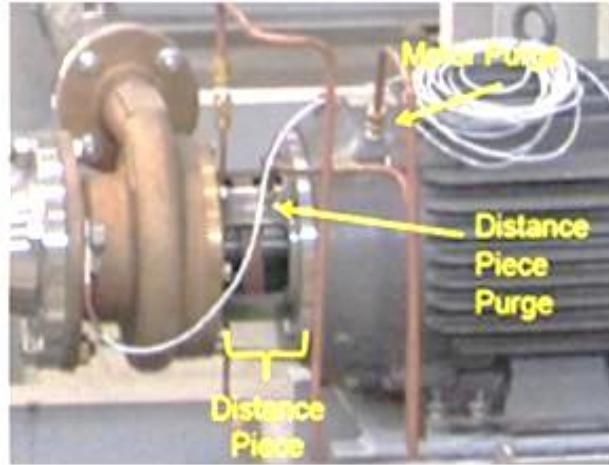
# LOX Loading Pump Motor Energy Release

- Oxygen: Pump **seal leak**, O<sub>2</sub> migrated from pump to motor through the **tunnel created by ice ball** over the **distance piece**
- Combustible Material: Electric motor components are not O<sub>2</sub> compatible
- Ignition Source: Not exactly known. Probably by **heat** generated from normal motor **friction**.

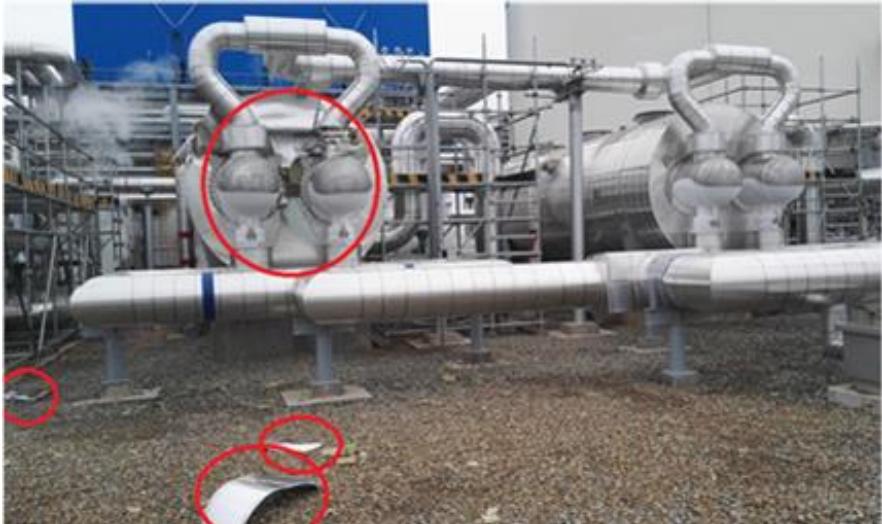
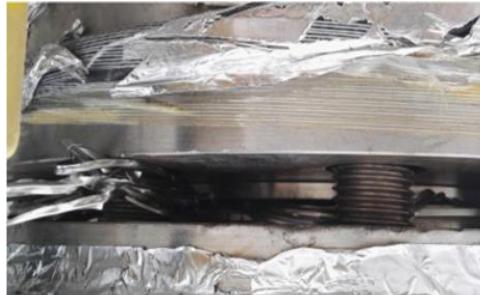
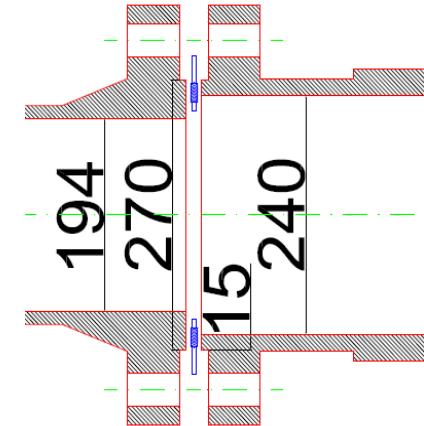
# GOX Gasket Failure

- The mismatch of flange seal surfaces resulted from **wrongly designed and manufactured outlet flange**, with wrong ID dimension. Error made by vendor designer.
- Error not caught during **drawing review and approval**.
- **Wrong gasket installed** (150# was installed instead of 600#)

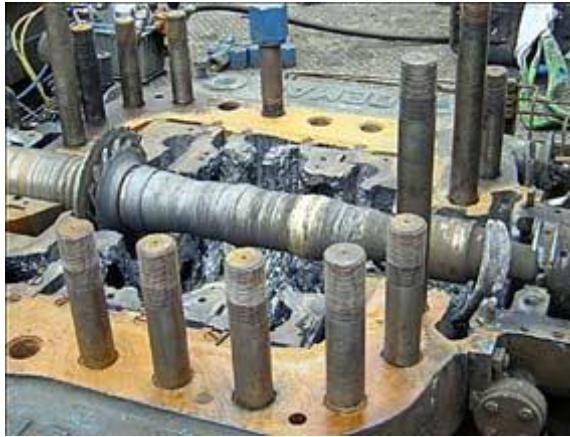
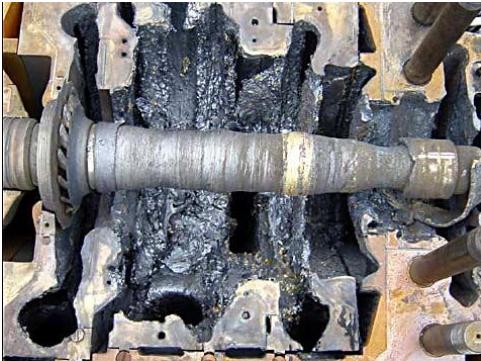
# GOX Compressor Fire - 2002

- Fire initiated in compressor; molten slag and metal flowed to the piping, ignited it and caused the breach.
- The fire lasted **5 seconds**.
- As a **safety precaution** all **oxidizer compressors** are **barricaded**. Barricade contained the fire **preventing injury**.
- Likely the fire was initiated by **frictional rub**; rub likely caused by **fatigue failure of an internal part** (impellor cover or blade)
- Rubs possible in compressors; cause friction ... ignition ... combustion. Practice is to barricade oxidizer compressors and to **allow personnel access** to the compressor **only during outages**.

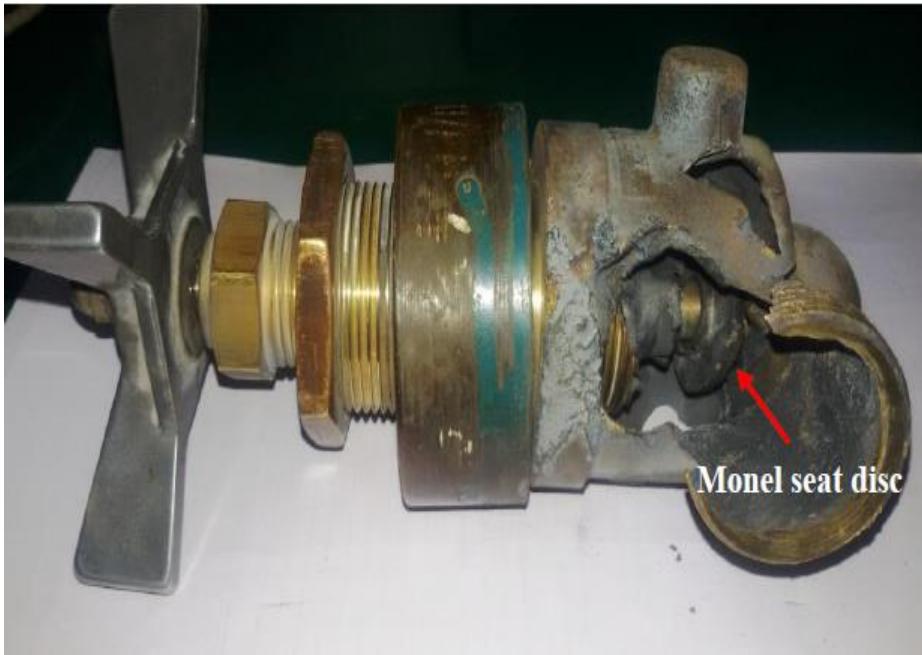
# Energy Release – O2 Cylinder Fill Panel Valve

- Fire occurred at the back of inlet **valve** located on manifold panel which was **being opened** to change over.
- **Maintenance** (including degreasing) was done on valve **two days prior to incident** to fix **leak in the valve**.
- **O2 Cleaning procedure** not strictly adhered to during maintenance event.

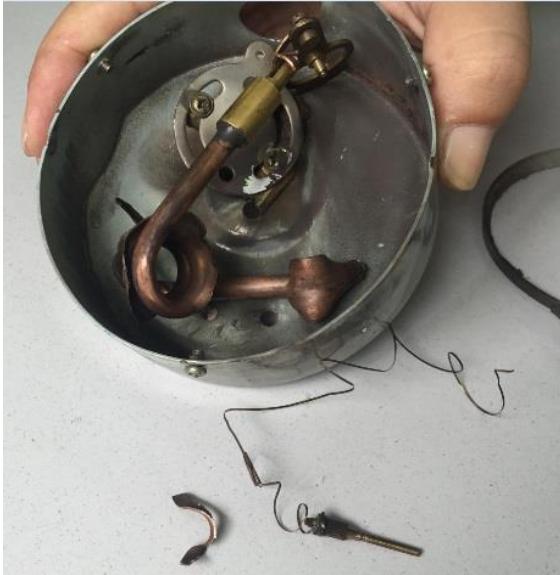
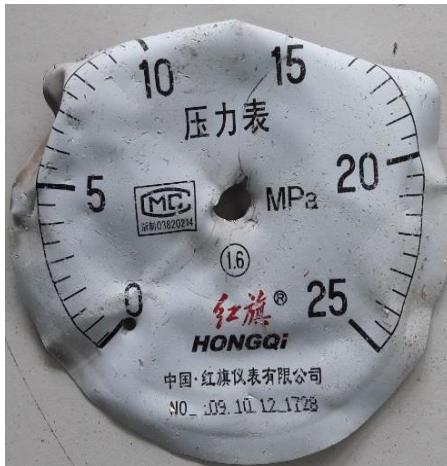
# Pressure Gauge Burst During Cylinder Pressure Check

- Operator was doing pressure check for medical oxygen cylinder.
- Incident happened when operator tightened the screw, and **opened** cylinder **valve slowly**.
- The gauge glass shattered **injuring** the operator on the right side of the chest.
- The **gauge that was used** was **not** compatible for oxygen service.

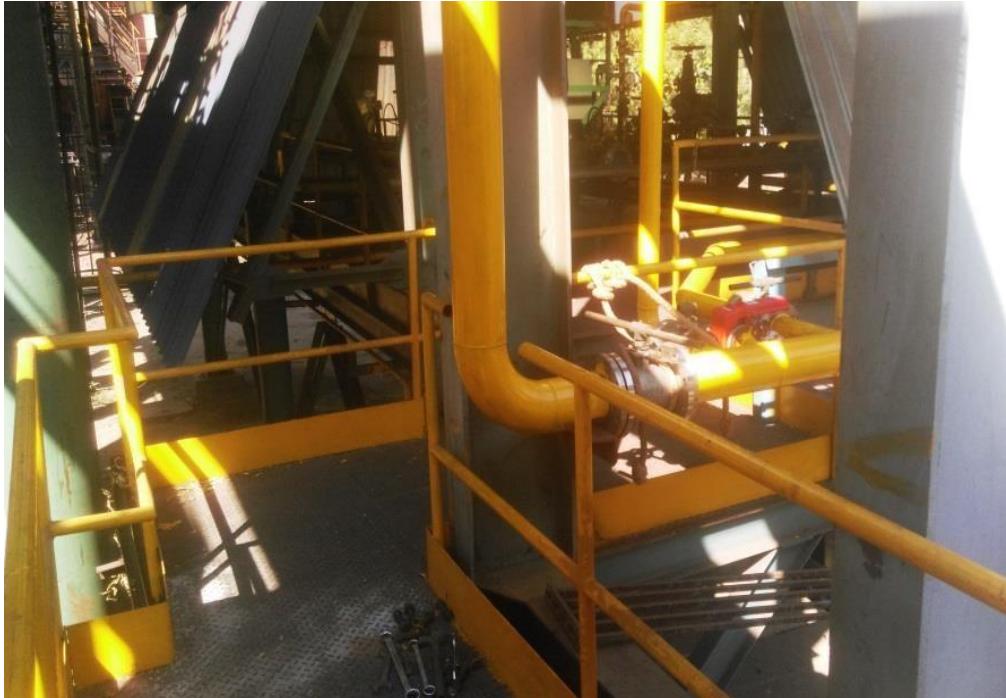
# Oxygen Pipeline Fire at Customer Site During First Fill

- Employee suffered **burn injury** when **O<sub>2</sub>** was **charged** for the **first time** into the pipeline
- fire occurred at the upstream flange of the valve.
- Valve was **not cleaned** for **oxygen service**
- Less than adequate **PPE**
- **No SOP** for charging oxygen for the **first time** in pipeline

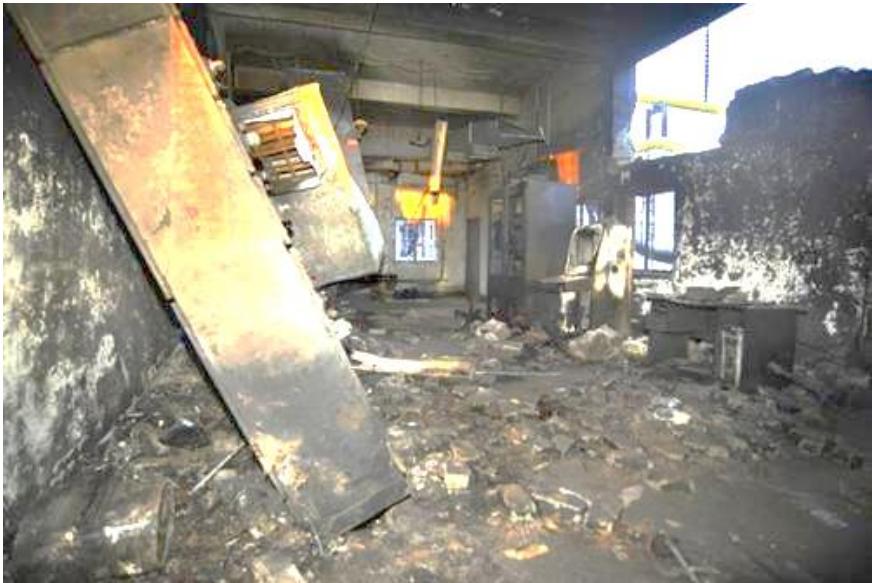
# Major Fire & Explosion At Oxygen Pipeline Pressure Reducing Station

Destroyed Control Room

- Fire and explosion at pressure reducing station on new O2 supply pipeline during **commissioning**
- Large number of **people (~50)** present at the control room at the time.
- Fire destroyed the control room and **19 people died**.
- Trapped particles in the filter at PRS (after the fire) showed that **particle impingement** on the steel pipeline in the filter area could have occurred that resulted in **ignition**.
- **Design practices** to prevent excess oxygen velocity might not have been properly followed.

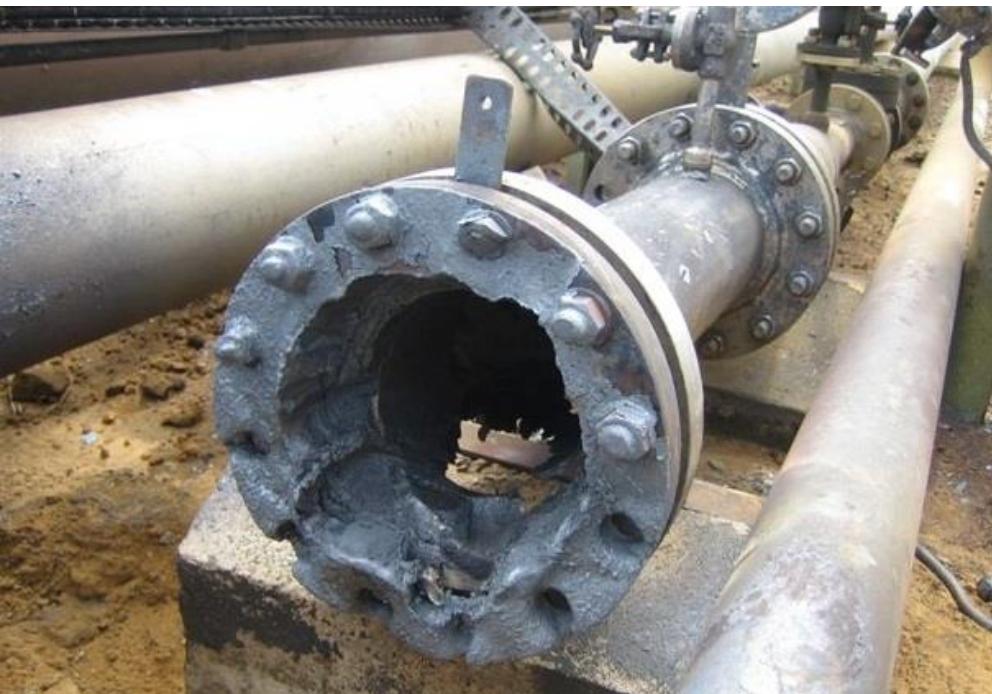
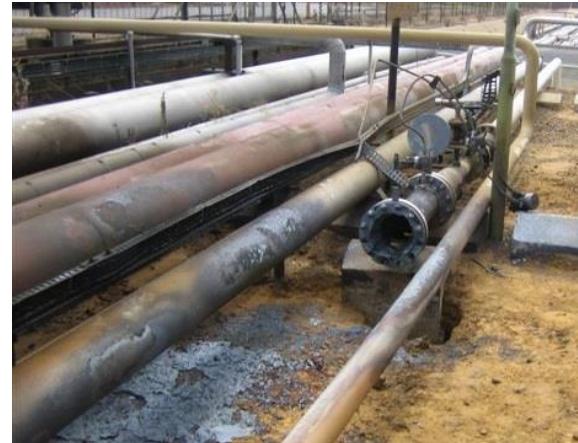
# Oxygen Pipeline Fire At Conical Filter Flange

- 6-inch O2 line – 3m section “consumed”
- Incident happened after upstream O2 tripped and was **re-started**
- **Particle impingement/ high O2 velocity**

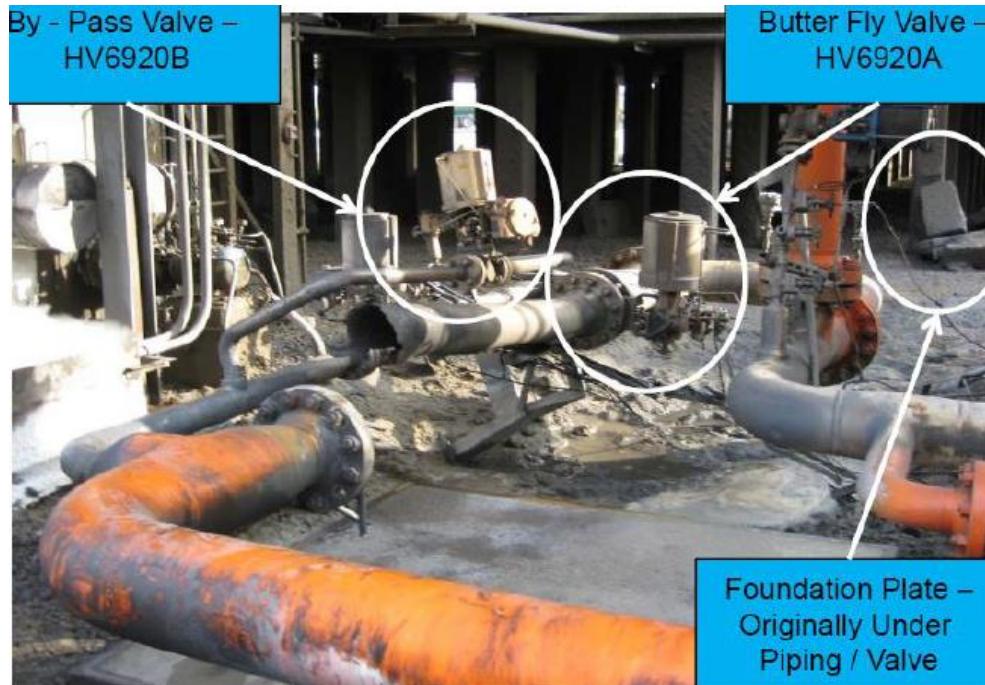
# Oxygen Pipeline Fire - Newly Modified Piping During Commissioning

- Deficiencies in O2 System Design expertise
- Inadequate Management of Change (MOC) approval process
