### Some Answers to the November 2012 Beacon Find-the-Problem Contest

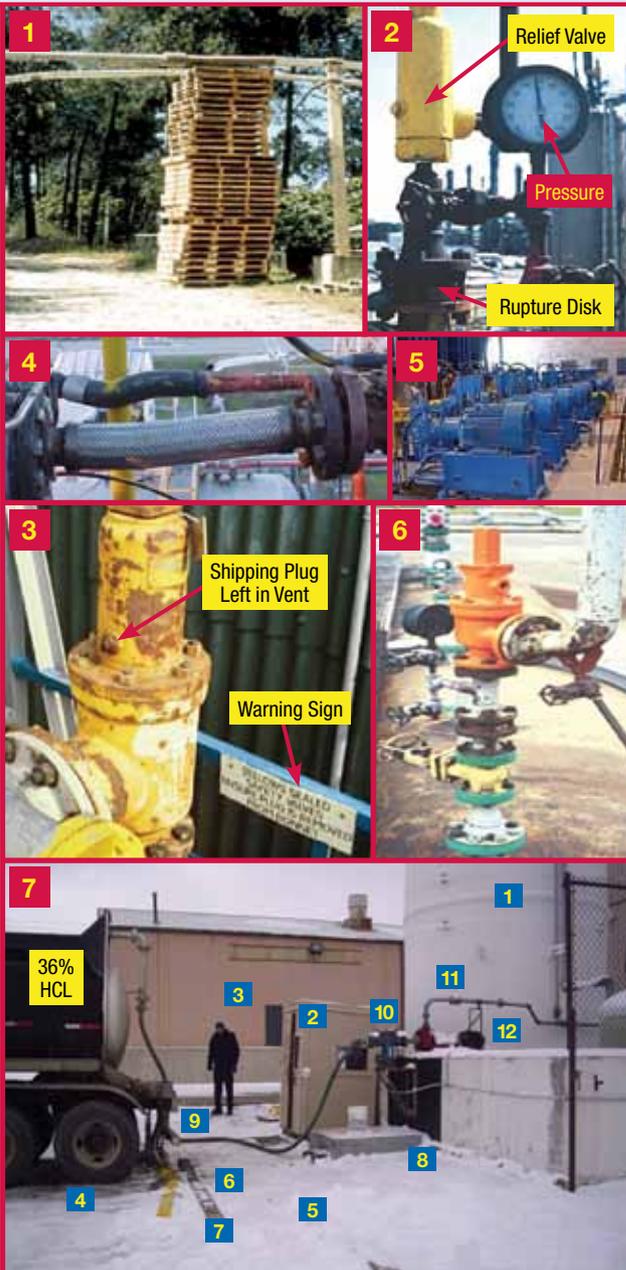
1. This is an easy one. Piping support is extremely poor.  
 2. The pressure between the rupture disk and the relief valve compromises the integrity of the emergency pressure-relief system. Rupture disks burst when the difference between the upstream pressure and the downstream pressure exceeds the rupture pressure. If there is pressure downstream of the disk, it will not burst at the intended process pressure.

3. Despite the warning sign, the plug in the bonnet of this bellows-sealed safety valve (which protects the valve during shipping) has not been removed. This will affect the pressure at which the valve opens.

4. Flexible hoses are being used to connect piping that does not fit together properly. Also, the flange on the right appears to be missing at least one bolt, and the faces of the flange do not align properly.

5. All of these pumps are identical in appearance and there is no evidence of any labeling.

6. The valves and other pipe fittings on the inlet of the relief valve (RV) result in greater inlet pressure drop, which could cause relief valve chattering. The block valve on the RV inlet does not appear to have anything to prevent someone from closing it and isolating the RV from the process.

7. There are many hazards in this photograph. Here are some of them (you may find others): (1) no visible label on the storage tank; (2) no eye wash or safety shower in the area; (3) the person in the picture is not wearing any personal protective equipment; (4) no chocks at tank truck wheels; (5) no visible spill containment; (6) many tripping hazards (and slipping hazards posed by the snow); (7) little or nothing to prevent the driver from backing the truck into the shed and the unloading piping; (8) inadequate platform to access the unloading connection; (9) no way to drain the hose when unloading is complete; (10) no pressure gages anywhere on the unloading piping; (11) the valve handle downstream of the pump is too high; (12) the unloading piping is poorly supported.
