## Liquefied Gas Cylinder Failure

December 2006

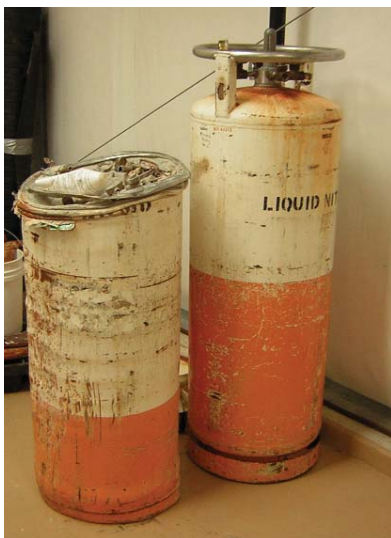
Intact cylinder and remains of a ruptured cylinder

A liquid nitrogen (Dewar) cylinder in a university chemistry laboratory catastrophically failed due to overpressurization. The incident occurred at 3 AM, when the building was not occupied, so there were no personal injuries; however, the damage sustained by the laboratory was extensive. Overpressurization blew out the bottom of the cylinder and propelled the cylinder upwards. The cylinder's pressure-relief devices, namely the pressure-relief valve and rupture disc, had been replaced at some point in the past by two brass plugs. But [before the incident], the cylinder may have been leaking through an old gasket, providing sufficient release of gas to prevent overpressure.

Approximately 12 hours before the explosion, the leaking gasket had been replaced, and the cylinder was refilled with liquid nitrogen. With the new gasket, the cylinder was completely sealed, and pressure could have been building up inside of it. The cylinder ruptured when its internal

pressure rose above 1,000 psi (69 bar). The catastrophic failure of the nitrogen cylinder was a result of the removal of the pressure-relief devices.

- ▶ Never modify any equipment containing hazardous materials or energy without a qualified engineering evaluation, and always conduct a management of change review.
- ▶ If you observe a high-pressure or liquefied-gas cylinder that appears to have been modified, or is corroded or otherwise damaged, report it to supervision immediately so it can be removed from service.
- ▶ Ensure that cylinders are properly maintained and periodically inspected, including the pressure-relief devices.
- ▶ If you use pressurized-gas cylinders, make sure you are properly trained in the safe handling of high-pressure cylinders.
- ▶ Share this incident with your colleagues in the laboratory who may use pressurized-gas cylinders.
- ▶ Read the Texas State Fire Marshall's Alert on this incident at <http://www.tdi.state.tx.us/fire/documents/fmred022206.pdf>.
