## But the pressure rating was okay...!?

### *Temperature and Pressure Ratings—usually an inverse relationship!*

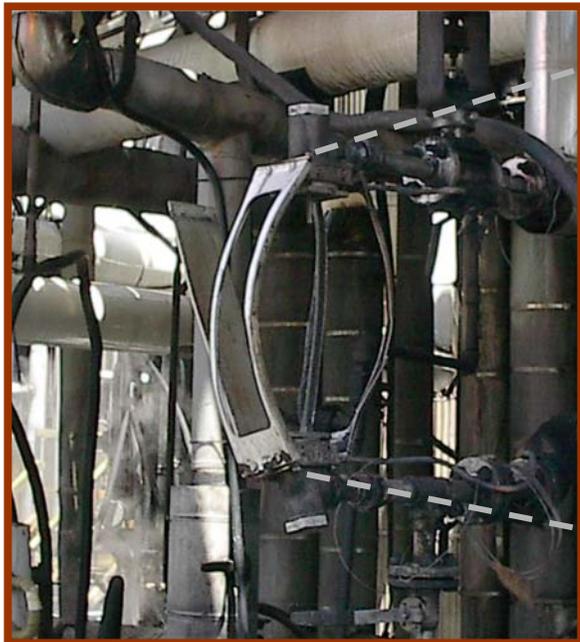
The picture on the immediate left shows a new rotameter. The other picture shows what happened when it was exposed to excessive pressure at high temperatures.

In this case, the line down stream of the rotameter had a history of plugging. Several times in the past, 150 psig steam was used successfully to clear the plug. When it plugged again, steam was used but this time the outcome was different!

- The rotameter was rated for 175 psig at 200° F. At 360° F, the rating drops to only 80 psig. Steam used to clear the plug was 150 psig and 360° F.
- The rotameter failed because it could not withstand the steam pressure *at the elevated temperature*.

☞ Remember that most equipment has lower pressure ratings at high temperatures. Looking only at the pressure rating can get you in trouble when heating is also involved. Know your equipment limitations and compensate where needed!

☞ Don't assume that a practice is safe just because it has not caused an accident before. You may have been lucky or the situation might have been *slightly* different before. This time may result in an accident.

☞ All operating and maintenance activities must be done "by-the-book" on **all** shifts. Don't try new things without evaluating the change (MOC) and do not revert to old outdated practices.
