December 2004

Bhopal—A Tragic Event

Union Carbide Bhopal Plant

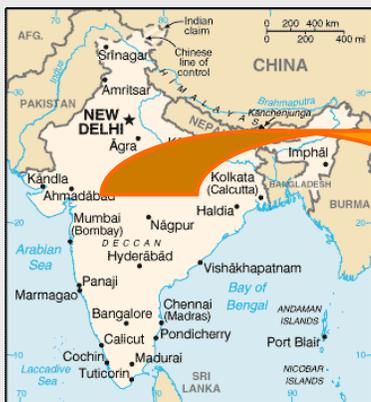
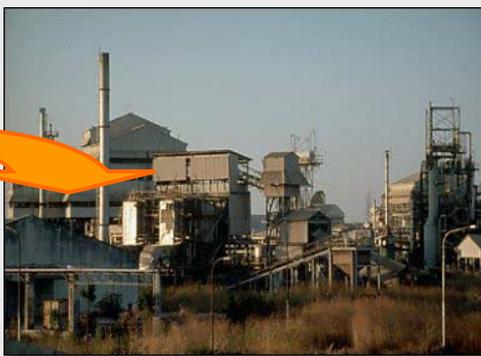
It was just after midnight, December 3, 1984 in Bhopal, India. A succession of events occurred in the Union Carbide India Limited facility that led to the release of ~40 metric tons of methyl isocyanate (MIC) gas. The consequences

were tragic: according to the Indian government, more than 3800 people died shortly after the release and thousands were injured.

? The basic cause has been agreed upon by most experts who investigated this event: a significant quantity of water entered the MIC storage tank. Water reacted with MIC, temperature and pressure rose and several safety systems could not deal with the event. Eventually, the vessel's relief device lifted, releasing MIC vapor.

Understand the reactivity hazards of all materials in your process. Read the reactivity section of your MSDS's, fully understand all reactivity instructions in your operating procedures and be knowledgeable about why your safety systems (e.g. interlocks, relief devices, scrubbers) are there and how they work.

If a material in your area reacts with water: 1) be cautious when washing equipment for maintenance or whenever a water hose is used, and 2) remember that compressed air may contain condensed water – be sure process air is free of water before blowing lines.

Understand the emergency procedures you are to take if the temperature or pressure increases quickly in vessels storing hazardous materials, especially those which are reactive.

Encourage your management and technical group to have a discussion about the “worst case” for the facility you work in and what safeguards have to be maintained to prevent that scenario from occurring.
