April 2005

Pressure Explosion Results

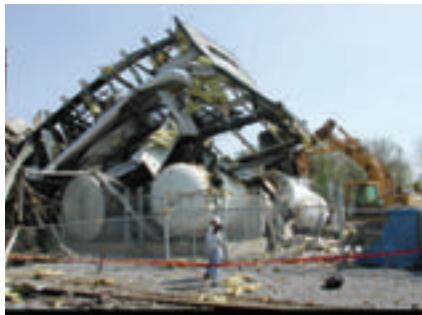
This accident investigated by and picture provided by the U.S. Chemical Safety and Hazard Investigation Board. Visit their site at <http://www.csb.gov>

A tank in this 55 year old facility that produces caramel coloring exploded, killing one worker and heavily damaging other equipment. Vessel fragments were thrown as far as 150 yards/130 meters and the top head of the vessel was propelled 100 yards/90 meters. Shell fragments damaged adjacent structures and equipment including an aqua ammonia tank. This resulted in the release of 26,000 pounds/12,000 kgms of aqua ammonia, causing nearby residents to be evacuated or told to shelter in place.

Other major damage included collapsed concrete block walls, destruction of the spray dryer area as shown in the photograph, and the rupture of a 6 inch natural gas line. Fortunately, automatic shut-off valves in the gas line prevented a major gas release.

- Never completely block in a vessel. Some form of emergency or manual pressure relief (or vacuum break) system must be available.
- Vessels that are heated should be monitored closely — especially if there are no safety instrumented systems or interlocks to shut off the heat source if needed.
- Before connecting an air or nitrogen line to a vessel, make sure that the vessel can withstand the full supply pressure or that the vessel has a suitable relief system set low enough to protect the vessel.
- When doing jobs that distract you from your regular operations job, periodically check the equipment to confirm that it is still operating normally.
- Do not underestimate the power of over-pressurization and its ability to cause catastrophic failure. Metal fragments can travel long distances and do significant damage!

The explosion was a simple case of over-pressurization.

The contents of the feed tank were overheated by steam coils, causing the vapor pressure to rise. There were no temperature alarms or interlocks to automatically stop the steam flow or notify operations that there was a problem. Because the operators were distracted by having to re-label a previously packaged order, they did not notice that the temperature in the tank had risen above specifications. At the same time the temperature was rising, the operators closed a vent line and opened an air pressurization line to the tank in an effort to “blow out” high viscous material. That act completely blocked in the vessel, which had no emergency relief system. The result — catastrophic failure to relieve the pressure.
