## A Safety Device Gone Wrong

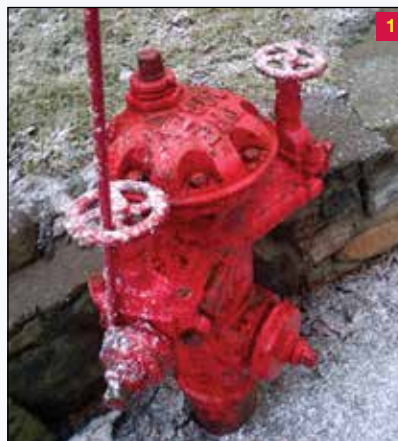
Picture 1 shows a fire hydrant in a town in the northern U.S. that gets a lot of snow in the winter. The vertical steel rod fastened to the left side of the hydrant is intended to mark the location of the hydrant, as shown in Picture 2. A flag is installed at the top of the rod as a safety device to enable firefighters to find the hydrant if it is covered with snow. The flag also marks the location of the hydrant so it is less likely to be damaged by snow-removal equipment, and so that people do not park vehicles where they will block access to the hydrant.

Clearly this safety device has created a problem. The metal rod was installed so that it passed through the valve handle. The valve cannot be opened without first removing the rod. The rod may also impede the use of a hydrant wrench to open the hydrant. While the rod and flag can be removed, this will take valuable time, possibly in an emergency situation.

- Any change to a system, including the addition of a new safety device, is a change that must be reviewed using your plant's management-of-change (MOC) procedure.
- When doing an MOC review of a new safety device, be sure to consider the possibility that the change introduces new hazards.
- After the change is reviewed, make sure it is implemented correctly and is ready for operation using your plant's pre-startup safety review (PSSR) process.
- Get emergency response personnel involved in the MOC and PSSR if the change impacts them.
