Mechanical Integrity

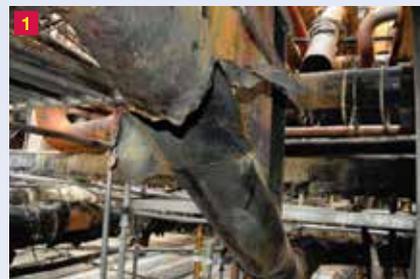
In August 2012, a pipe in a crude distillation unit (CDU) in a refinery in California ruptured, releasing hot, flammable hydrocarbon process fluid (Photo 1). The released material partially vaporized, forming a large vapor cloud that ignited. The pipe failed due to thinning caused by sulfidation corrosion, a common damage mechanism in refineries. Sulfidation corrosion failures are of great concern because of a comparatively high likelihood of catastrophic failure. This can happen because corrosion occurs at a relatively uniform rate over a broad area, so a pipe can get progressively thinner until it bursts, rather than a failure starting as a small leak at a pit, crack, or local thin area.

- Immediately report any leak that you discover, no matter how small, and follow up to make sure action is taken.
- If you are responding to what appears to be a small leak in a large pipe or vessel, consider the possibility that the “small” leak is actually caused by a large area of thin or weak metal that could suddenly become a large leak. Plan your response to ensure that people are protected should this happen.

- If you are replacing piping or other equipment, make sure that you use the correct material for all replacement parts. Follow the positive material identification (PMI) procedures at your facility and verify implementation in the field. Perform a 100% component inspection of what has been replaced during a turnaround before restarting.

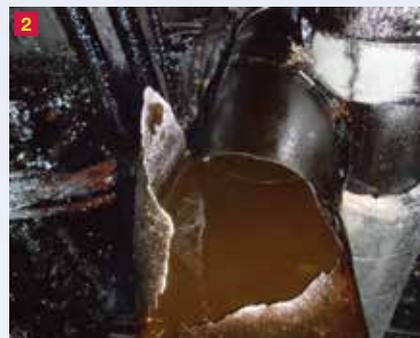
In November 2013, a fire erupted after a leak from a pipe containing vacuum residue at a CDU in a refinery in Brazil (Photo 2). The leakage occurred due to the rupture of a straight section of pipe in a pipe rack near the pre-flash tower of the CDU. The investigation determined that the pipe section was very thin (less than 1 mm). The specified material for this pipe section was an alloy steel, but the actual material was found to be carbon steel — the pipe section had been replaced during a maintenance shutdown in 1998, and the wrong material of construction was used.

In both of these incidents, the mechanical integrity management system was not successful at detecting and replacing deteriorated piping components before they failed. In the 2013 incident, the maintenance system did not ensure that the correct material of construction was used when the pipe was replaced. More-effective mechanical integrity and maintenance programs could have prevented both incidents.
