# Process Safety Lessons from the OceanGate Titan Implosion

Richard Carter, P.Eng. ■ Watchmen Instrumented Safety Experts Ltd.

In June 2023, OceanGate's Titan submarine and its crew perished while exploring the wreckage of the RMS Titanic. A review of the hazards the company overlooked holds many lessons for engineers working in process safety.

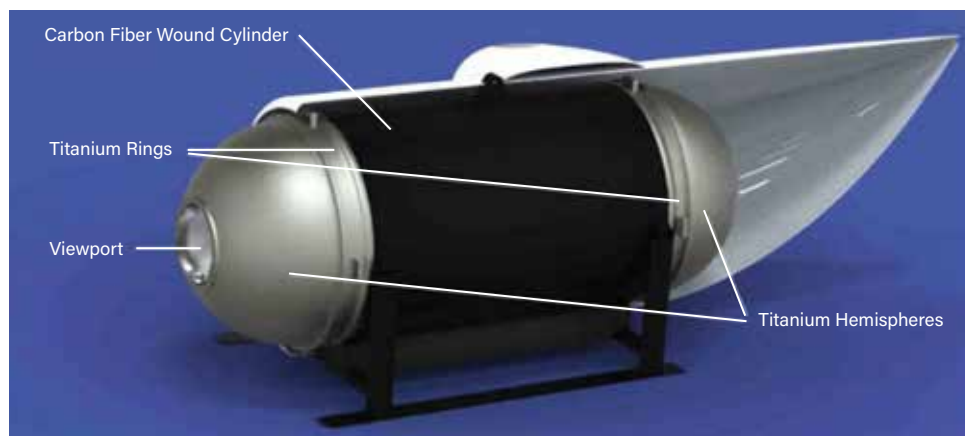
A diagram of the main components of the Titan pressure hull is shown in Figure 1 (4). The pressure hull was composed of a cylinder made of a wound carbon fiber epoxy matrix with a titanium hemisphere bonded to each end with adhesive. An acrylic viewport was incorporated into the front (fore) hemisphere, and the cylinder and rear (aft) hemispheres were covered by a white fiberglass shell. The tail portion of the shell was not pressurized (1).

Figure 1. The body of the Titan submersible featured a carbon fiber body between titanium rings and hemispheres (4).

Carbon fiber is a lightweight but strong material, consisting of strands of carbon embedded in an epoxy material that adheres them together and provides structural support. The hull cylinder was manufactured by wrapping carbon fibers in epoxy around a metal cylinder, followed by curing in an autoclave, causing the epoxy to bind the carbon fibers together (5).

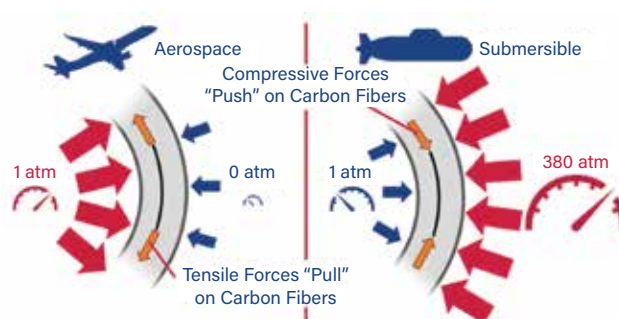
Figure 2. The carbon fiber frame used in the Titan submersible was inspired by aerospace technology. However, the effects of the pressure differential on the fibers within a carbon fiber matrix in an aerospace application in internal pressure service (left) and a submersible application in external pressure service (right) vary dramatically.

Carbon fiber is strongest in cases where the forces are in tension. The fibers can be considered similar to very small strings that, when pulled on, resist pulling and stretching with a high degree of strength. In an aerospace application, such as an airplane, the pressure inside the craft is greater than the pressure outside, and this puts the carbon fibers into tension due to the forces pushing outward from inside the craft.

However, carbon fiber is not as strong under compressive forces (6). The carbon fiber “strings” are not nearly as effective against a force pushing on them, in the same way that a string or rope does not provide much resistance against being pushed, and so under compressive forces, much of the strength comes from the epoxy matrix holding the fibers together. The difference in force direction on the carbon fibers is illustrated in Figure 2. Note that Stockton Rush incorrectly stated that it was the inverse and that carbon fiber became stronger under compressive loads, similar to concrete (8).

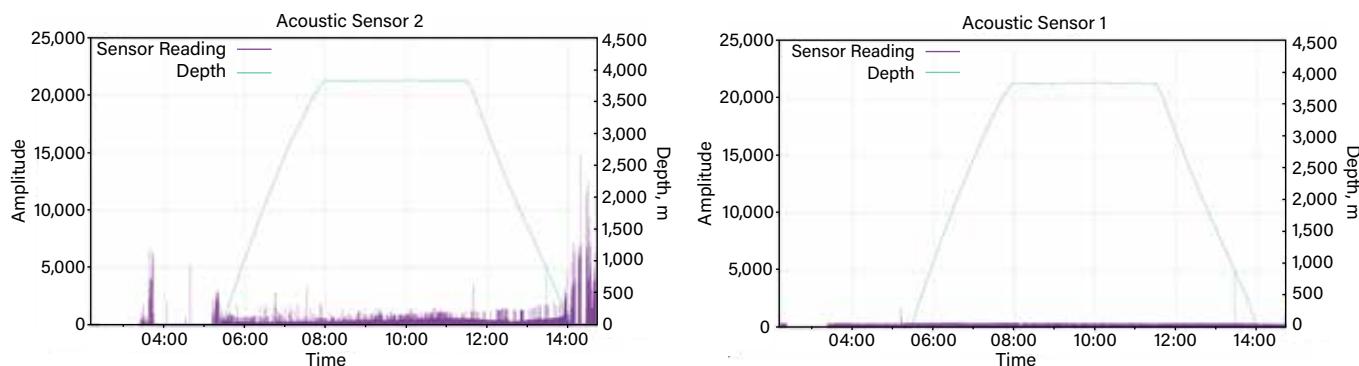
Finally, safeguards must be audited to ensure they are working correctly and can reasonably be expected to be available and effective when they are required to act to prevent a hazardous event (Figure 3) (22). If a safeguard is

▲ **Figure 3.** This comparison of acoustic monitoring Sensor 2 (left) and Sensor 1 (right) during Dive 76 indicates that Sensor 1 did not appear to register the acoustic events detected by Sensor 2 (22).

found to not be working correctly, the reason for it needs to be investigated and a solution implemented to restore it to working order. If this is not possible or practicable, an alternative means of protection must be implemented to address the risk gap created by this safeguard not working correctly. Although accessing the sensors for inspection, testing, and maintenance may not have been possible, one way to audit the sensors for accurate detection would have been by comparing the recorded output of different sensors together to see if they detected similar acoustic events. It was determined that three out of the eight sensors likely were not detecting or reporting acoustic events (Figure 3) (22), indicating that there may have been a systematic issue that needed to be investigated to prevent the failure of the remaining sensors (22).

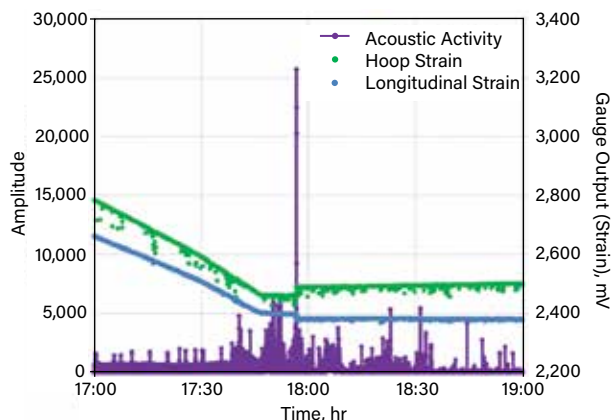
▲ **Figure 4.** A comparison of acoustic and strain data at the end of Dive 80 reveals an enormous momentary increase in acoustic activity at the same moment personnel heard a loud bang inside the submersible (23).

These weak signals are especially critical when innovating and moving beyond the known safe operating boundary, because it might not be clear what signals are revealing. In the case of the Titan, there were signals, both weak and strong, leading up to the implosion that, had they been followed up on, could potentially have prevented the implosion and loss of life. One of the most significant, in hindsight, is a loud bang sound that was heard shortly after surfacing from Dive 80 on July 15, 2022 (1). A comparison of the acoustic and strain monitoring data (Figure 4) shows that the sound coincided with a sudden change in the longitudinal and hoop strains of the hull (23).

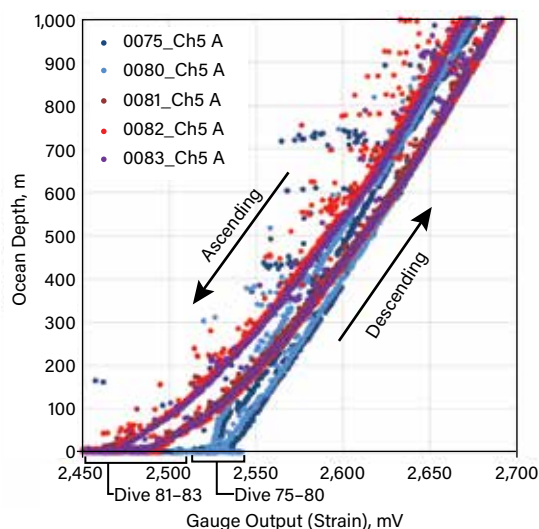
This indicates a significant change in the operation of the vessel; data from the strain gauges on previous dives does not show this sudden change in hull strain. Furthermore, this event appears to have impacted the response of the hull strain to pressure changes on subsequent dives. Figure 5 shows how the strain recorded during Dives 75 and 80 — prior to when the bang sound was heard — was different from the strain on Dives 81 through 83 — after the bang sound was heard (23). The difference in the response of the strain monitors indicates a persistent change in the hull’s response to pressure, which should have been detected and investigated. Instead, the noise was dismissed by Stockton Rush as caused by a shift of the Titan’s frame, and he

▲ **Figure 5.** A comparison of hull strain response before and after the loud bang was heard reveals a significant difference in the way the hull responded to pressure changes (23).

directed that no further investigation was required. The U.S. Coast Guard's Marine Board of Investigation later determined that the most likely cause of the "bang" sound was separation between layers of carbon fiber within the cylinder walls, significantly compromising the material strength (2).

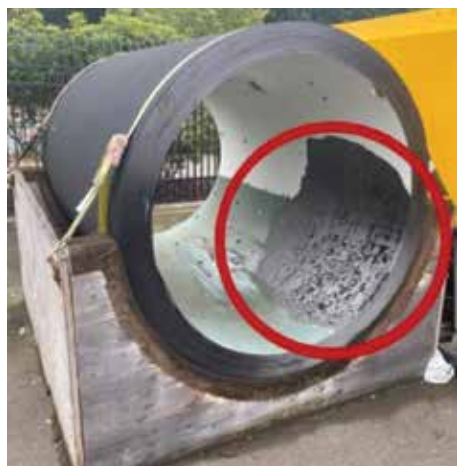
◀ **Figure 6.** A large crack in the internal hull surface of Version 1's (V1's) carbon fiber hull could have alerted engineers to inherent flaws in their design strategy (1).

One incident that warned that there was a potential concern with the submersible's design was the failure of the initial Version 1 (V1) hull. The V1 carbon fiber cylinder, which was manufactured as one continuous layer, developed a large crack (Figure 6) that was identified by an OceanGate pilot in June 2019, leading to the hull being retired in October of that year (1).

This was clearly a signal that the pressure and cyclic operation of diving and surfacing were causing fatigue and damage to the carbon fiber hull. The reason that OceanGate used five separate layers of carbon fiber in the Version 2 (V2) hull, which was installed on the Titan at the time of implosion, was an attempt to prevent reoccurrence of this failure, as it was believed that wrinkles that formed in the single continuous layer contributed to the V1 hull failure (3). However, the new five-layer structure was not tested prior to development of the final V2 hull, and no scale models were developed using this process to test this theory (2).
