The Right and the Wrong – Two Process Design Optimization Examples

What case study story would be complete
without spraying diesel out on the unit?

James Turner
Fluor Enterprises, Inc.

Oct. 4, 2012

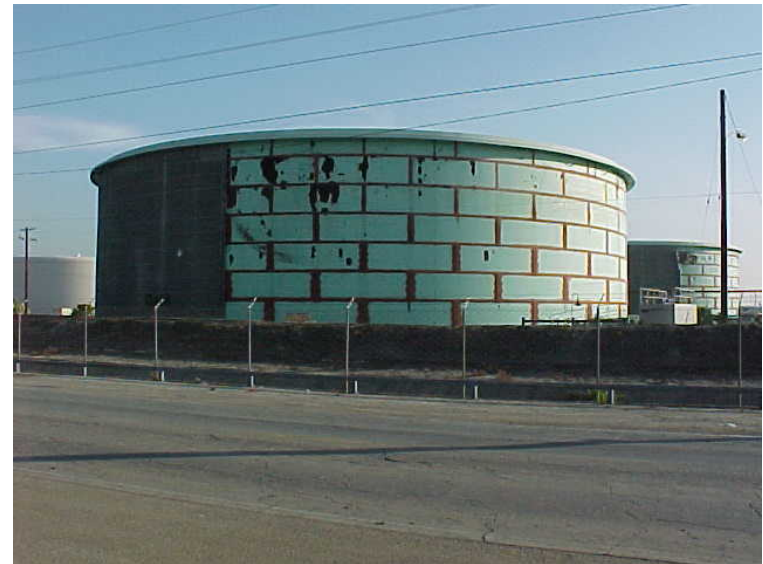
NEWSFLASH – On November 8, 1999, a refinery storage tank near Catlettsburg, KY ruptured, spilling ~285,230 gallons of petroleum distillate (gas oil) into a tributary of the Big Sandy river. Some of the gas oil was entrained with steam escaping the tank and “rained” down on the surrounding community.

Operations ran down hot gas oil from unit to tank, which mixed with cold gas oil – combined temp ~ 215-230°F

As gas oil was pumped out, hot gas oil caused water to vaporize, raising pressure in tank, causing the side of the tank to rupture.

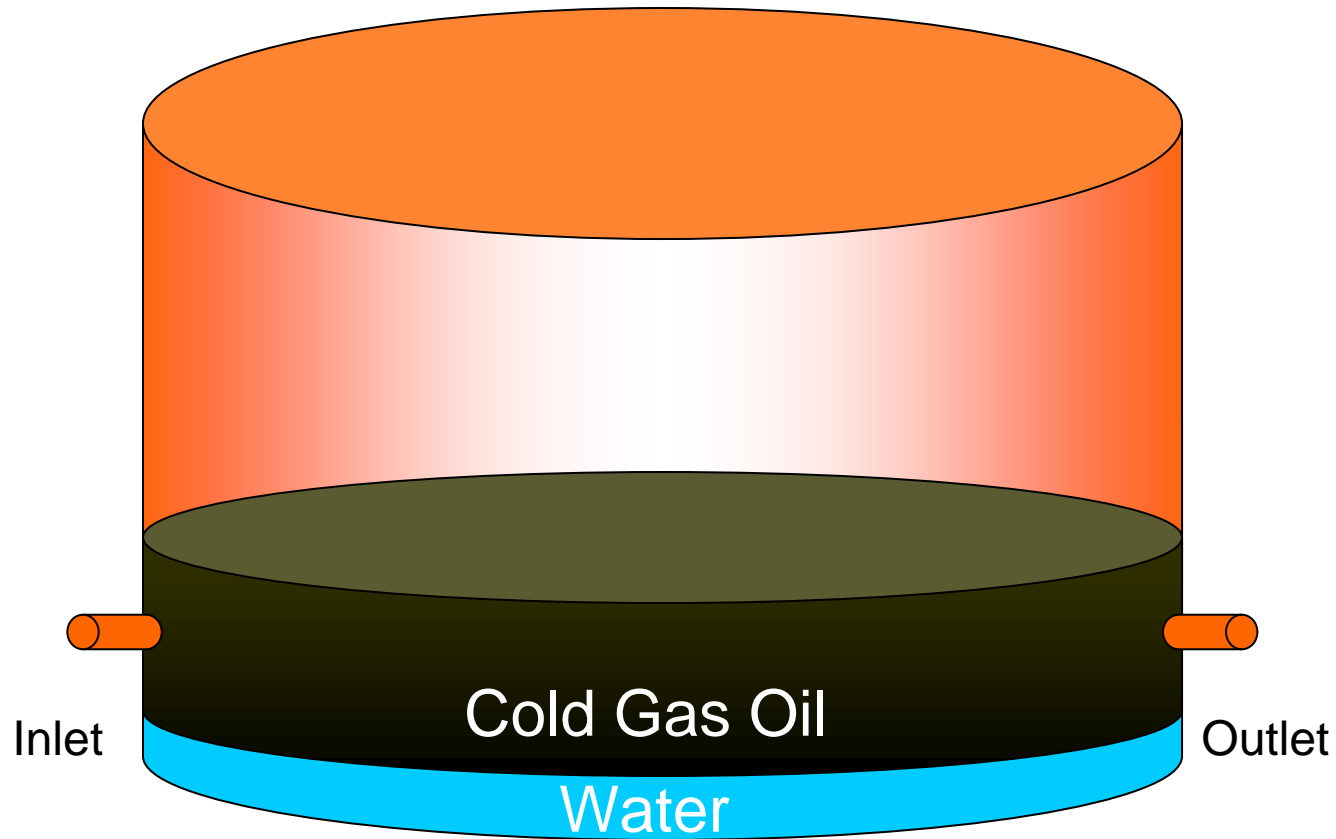
Normal Operation – 150-180°F Gas Oil

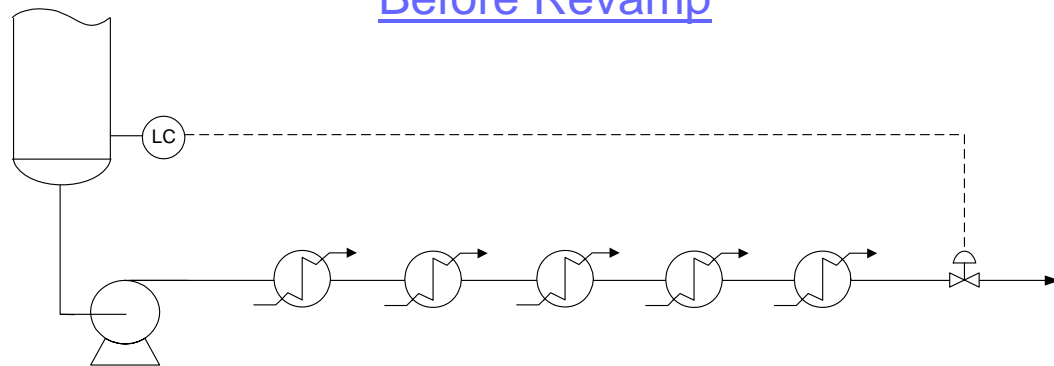
Before Revamp

The product rundown circuit was modified with the ability to isolate one train for cleaning

The original design intent apparently was that the exchangers were designed for pump “shut-in” – there were no PSVs in the circuit

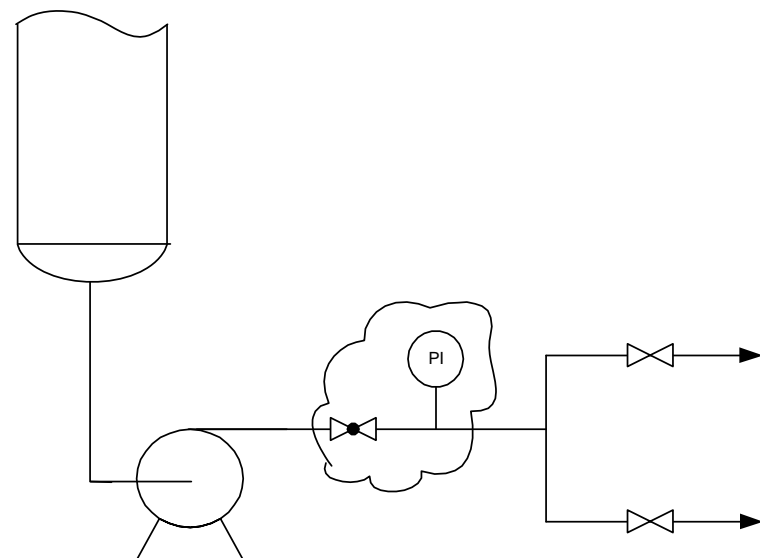
Engineering Solution:

Add a globe valve followed by a PI, to be used to manually throttle the pressure before the exchangers during start-up

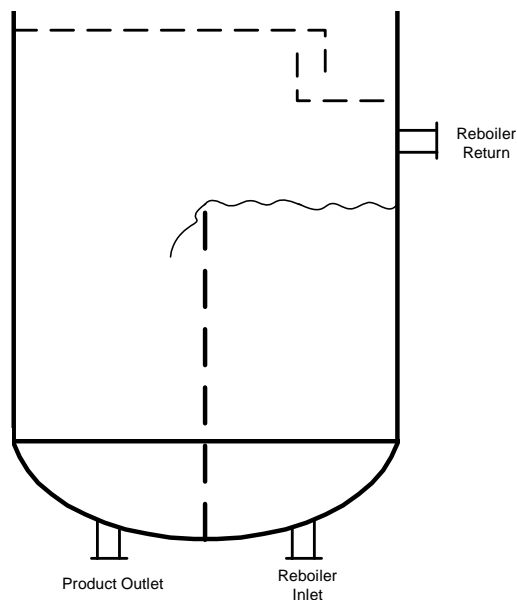
Recirculating
Thermosiphon

Existing Tower/Reboiler design was a recirculating thermosiphon – this means that the reboiler is at a higher pressure than the tower due to the liquid static head.

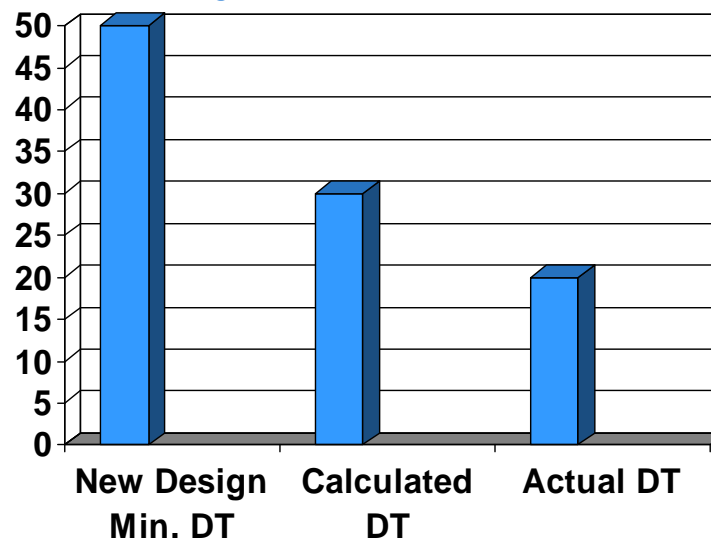
Reboiler Temperature
Driving Force, °F

The three factors caused a “pinch” on exchanger temperatures, making the available exchanger surface area inadequate

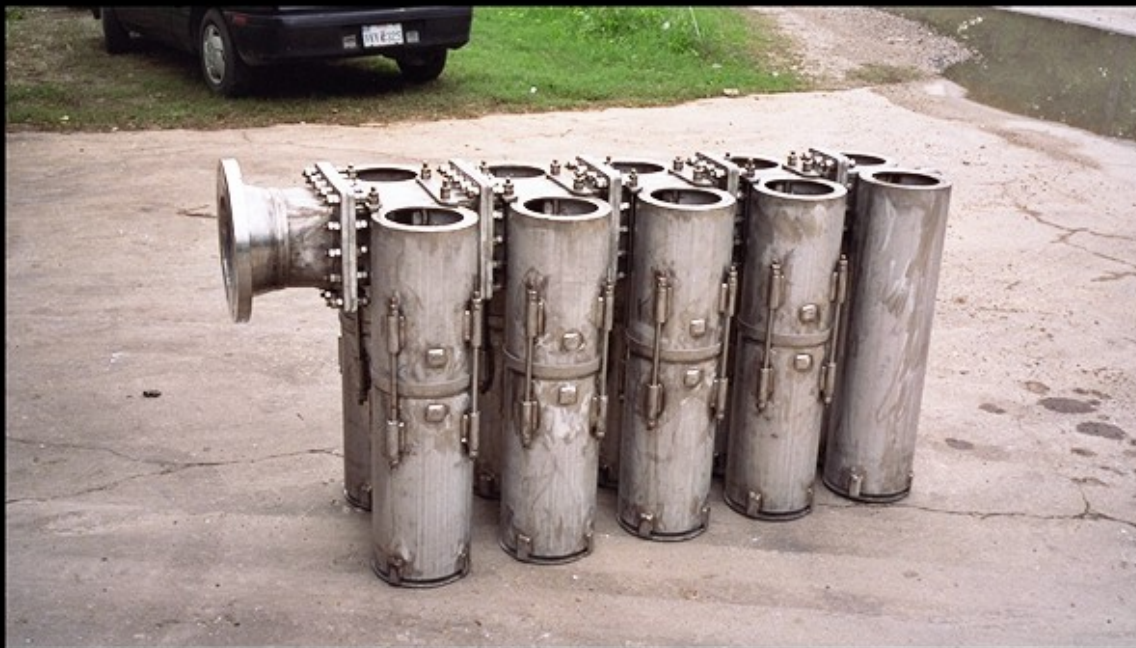
“Vortex Cluster”

- ◆ Result of data gathering – no practical solution by manipulating process conditions
- ◆ Industry survey found no problems with refiners that have horizontal separators
- ◆ one refiner that had solved a similar problem by install vendor inlet internals
- ◆ My recommendation was to install vendor internals to improve the separation
 - Industry experts that were consulted said it wouldn't work

- ◆ This was the first time that Fluor had tried this type of internals in this service -
 - Fortunately, it worked very well!
- ◆ Fluor has done many other projects with this client since (including more than one multi billion project)
- ◆ These internals have been subsequently used in several similar situations, all with good success
- ◆ Recently, these internals were used for the first time in a Crude Unit Preflash Column
 - They also worked very well in this application.
