**BUILDING
PROCESS SAFETY
CULTURE:
Tools to Enhance
Process Safety
Performance**

Challenger Case History

[The following information has been taken from the US government publication *Report of the Presidential Commission on the Space Shuttle Challenger Accident* (the Rogers Commission report).]

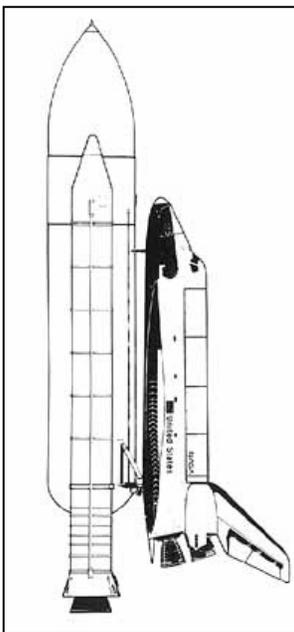
The leak from the booster rocket field joint continued to grow, impinging upon the lower portion of the external fuel tank. The external fuel tank contained (in separate vessels) the liquid hydrogen and liquid oxygen fuel that powered the shuttle's main engines. At about 65 seconds into the mission, the liquid hydrogen tank began to leak.

At about 73 seconds, the hydrogen tank failed catastrophically, and the liquid oxygen tank failed shortly thereafter. Within milliseconds, the explosively burning hydrogen and oxygen enveloped Challenger. Challenger broke into several large sections (photo on next page). The solid rocket boosters broke free and erratically flew about until Ground Control issued the remote destruct command. The main engine/tail section (with engines still burning), one wing, and the forward fuselage could be identified as they exited the fireball. It is believed that the crew module remained intact until it slammed into the sea.

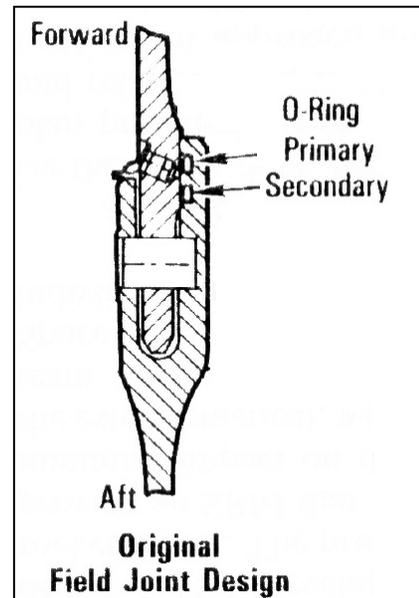
- Thiokol engineers had correlated lower launch temperatures with more severe erosion of both O-rings, and had a basic understanding of why this was the case, based upon the lowered resilience of the elastomer O-rings at lower temperatures. As the pressure inside the SRB increased during launch, the gaps in the field joint increased, and the O-rings were less capable of sealing the widening gaps at lower temperatures. This resulted in combustion gas blow-by, leading to erosion of the O-rings.

- In spite of the above knowledge, no criteria had been established for minimum temperature at launch. A conference call between Thiokol staff and the various NASA offices involved in approving the launch was held the night before the launch. During this call, Thiokol engineers advised delaying the launch until later in the day. In the face of pressure from NASA managers, Thiokol managers overruled their engineers and approved the launch on the original schedule.
- The top administrators at NASA were unaware of the issues related to the technical issues related to the performance of the joint at lower temperatures. NASA site managers did not pass information about Thiokol's concerns up the line within the NASA organization. The Commission concluded that it was likely that NASA management would not have gone forward with the launch if the "had known all the facts."
