# Lessons Learned from Recent Process Safety Incidents

ALBERT NESS

CENTER FOR CHEMICAL PROCESS SAFETY

These five incidents demonstrate how seemingly small mistakes or temporary lapses in judgment can result in disaster.

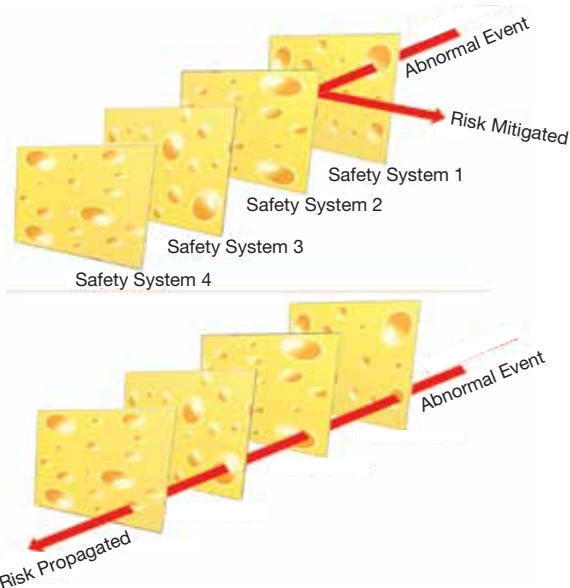
Accidents almost always have more than one cause. For many years, safety experts have used the Swiss cheese model (3) to help managers and workers in the process industries understand the events, failures, and decisions that can lead to a catastrophic incident or near miss. According to this model (Figure 1), each layer of protection is depicted as a slice of Swiss cheese, and the holes in the cheese represent potential failures in the protection layers, such as:

Incidents are typically the result of multiple failures to address hazards effectively — represented by the holes in successive slices aligning. A management system may include physical safety devices or planned activities that protect and guard against failure. An effective PSM system has the effect of reducing the number of holes and the sizes of the holes in each of the system's layers, thereby reducing the likelihood that they will align.

▲ **Figure 1.** The Swiss cheese model illustrates that when the weaknesses in layers of protection align, an accident can occur.
