The primary focus of this presentation are the circumstances leading up to the Columbia shuttle disaster. However, to emphasize that Columbia was not a one-of-a-kind event, and to illustrate the potential consequence of failing to acknowledge and address cultural weaknesses, the Challenger shuttle disaster (which occurred 17 years before) is described, and parallels are drawn.

Also, to provide relevance to our industry, the Piper Alpha and Flixborough disasters are described in a way that emphasizes the general applicability of the safety culture learnings from Columbia.

Most of the information in this presentation was taken from from the publicly available investigation reports. The *Process Safety Culture* project team feels that the lessons and organizational root causes identified in these four investigations are applicable to all organizations that operate facilities handling hazardous materials or that engage in hazardous activities.

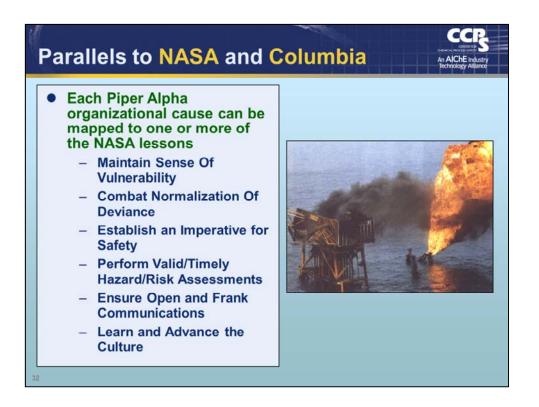
The investigation also revealed that personal safety and emergency response training was haphazardly conducted. A visitor to the platform was to receive safety training, including training on the use and location of the lifeboats, if this was the first visit to Piper Alpha, or if more than 12 months had elapsed since the last refresher training. Some survivors recounted that such training was waived if they had ever previously been offshore anywhere else. Some were unaware of their lifeboat assignments or where to find them.

Evacuation and emergency shutdown drills were scheduled, but often deferred due to weather conditions or other conflicts.

Platform mangers had not been trained/drilled on the proper responses to major emergencies on other platforms, hence the confusion as to whether they should have suspended production after learning that there were problems on Piper Alpha. To complicate this matter, different platforms were owned by different companies.

The lack of effectiveness of the Piper Alpha platform manager during the emergency (he was one of the staff who evacuated to the crew quarters and suffocated there) lead the inquiry to question the adequacy of his training.

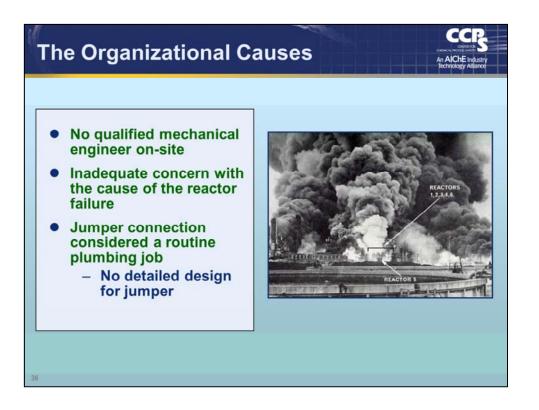
The installed jumper was leak checked at normal operating pressure, but the system was not pressure tested in a fashion appropriate for this sort of modification to a pressurized process system. Had the jumper been tested at 1.3X the reactor design pressure (as required by British standards) it would have likely failed... hopefully preventing the explosion that subsequently occurred.

It is believed that the unbalanced forces imposed on the bends in the piping, coupled with the flexibility introduced by the expansion bellows on each end of the jumper, allowed the inadequately supported and unconstrained jumper to oscillate. Ultimately, one of the bellows failed.

[The figure shows the installed jumper, supported on scaffolding. Surprisingly, perhaps, the jumper remained in service for two months before failing.]

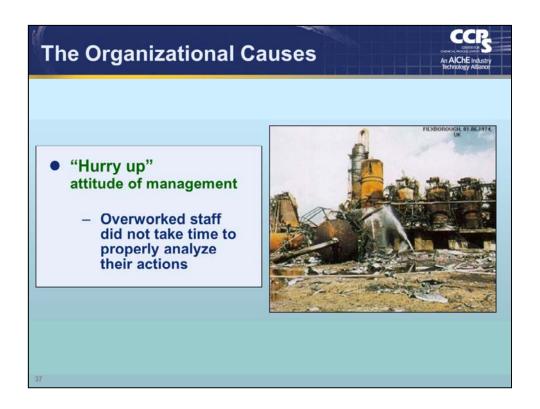
The works engineer had resigned earlier in the year. While there were chemical and electrical engineers on staff, there was no qualified mechanical engineer employed at the site.

In the perspective of the staff involved in planning and implementing this modification, this was a routine plumbing job. No detailed design was provided for the jumper; in fact, the "design drawing" consisted of a chalk sketch on the maintenance shop floor.

Even though reactor 5 had experienced a six-ft long crack, it was decided that there was no need to inspect the other five reactors, which were exposed to similar service conditions. The investigation team suggested that the time required to make this inspection might have provided staff an opportunity to reflect on, and reconsider, their hasty plans to jumper between the reactors.

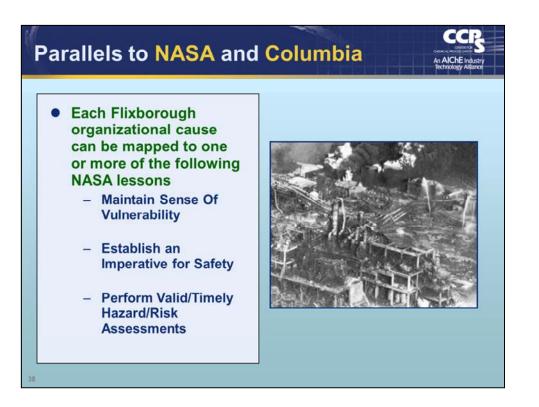
The investigation team did not fault the safety attitude of company and site management, but did imply that there was a lack of appreciation of the impact on plant staff resulting from the departure of the works engineer, and the emphasis on a prompt return to production.

Workloads were increased by the absence of the works engineer, and some staff were working in areas not consistent with their areas of competence.

The investigation team concluded that these factors prevented staff from taking the time necessary to properly evaluate their plans and actions.
