Process Safety Beacon

Pressure Explosion Results

April 2005

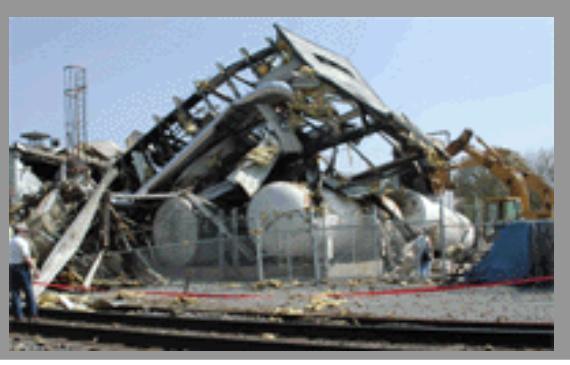
This accident investigated by and picture provided by the U.S. Chemical Safety and Hazard Investigation Board. Visit their site at http://www.csb.gov

A tank in this 55 year old facility that produces caramel coloring exploded, killing one worker and heavily damaging other equipment. Vessel fragments were thrown as far as 150 yards/130 meters and the top head of the vessel was propelled 100 yards/90 meters. Shell fragments damaged adjacent structures and equipment including an aqua ammonia tank. This resulted in the release of 26,000 pounds/12,000 kgms of aqua ammonia, causing nearby residents to be evacuated or told to shelter in place.

Other major damage included collapsed concrete block walls, destruction of the spray dryer area as shown in the photograph, and the rupture of a 6 inch natural gas line. Fortunately, automatic shutoff valves in the gas line prevented a major gas release.

Never completely block in a vessel. Some form of emergency or manual pressure relief (or vacuum break) system must be available.

Vessels that are heated should be monitored closely—especially if there are no safety instrumented systems or interlocks to shut off the heat source if needed.

Before connecting an air or nitrogen line to a vessel, make sure that the vessel can withstand the full supply pressure or that the vessel has a suitable relief system set low enough to protect the vessel.

The explosion was a simple case of over-pressurization.

The contents of the feed tank were overheated by steam coils, causing the vapor pressure to rise. There were no temperature alarms or interlocks to automatically stop the steam flow or notify operations that there was a problem. Because the operators were distracted by having to re-label a previously packaged order, they did not notice that the temperature in the tank had risen above specifications. At the same time the temperature was rising, the operators closed a vent line and opened an air pressurization line to the tank in an effort to "blow out" high viscous material. That act completely blocked in the vessel which had no emergency relief system. The result catastrophic failure to relieve the pressure.
