Liquefied Gas Cylinder Failure

December 2006

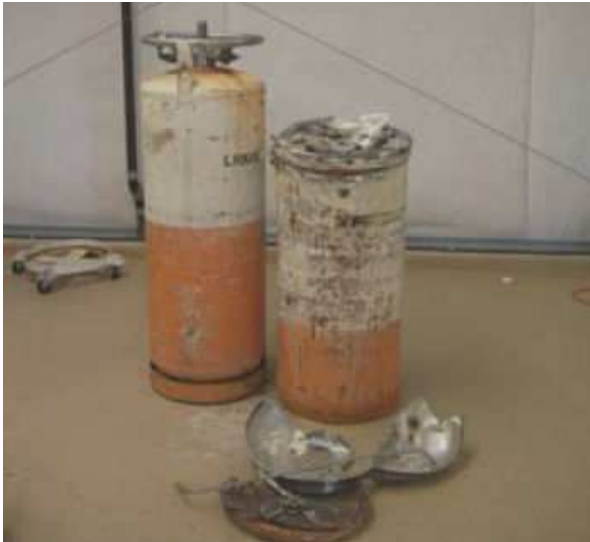
Intact cylinder and remains of ruptured cylinder

before the explosion, the leaking gasket had been replaced and the cylinder refilled with liquid nitrogen. With the new gasket, the cylinder was now completely sealed, and pressure could build up. The cylinder ruptured when its internal pressure rose above 1000 psi (69 bar). The catastrophic failure of the nitrogen cylinder was a result of the removal of the pressure relief devices.

A liquid nitrogen (Dewar) cylinder in a university chemistry laboratory catastrophically failed due to over pressurization, causing substantial damage. Fortunately the incident occurred at 3 AM and the building was not occupied, so there were no injuries. The over pressurization blew out the bottom of the cylinder and propelled the cylinder upwards. The cylinder pressure relief valve and rupture disc had been replaced by two brass plugs at some time in the past by an unknown person. Before the incident, the cylinder may have been leaking through an old gasket, providing sufficient release of gas to prevent over pressure.

Approximately twelve hours

- Never modify any equipment containing hazardous materials or energy without qualified engineering evaluation, and always conduct a management of change review.
- If you observe a high pressure or liquefied gas cylinder that appears to have been modified, or is corroded or otherwise damaged, report it to supervision immediately so it can be removed from service.
- Ensure that cylinders are properly maintained and periodically inspected, including the pressure relief devices.
- If you use pressurized gas cylinders, make sure you are properly trained in the safe handling of high pressure cylinders.
- Share this incident with your colleagues in the laboratory who may use pressurized gas cylinders.
- Read the Texas State Fire Marshall's Alert on this incident: <http://www.tdi.state.tx.us/fire/documents/fmred022206.pdf>

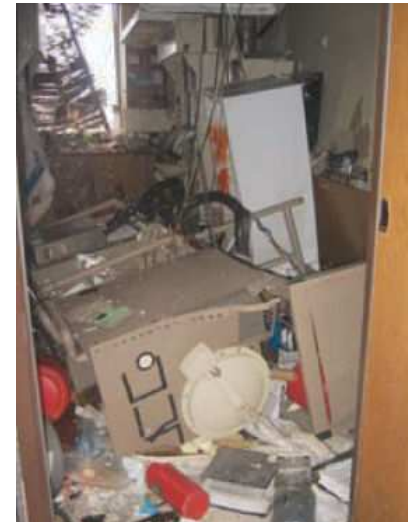
Laboratory Damage
