Check your equipment before you start the job!

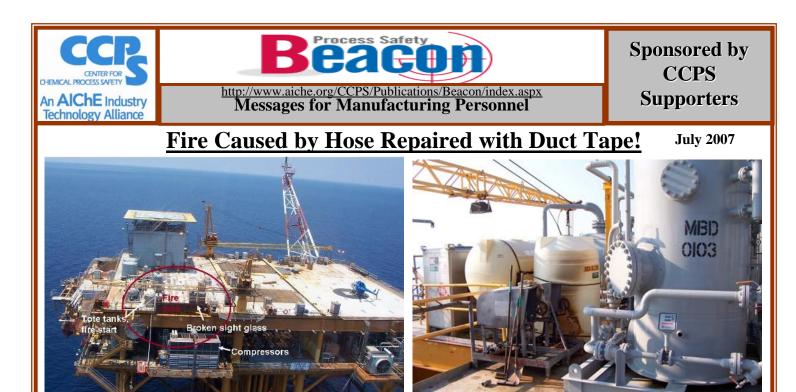
On an offshore oil platform, operators were transferring methanol from a portable chemical transporter tank connected by a hose to a storage tank. When the tank was lifted by a crane to gravity feed the storage tank, methanol began spraying out from a hole in the hose. The methanol ignited on the top deck. Methanol that was sprayed over the side also ignited by the hot exhaust of a compressor located immediately below the transfer point on the second deck. The fire was compounded by the breaking of the transfer tank's sight glass when a crewman attempted to kick the valve closed. The fire spread as relief valves on two other chemical transport tanks opened.

After twenty-two 30-pound hand-held chemical fire extinguishers, two 125-pound wheeled fire extinguisher units, and the firewater system were used, the fires on both decks were contained. One man received second-degree burns. After the fires were extinguished, it was discovered that the hose used to feed methanol from the transporter to the storage tank was split and had been repaired with duct tape prior to the operation!

- NEVER make temporary or unauthorized repairs on equipment in hazardous material service without a management of change review by qualified personnel.
- ALWAYS inspect equipment before using it. If there is any sign of damage, corrosion, improper repair, or any other defect, replace the equipment before you start the job.
- Avoid transferring flammable products near ignition sources such as compressors.
