Messages for Manufacturing Personnel

## Thirty Years Ago – An LPG Tragedy

November 2014

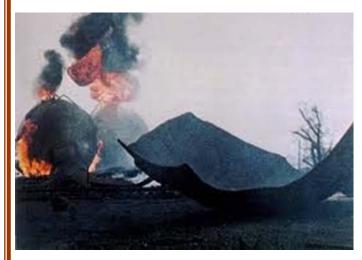
At about 5:30 AM on November 19, 1984 there was a major fire and a series of explosions at a liquefied petroleum gas (LPG) storage and distribution terminal at San Juan Ixhuatepec, Mexico City, Mexico. There were approximately 600 fatalities, approximately 7,000 injuries, 200,000 people were evacuated, and the terminal was destroyed. The blasts were recorded on a seismometer 20 km (12.4 miles) away, and the largest blast registered 0.5 on the Richter scale. Most of the injuries and fatalities were in the surrounding community – people were living as close as 130 m (425 ft.) from the terminal.

- Understand the magnitude of a potential incident in your plant, and what safety systems are in place to prevent and mitigate the event
- Report all failures of safety systems and equipment and ask your management to have them repaired.
- Check that all pressure relief devices are inspected and maintained as required by your plant's policy.
- Confer with your safety and production engineers to determine how to manage risk, including the possibility of shutting down, if critical safety equipment is not working properly.
- Remember that poor housekeeping in a plant is often a symptom of a poor safety culture. Take care of your plant and all of its equipment, especially safety equipment.
