Management of Change

July 2017

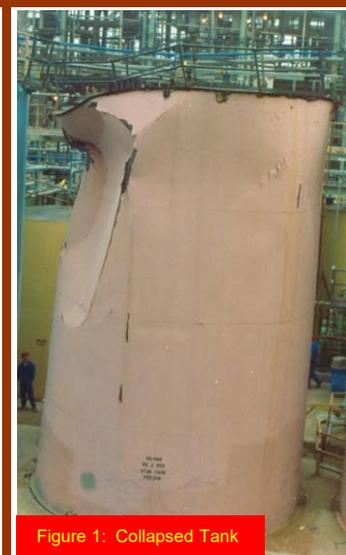
Figure 1: Collapsed Tank

Incident 1: The vent system on a low pressure storage tank 20 ft (~ 6 m) diameter and 30 ft (~ 9 m) high was modified to reduce environmental emissions. The tank had operated for 20 years with a nitrogen blanket and a simple hinged breather vent to provide overpressure and vacuum protection. The new system was much more complex, including a compressor and more complex piping. The tank was returned to service and filled. The first time it was emptied, the tank collapsed (Fig. 1) because it was not properly vented. Fortunately there were no leaks or injuries, but the tank had to be replaced.

In Incident 1, the MOC review was done, but all operator training was not completed. The training focused on the new vent compressor and condenser. The training did not stress the critical importance of a ½ inch (13 mm) valve on instrument tubing which controlled pressure/vacuum protection. After the collapse, that tubing valve was found closed, and it was key to protection of a complex system. The valve should have been locked or otherwise sealed open. The design and training could have been simplified to reduce the likelihood of human error. Small details can provide opportunities for human error which have big consequences.

- Make sure you are trained on any changes to your plant, and that you understand how to operate modified equipment. Get help if you are required to operate modified equipment without training.
- Never make changes to the piping or equipment in your plant without following your plant's MOC process.
- If any equipment, existing or as modified by a change, is complex and likely to result in human error, tell management and engineering and ask them if the equipment can be simplified.
- Completely understand any changes made to equipment owned by others, such as a trucking company, when it is used in your plant.
- When transferring material, make sure that **all** valves are in the correct position (see the August 2015 *Process Safety Beacon*).

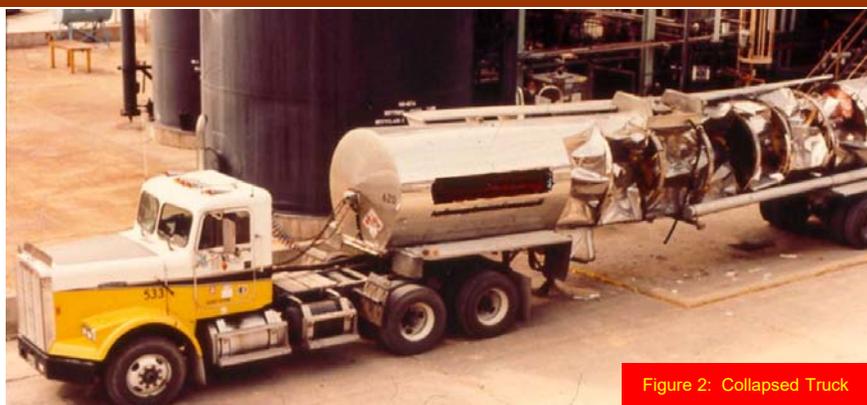
Figure 2: Collapsed Truck

Incident 2: A tank truck owned by a trucking company had been modified with tubing so that a nitrogen hose could be connected to the tank without somebody climbing a ladder on the truck. There was a valve in the nitrogen line on the top of the truck, and it was mistakenly left closed. The tank truck was pumped out using a plant pump and, with no nitrogen flowing to the tank, a vacuum was created and the tank catastrophically collapsed (Fig. 2). The tanker did have a pressure/vacuum relief device, but it failed.

In Incident 2, there was no MOC review for what seemed to be a minor change, which was made by the truck owner. The truck driver misunderstood the operation of a new type valve and he inadvertently left the nitrogen valve on top of the truck in a closed position when preparing to unload the truck.
