Ice Ruptures Unused Pipe and Causes Fire!

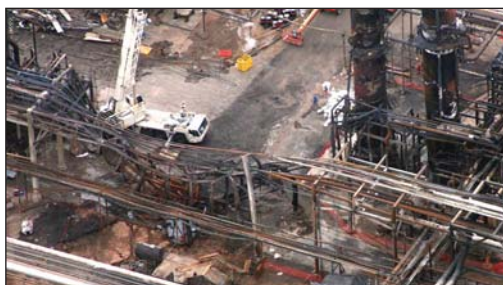
A section of piping in a refinery unit was taken out of service during a process modification. The unused piping was not physically removed, nor was it isolated from the active piping with slip blinds. Instead, it was isolated from the connected piping by closed isolation valves. The active piping contained liquid propane under high pressure, and the propane contained a small amount of liquid water entrained as a separate water phase. Debris jammed in the seat prevented one of the isolation valves from closing fully. This allowed wet liquid propane to leak from the active piping into the unused piping. The water, which is heavier than propane, accumulated at a low point in the unused piping. During the winter, the water that had accumulated in the unused piping froze. When water freezes it expands, and this expansion caused a crack in the unused pipe. When the weather warmed, the ice melted and propane leaked from the active piping through the leaking isolation valve, and then out through the cracked pipe. A large flammable vapor cloud formed and ignited. The resulting fire caused four injuries, the refinery had to be evacuated, and it was shut down for nearly two months. The fire caused major damage to other equipment and piping, resulting in additional release of flammable materials and escalation of the fire. More than two tons of chlorine was also released from containers impacted by the fire.

- Make sure that all process modifications, including removal of equipment or piping from service, have a management of change review.
- Make sure that all equipment in your plant that is not in routine use is either physically disconnected from active equipment and piping, or positively isolated using slip blinds or other reliable isolation systems.
- Consider potential hazards of accumulation of material in pipe branches that are not routinely used or that have low flowrates.
- Be prepared for cold weather in winter. Make sure that you follow procedures to prepare the plant for winter, to prevent freezing of critical equipment.
