What Is Supporting Your Equipment?

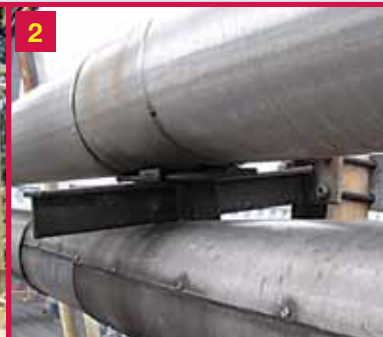
Picture 2: The steel supporting the pipes has bent, possibly because the weight of the pipes is more than the steel can support. Perhaps this was a result of a change. Was a second pipe added without considering the design of the supporting steel?

As you work in your plant, look for problems with poorly supported equipment, excessive vibration, or other issues. A good general rule: If it doesn't look like it did on the day it was installed, there might be a problem. Report problems to your management, and follow up to make sure that the problems are corrected.

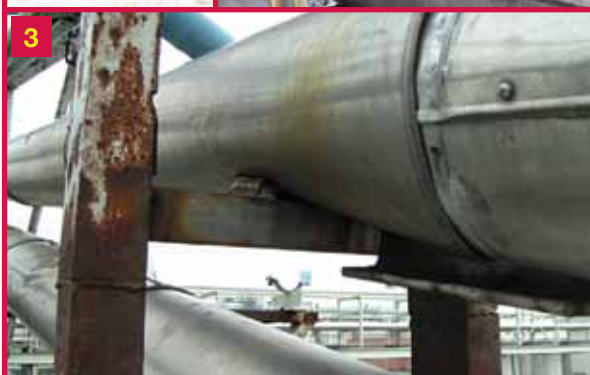
Picture 3: The pipe has moved horizontally and the pipe support stand has moved out of the support shoe.

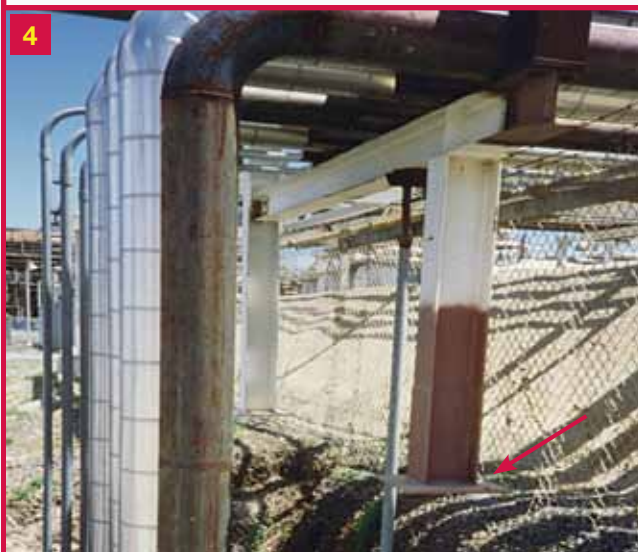
Picture 4: Look closely. The steel supports are not touching the ground. They are hanging from the pipes rather than supporting them.

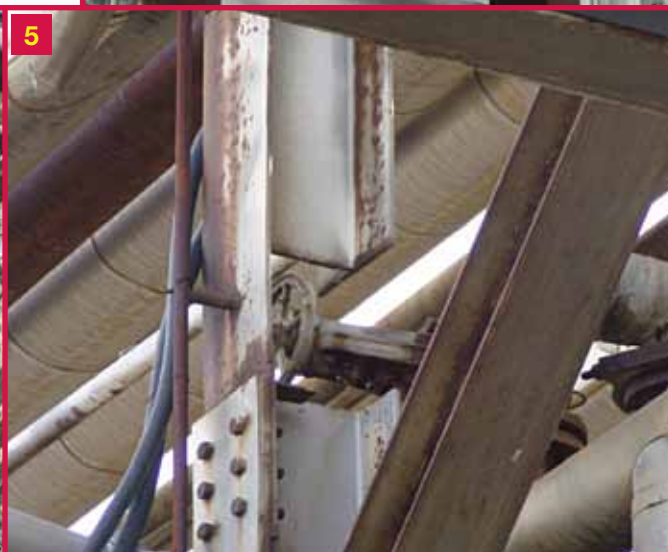
Picture 5: A section of the structural steel has been cut out to make room for a valve.
