Remembering Piper Alpha

This month marks the 25th anniversary of the *Piper Alpha* offshore oil platform disaster in the North Sea approximately 110 miles (180 km) from Aberdeen, Scotland. On July 6, 1988, a series of catastrophic explosions and fires destroyed the platform. Of the 226 people on the platform at the time of the event, 165 died, along with two emergency responders during a rescue attempt. The platform was totally destroyed.

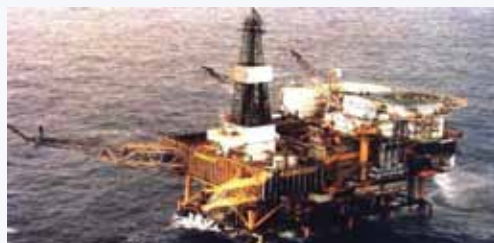
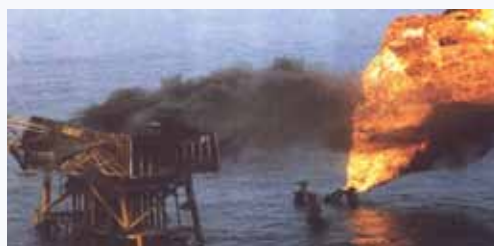
Investigation was hindered by a lack of physical evidence. Based upon eyewitness accounts, investigators concluded that a release of light hydrocarbon occurred when a pump was restarted after having been prepared for maintenance. Unknown to the workers starting the pump, a relief valve in the pump discharge had been removed for maintenance. A blank had been loosely installed in place of the relief valve at a location that was not readily visible. When the pump was started, this blank leaked, producing a flammable cloud that subsequently found an ignition source. The pump was started at about 10 p.m., and by 1 a.m. the platform had been entirely destroyed and most of its occupants had been killed.

- Be complete in documenting the status of all equipment in your plant logs. At the end of your shift, clearly communicate the information to the incoming workers. Take the time to make sure they fully understand the status of all operating equipment, and the status of all maintenance jobs.
- Always follow work-permit procedures exactly as required, including all documentation, communication, and recordkeeping. Do not take shortcuts, and be sure to personally check everything on the permit. Never assume that things have been done correctly — if you are going to sign the permit, check it yourself.
