Boone Dam Hydro-Geo Model and Seepage Remediation

Patrick V. Kiser, PE
GCP&S Manager, Civil Engineering
01 December 2015

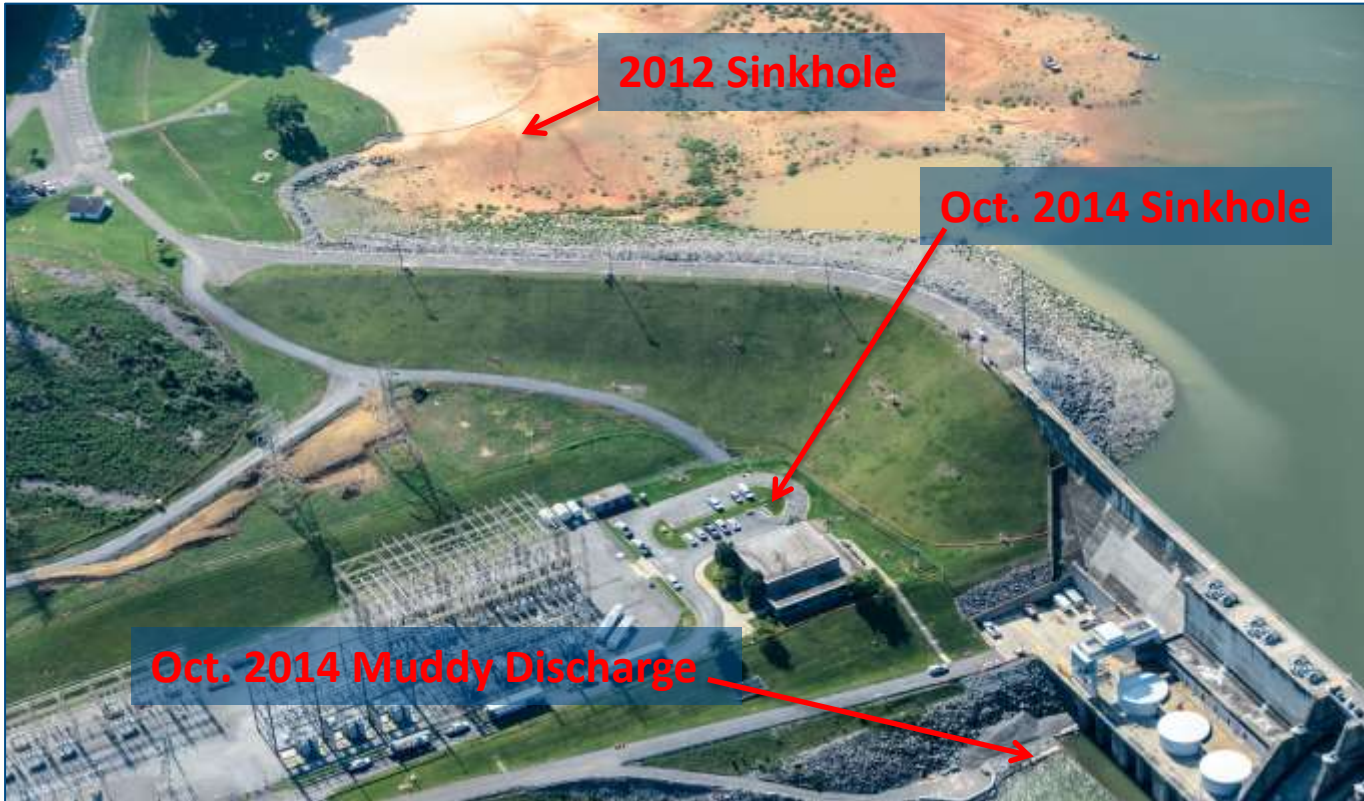
Muddy Seep in Tailrace

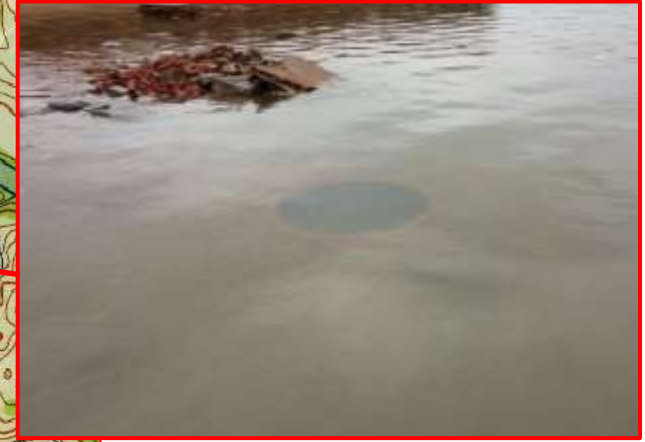
Artesian well in reservoir indicates higher head from regional groundwater recharge

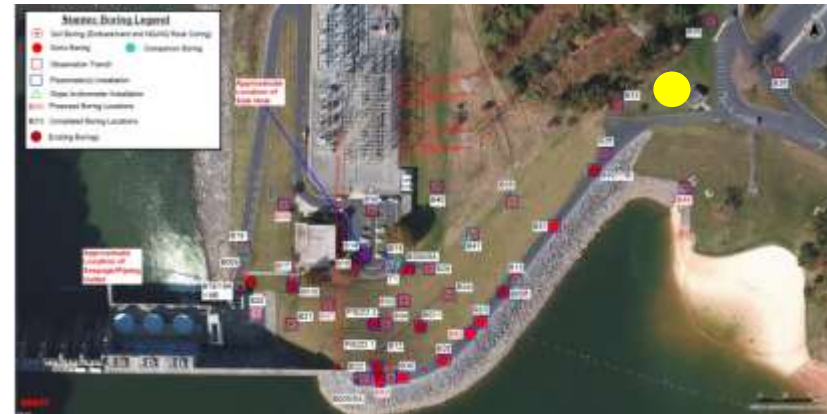
Piezometric data indicates heads significantly higher than headwater in the right rim and flow paths toward the toe. B-27, shown below, is ~ 20 feet higher than the current headwater.

Upstream of cutoff

Tip in Epikarst from Elev. 1389 to 1364

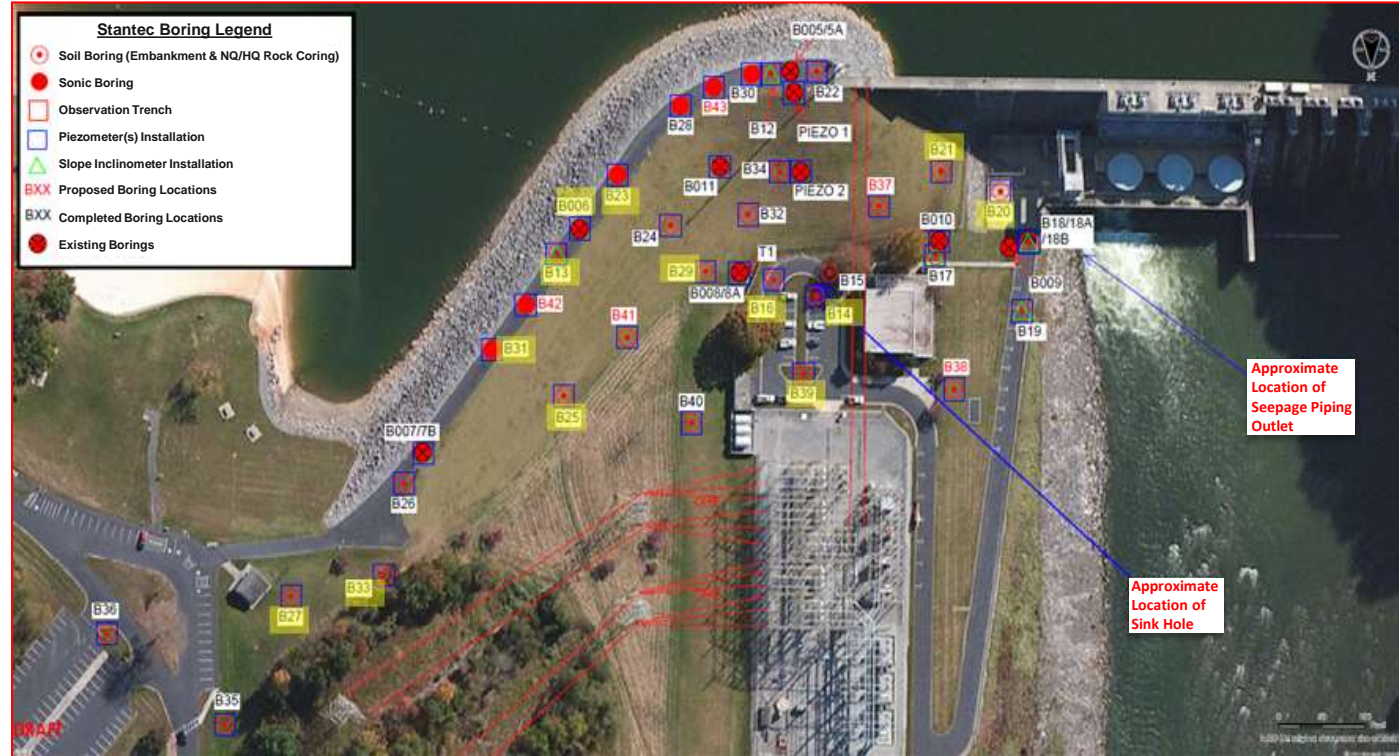
Piezometers
with response
to high
infiltration event

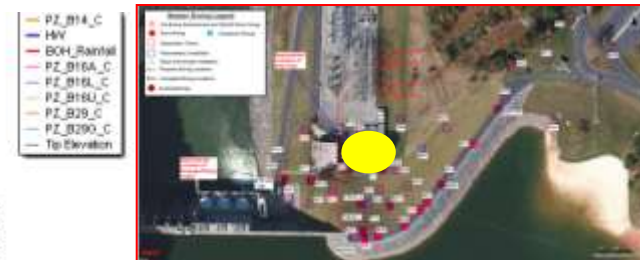
Piezometers at downstream toe respond to high infiltration event

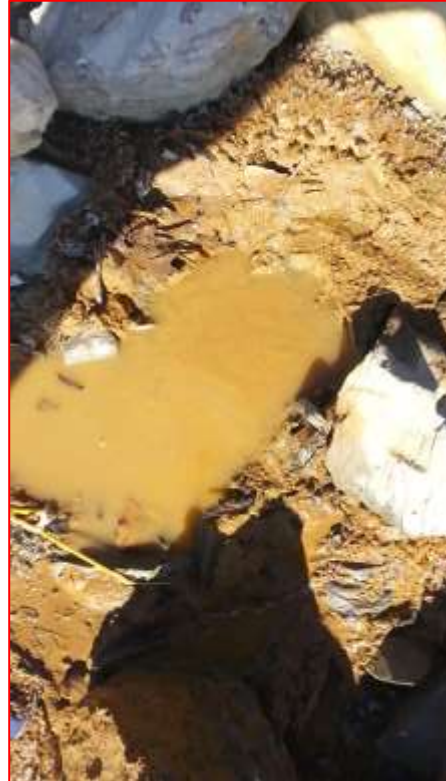
Seep #2
Video

Following a high infiltration event on March 5, 2015 muddy seeps were observed along the upstream face of the dam

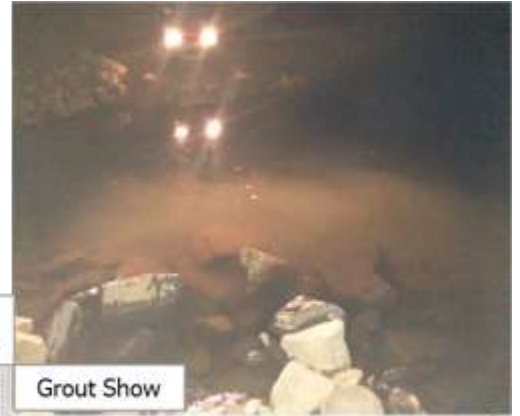
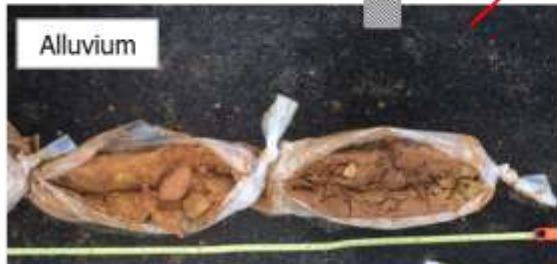
B-30 Grout Event

Grouting of the B30 instrument pushed grout from downstream of the cutoff to the reservoir

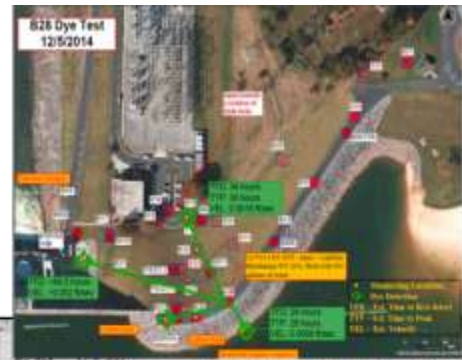
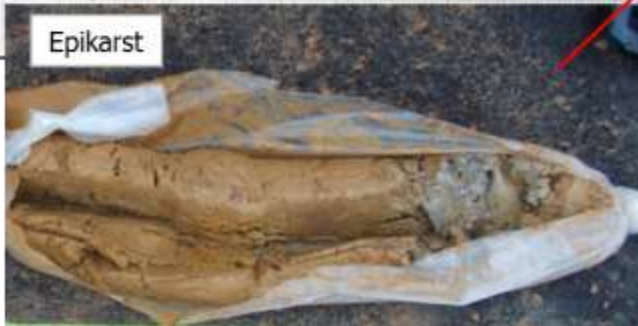
B-28 Dye Test

B28 dye test pushed dye from downstream of cutoff to the upstream of the cutoff
